Post Hurricane Irma Engineering Evaluation of Southpoint Condominiums Fort Lauderdale, Florida

Prepared for:

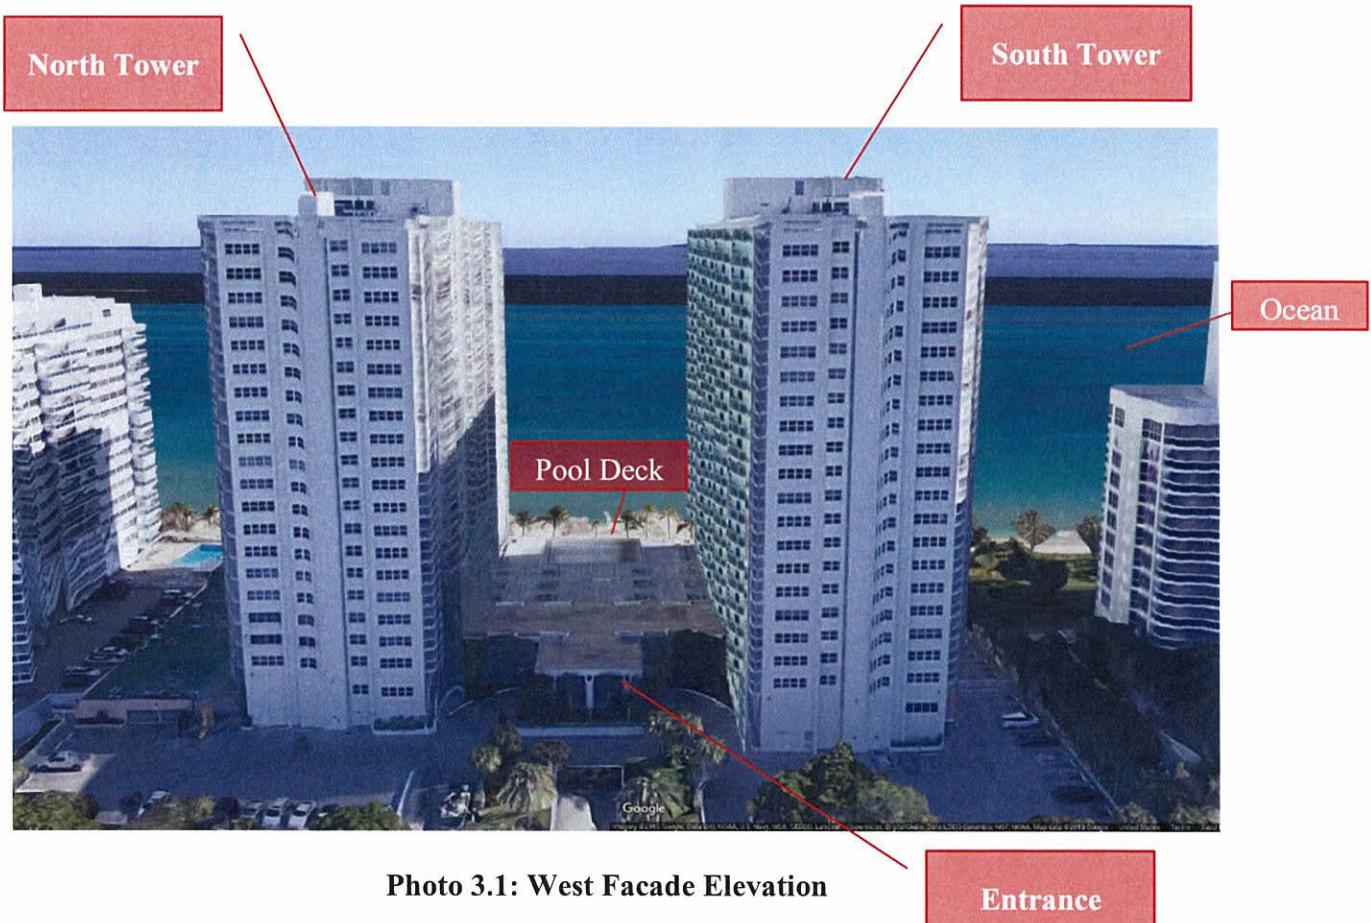
Similarly, the structural system of the buildings consists of reinforced concrete columns, beams, supporting the slabs and block walls. The exterior walls are stucco clad masonry with aluminum framed glass windows and doors that lead to the balconies with aluminum railings and glass panels. The balconies are distributed and located at the south and north direction. The interior partitions are mostly drywalls with metal studs. The beams, block walls, and floor slabs resist and transfer the lateral wind loads imposed on the building to the foundations.

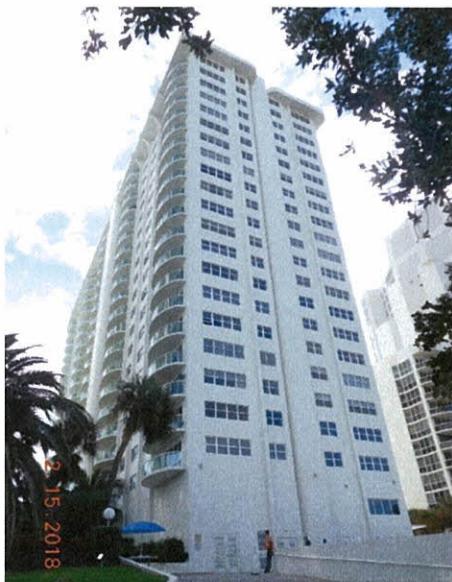
Photo 3.2 South Tower West Elevation

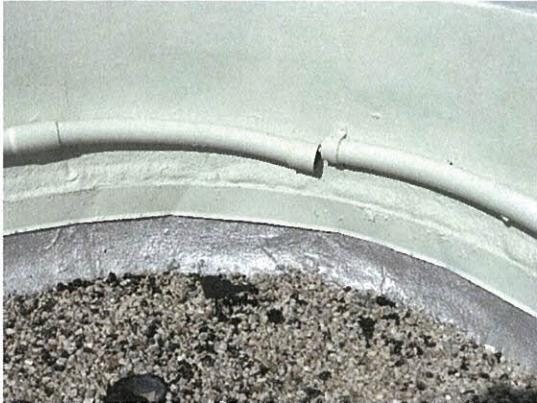
Photo 5.1.1.1 Damaged conduit pipe at roof parapet wall detached by the wind pressures exerted on the building from the Hurricane.

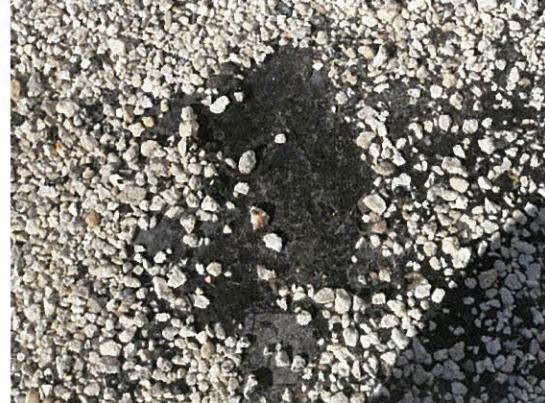
Photo 5.1.1.2 Cracked roof membrane from sun exposure as Irma's winds displaced gravel.

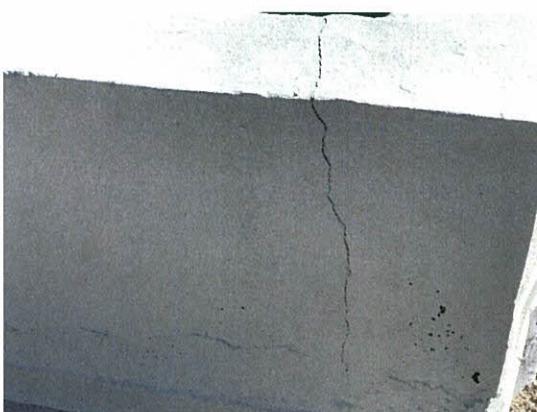
Photo 5.1.1.3 Parapet concrete wall crack on east side of the south tower caused by the wind buffeting to the building envelope generated by Irma's wind pressures.

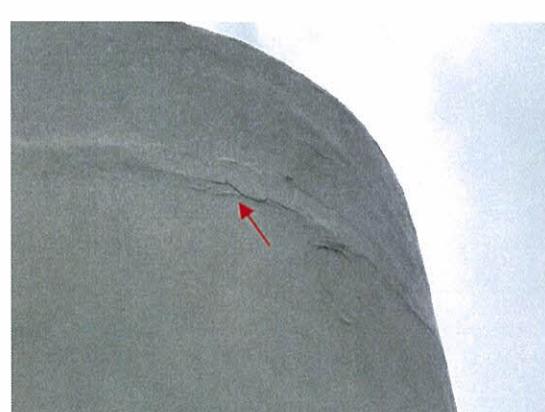
Photo 5.1.1.4 Cracked stucco at machine room wall from building and building components movement due to the wind pressures caused by Irma. Water intrusion occurring at this location.

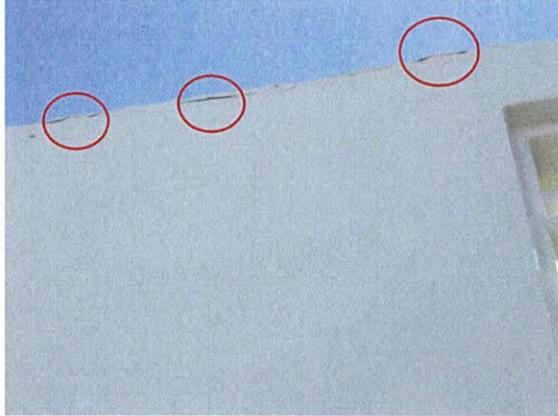
Photo 5.1.1.5 Openings at wall cap of machine room at the roof level caused by stresses produced by Irma's strong wind pressures.

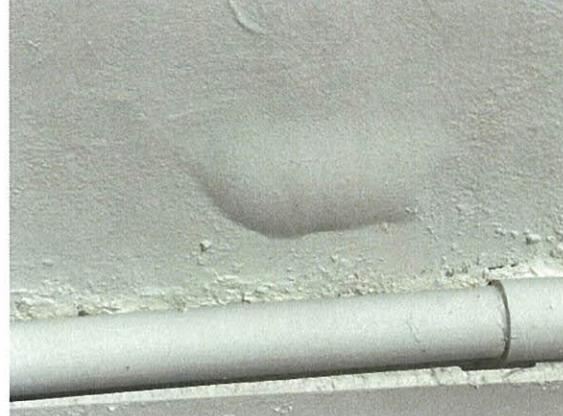
Photo 5.1.1.6 Blisters at parapet wall above the counterflashing from water infiltration via cracks at wall which were caused by the wind buffeting due to Irma's wind pressures.

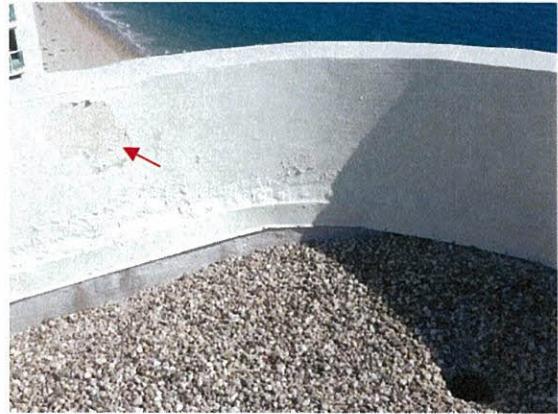
Photo 5.1.1.7 Coating delamination from water infiltration via cracks at wall caused by Irma's combination of intense wind pressures and rain

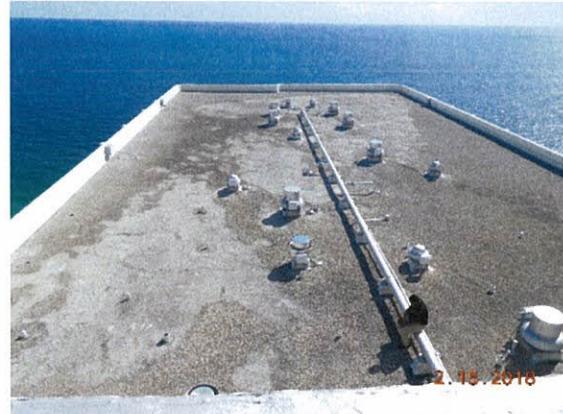
Photo 5.1.1.8 Displaced roof gravel caused by Hurricane Irma intense wind gust

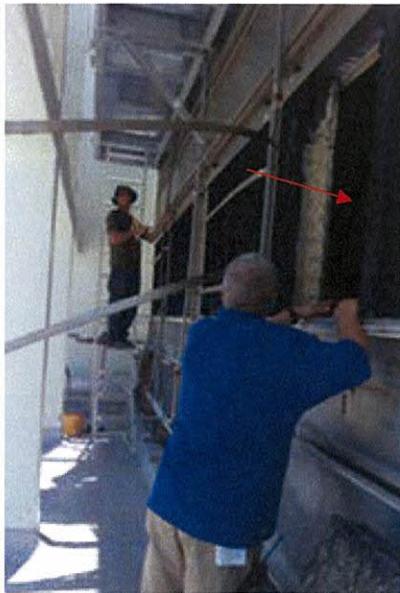
Photo 5.1.1.9 Blown out cooling tower filters caused by the wind buffeting due to the Hurricane's pressures.

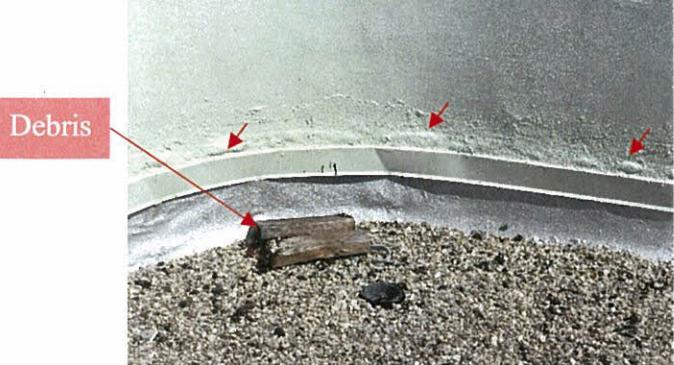
Photo 5.1.2.1 Blister at parapet wall above counterflashing from water intrusion via cracks at wall from the wind buffeting exerted to the building caused by Irma's strong wind pressures.

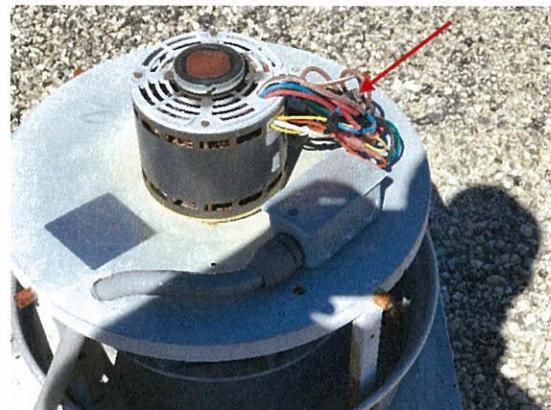
Photo 5.1.2.2 Exposed conduits from blown out fan cover caused by Irma's wind pressure per building staff.

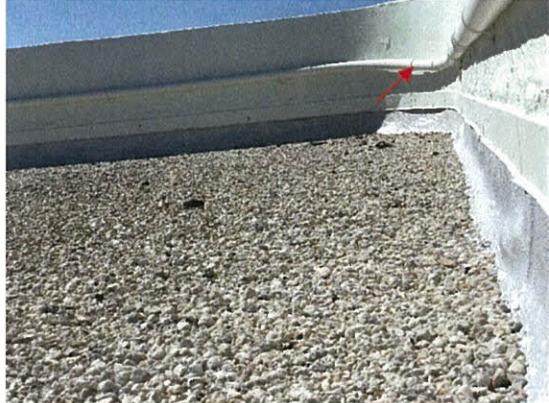
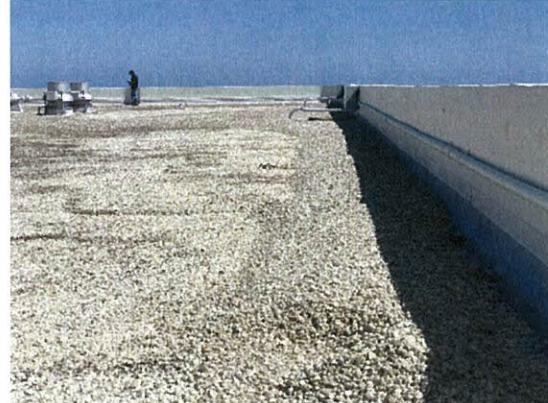
Photo 5.1.2.3 Loose pipe from blown out clamp due to the uplift forces produced by Irma's wind pressures at this location.

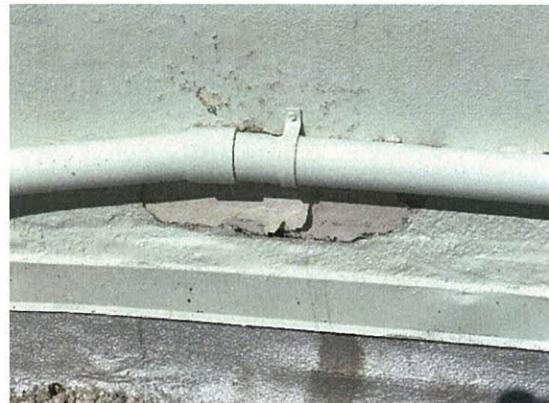
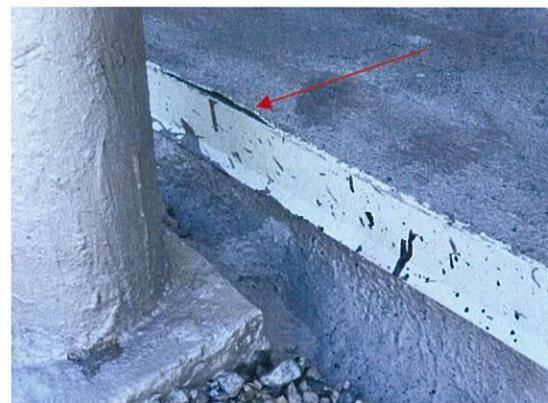
Photo 5.1.2.5 Delaminated paint coat caused by water infiltration through cracks at parapet wall from the wind buffeting caused by Irma's strong wind pressures.

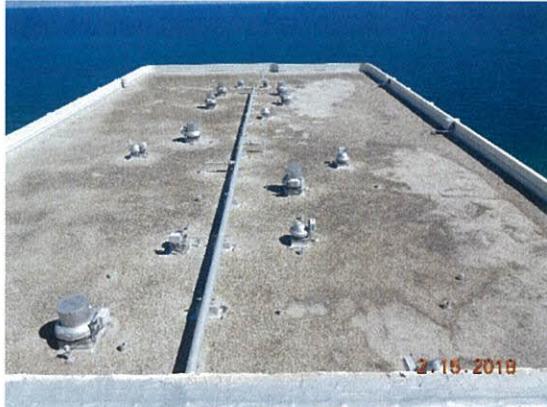
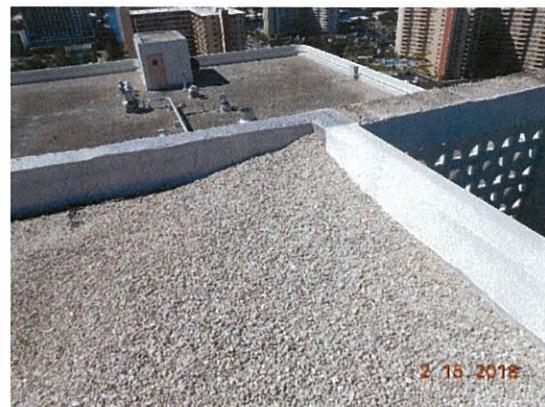
Photo 5.1.2.7 Displaced roof gravel caused by hurricane Irma intense wind gust.

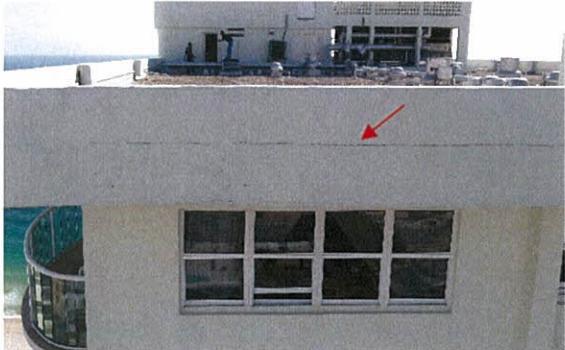
Photo 5.2.1.1 Horizontal crack at parapet wall of the south tower (north elevation) allow water to penetrate exterior and form blisters on the inner face of the parapet wall. Cracks along the building façade were caused by the building movement which occurred during the Hurricane.

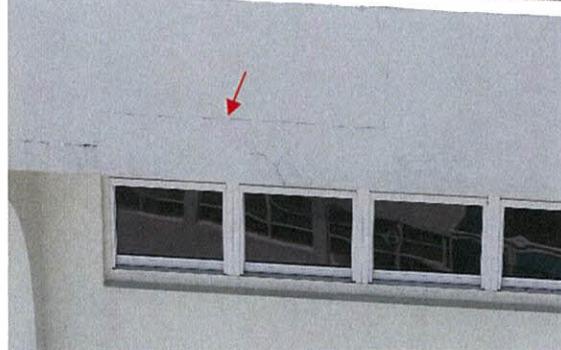
Photo 5.2.1.2 Horizontal crack at parapet wall of the south tower (south elevation) caused by the wind buffeting exerted on the parapet wall generated by Hurricane Irma's wind pressure.

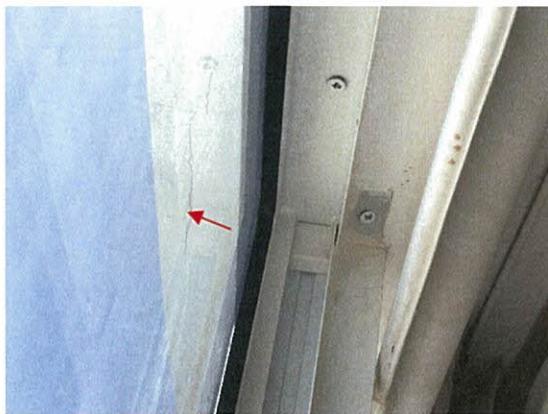
Photo 5.2.1.3 Window header crack caused by the wind buffeting of windows generated by the Hurricane wind pressures allowed water to infiltrate the interior of the unit (at unit 902S). Resident had no issues prior to Hurricane Irma.

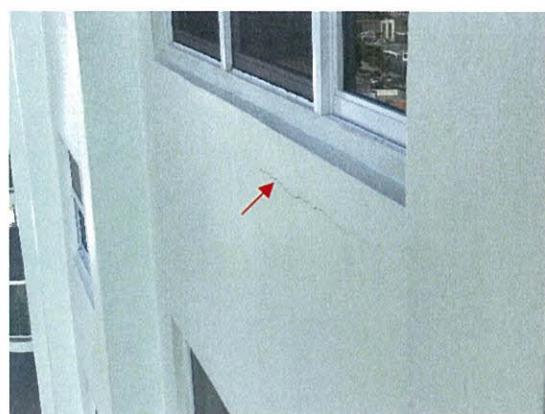
Photo 5.2.1.4 Wall crack at wall below window caused by the wind buffeting of windows produced by Irma's wind pressures allowed water to infiltrate the interior of the unit.

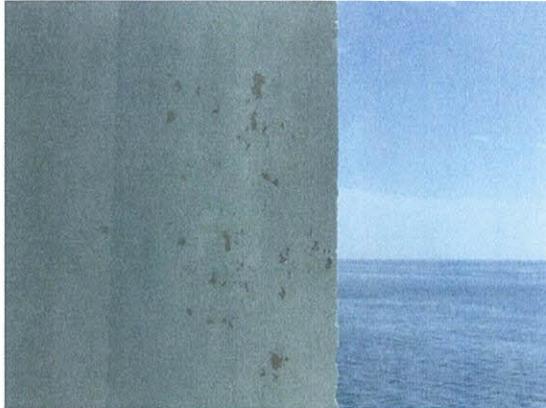
Photo 5.2.1.5 Paint delamination at column caused by Irma's wind pressures at the south tower.

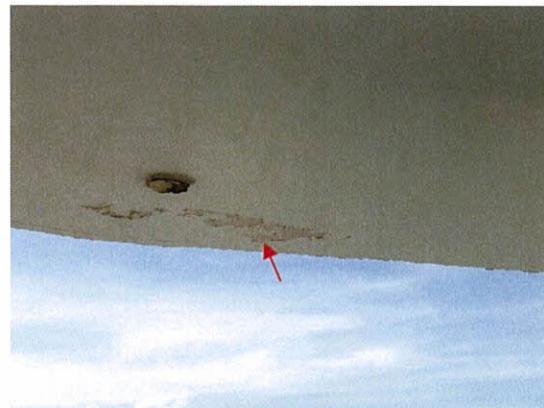
Photo 5.2.1.6 Paint delamination at projected slab soffit caused by Irma's wind pressures (observed from unit PH1S).

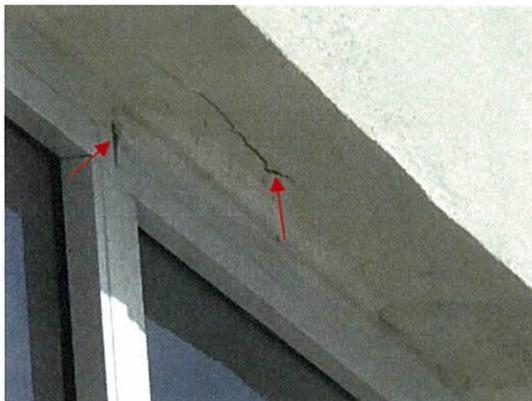
Photo 5.2.1.7 Crack at window header caused by the buffeting of windows due to Irma's wind pressures (1106S). Also, window frame is crack at midpoint.

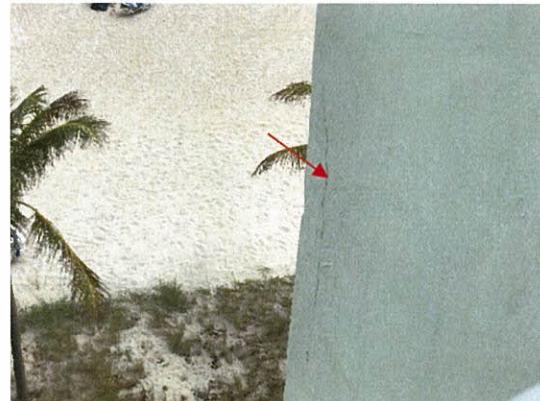
Photo 5.2.1.8 Cracked concrete column as observed from unit 501S caused by the building movement due to Irma's wind pressures.

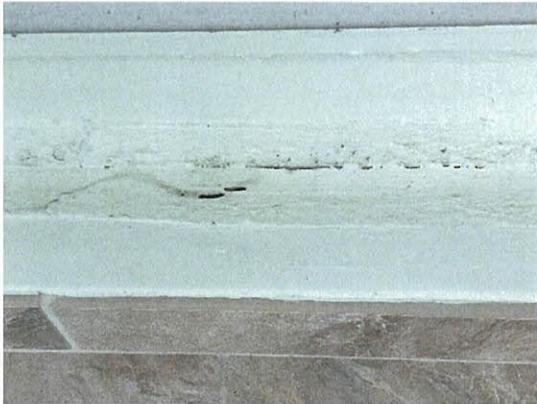
Photo 5.2.2.1 Voids observed at base of windows caused by the wind buffeting of windows produced by the Hurricane wind pressures (at unit 301N)

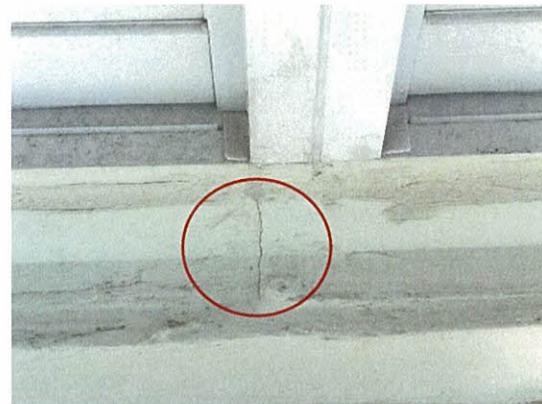
Photo 5.2.2.2 Cracks at base of balcony window (exterior) caused by the buffeting of windows produced by Irma's wind pressures observed at unit 1102N

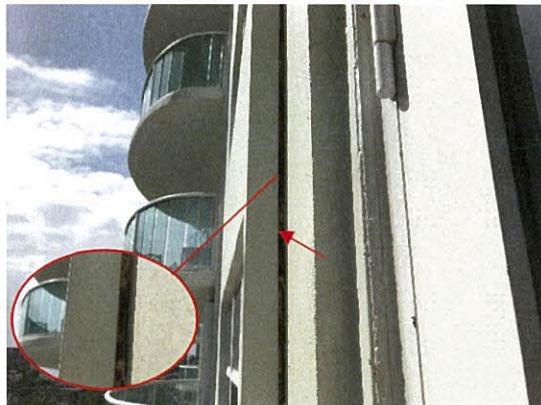
Photo 5.2.2.3 Cable cover detached from wall caused by the buffeting generated by Irma's wind pressures exerted on the building envelope. Water entered the unit interior through cable opening at wall (unit 406S).

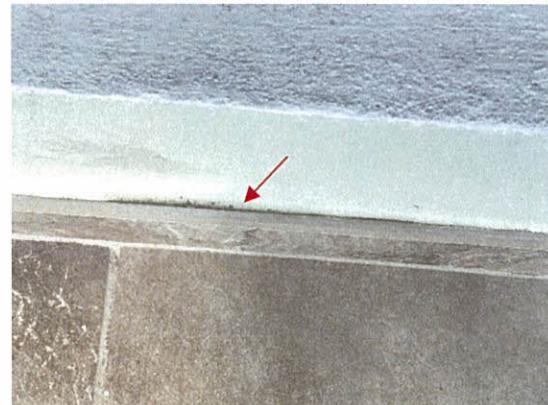
Photo 5.2.2.4 Cracked caulking at balcony wall base trim (exterior) at unit 2008S caused by wind buffeting of tiles due to wind pressures generated during the Hurricane.

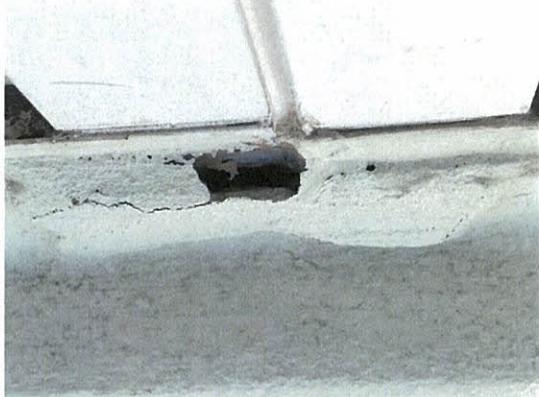
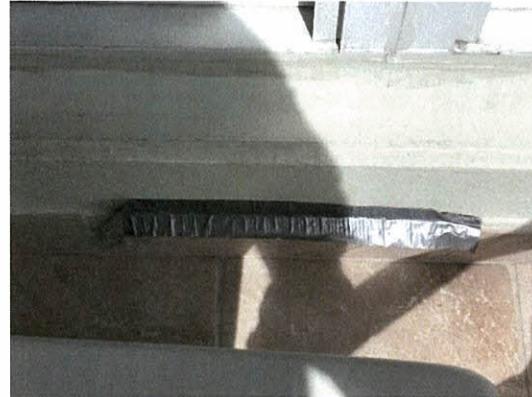
Photo 5.2.2.5 Perforated balcony window sealant from wind debris impact caused by Irma's wind pressures allowed water to infiltrate the unit. Resident covered opening with duct tape (1806S).

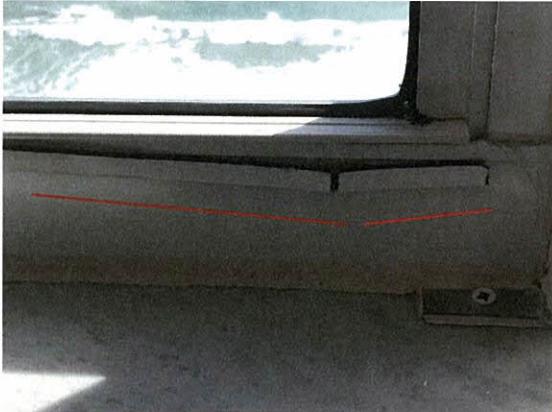
Photo 5.3.1 Damaged window frame (902S) caused by wind buffeting of the windows generated by the Hurricane Irma's wind pressures.

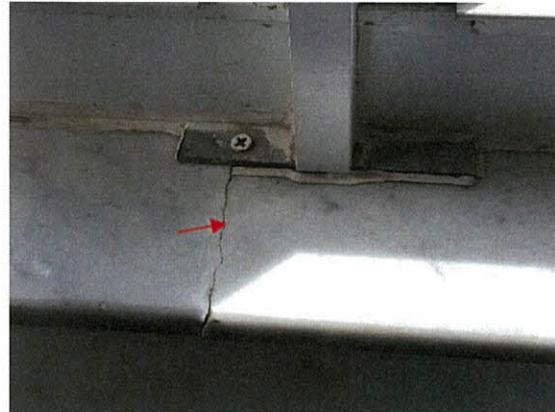
Photo 5.3.2 Cracked window sill and displaced window bottom connection caused by the buffeting of windows due to Irma's wind pressures (902S)

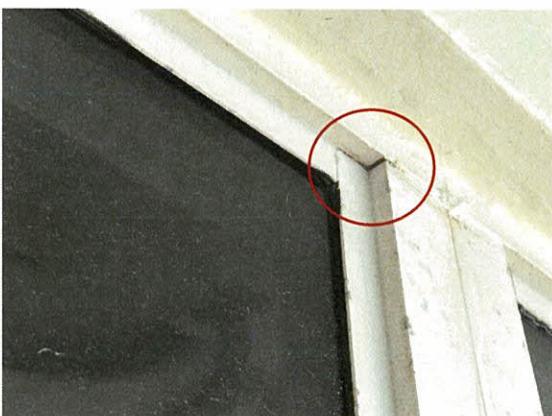
Photo 5.3.3 Cracked balcony window frame at top caused by the buffeting of windows generated by Irma's wind pressures (902S)

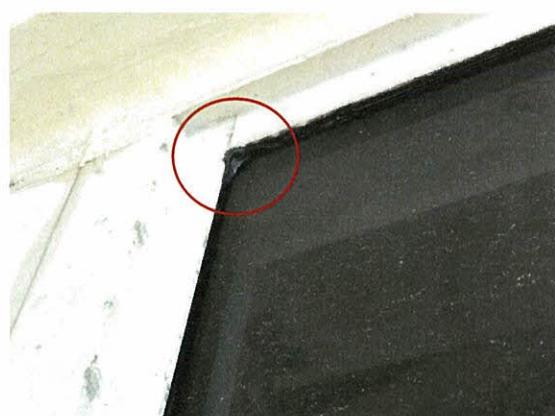
Photo 5.3.4 Damaged window gasket at balcony caused by the wind buffeting of windows from the Hurricane which displaced the rubber seal (gasket) (902S)

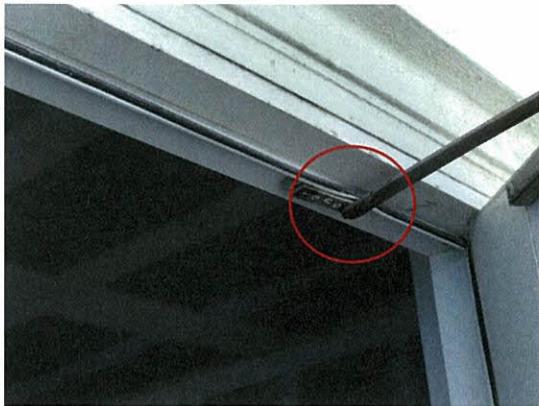
Photo 5.3.5 Bent balcony door frame at top caused by the buffeting of doors due to Irma's wind pressures (1701S)

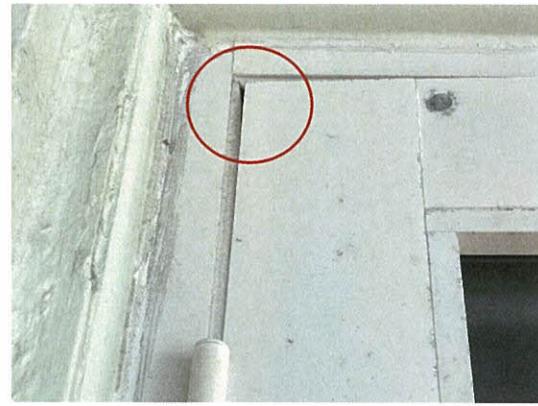
Photo 5.3.6 Separated door rubber seal caused by the wind buffeting at balcony door generated from Irma's wind pressures (1602S)

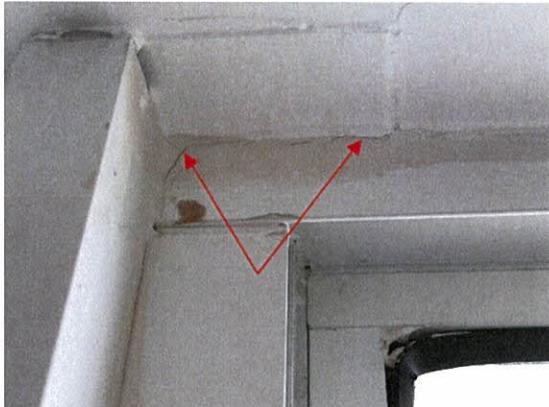
Photo 5.3.7 Cracked balcony window caulking caused by the wind buffeting produced by the wind pressures during Irma (1806S)

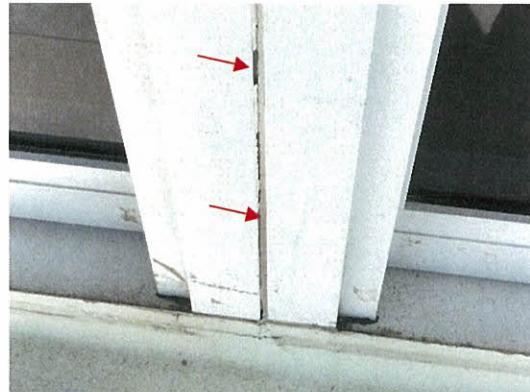
Photo 5.3.8 Cracked window caulking between window seams caused by the buffeting of windows generated by Irma's wind pressures (301N)

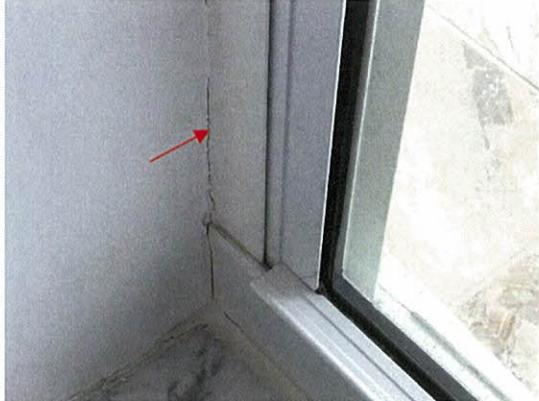
Photo 5.3.9 Cracked balcony window caulking caused by the wind buffeting of windows due to Irma's wind pressures (301N)

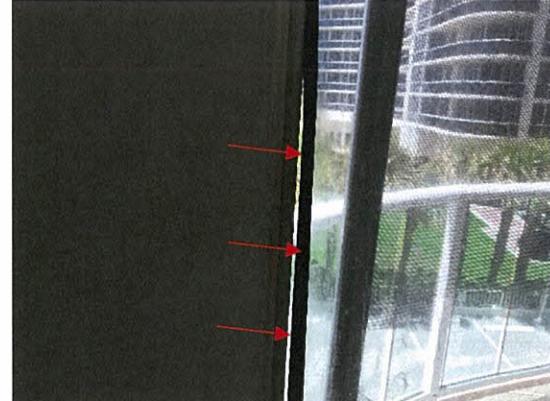
Photo 5.3.10 Failed sliding door assembly caused by wind buffeting of doors due to Irma's wind pressures (204S)

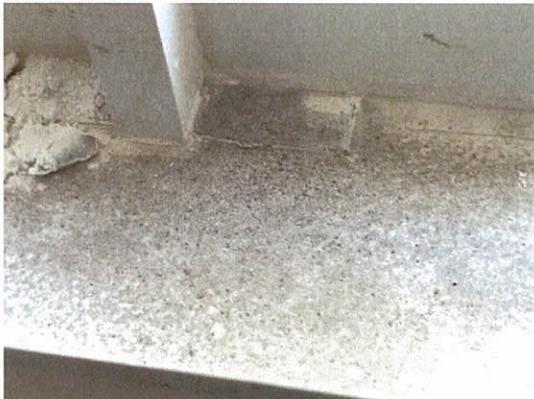
Photo 5.3.11 Sand infiltration at window sill in the bedroom from flexing of windows caused by the wind buffeting which occurred during the Hurricane (204S)

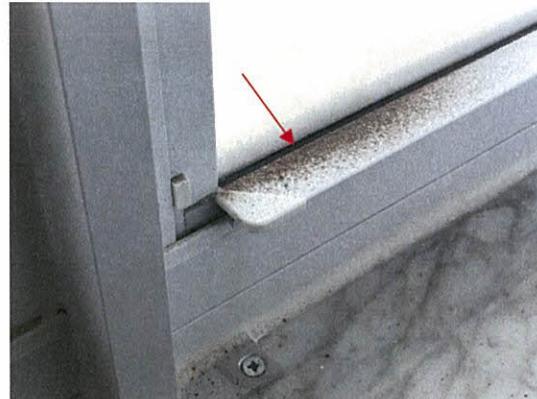
Photo 5.3.12 Sand infiltration accumulated at window lip which enter unit from flexing of windows caused by the wind buffeting that occurred during the Hurricane (PH8N)

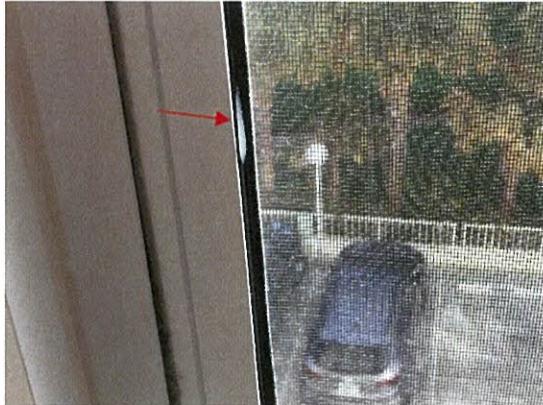
Photo 5.3.13 Displaced rubber seal at bedroom caused by buffeting of windows due to Irma's wind pressures (304S)

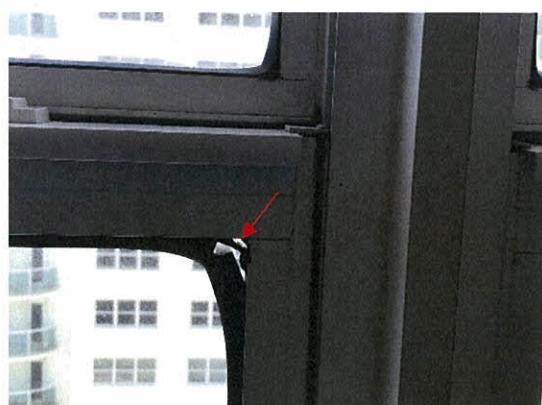
Photo 5.3.14 Displaced rubber seal at bedroom caused by the buffeting of windows generated by Irma's wind pressures. Evidence of wind entering through the window seal was observed (2104S)

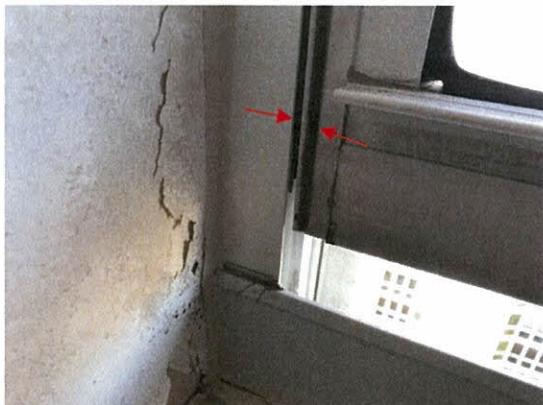
Photo 5.3.15 Racked window frame from buffeting caused by Irma's wind pressures (2106S)

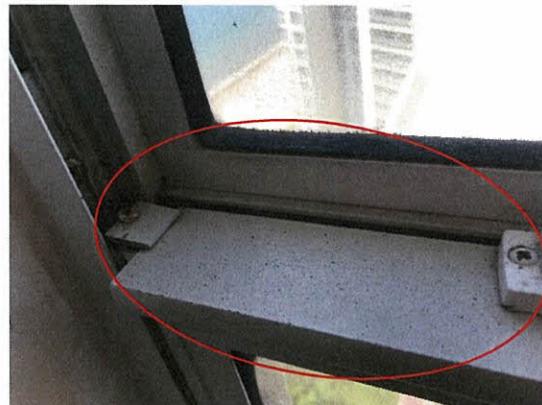
Photo 5.3.16 Sand intrusion through window opening caused by the buffeting of windows generated by Irma's wind pressures. See photo 5.3.15. (Unit 2106S)

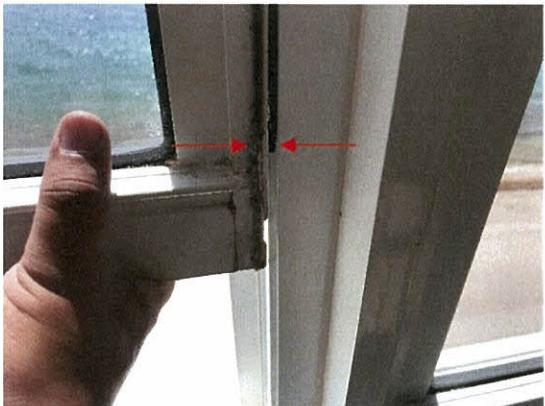
Photo 5.3.17 Racked window frame caused by the wind buffeting due to Irma's wind pressures (1502S)

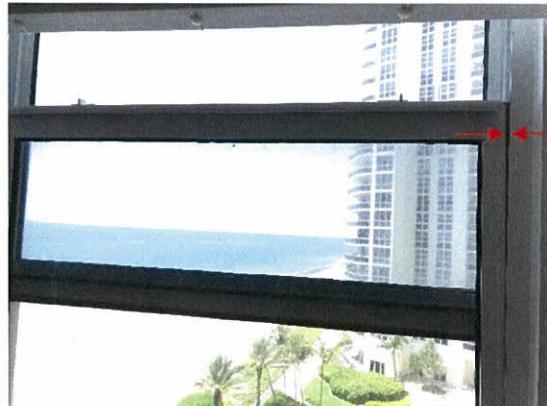
Photo 5.3.18 Racked window frame caused by the wind buffeting of windows due to Irma's wind pressures (702S)

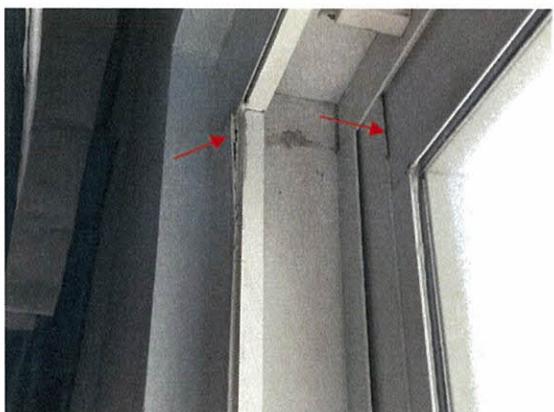
Photo 5.3.19 Separated window frame caused by the wind buffeting produced by the Hurricane's wind pressures (2006S)

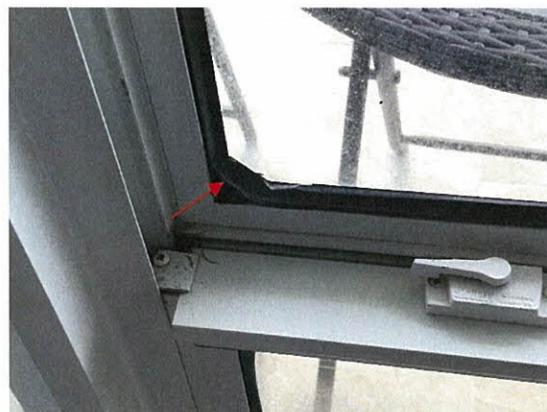
Photo 5.3.20 Displaced window rubber seal caused by the wind buffeting due to Hurricane Irma's wind pressures (2006S)

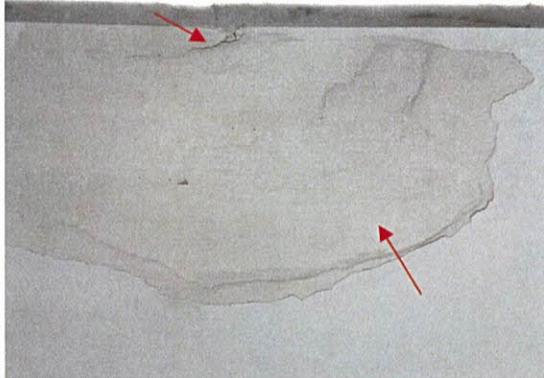
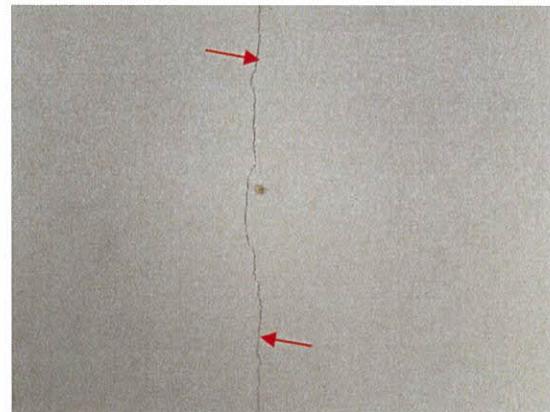
Photo 5.4.1.1 Delaminated coating from water infiltration which entered the unit through opening at window sill caused by the wind buffeting produced by Irma's wind pressures.

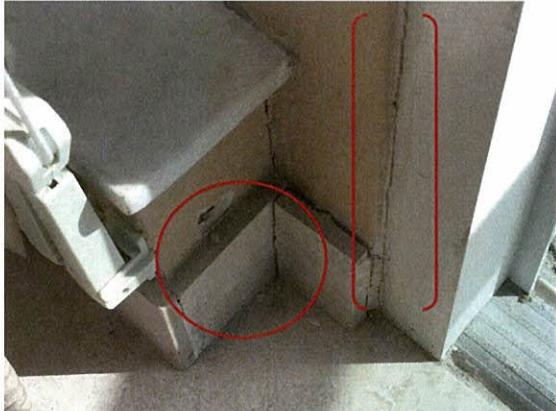
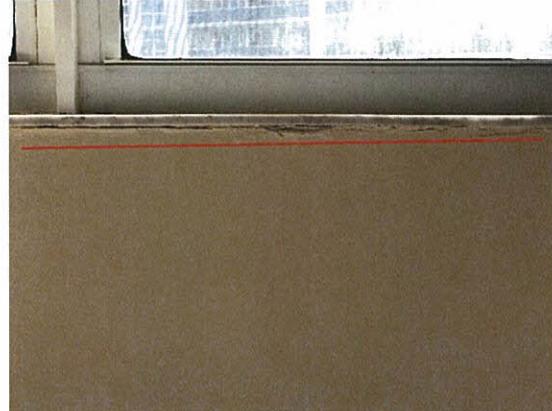
Photo 5.4.1.3 Separation of door between door frame and jamb due to building movement caused by the buffeting of doors. Water damage observed.

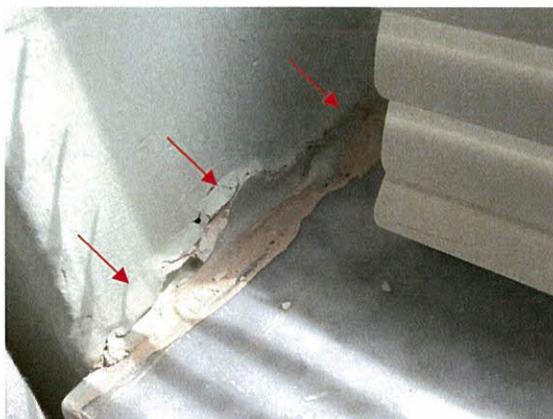
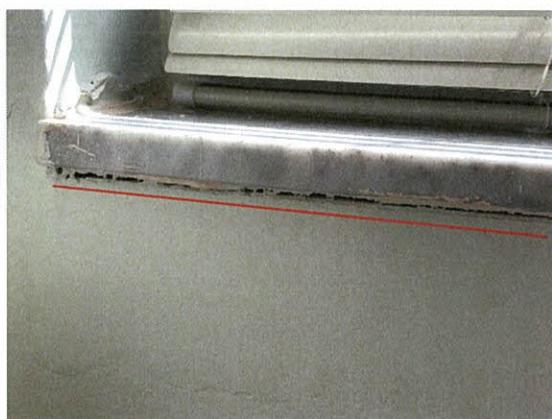
Photo 5.4.1.5 Water damage observed at window jamb location which enter the unit through opening created by the buffeting of windows due to Irma's wind pressures.

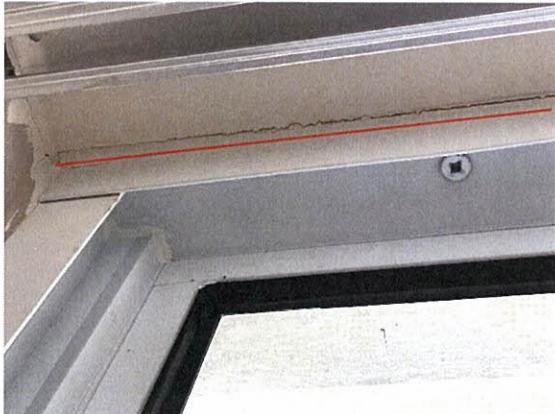
Photo 5.4.1.7 Separation of window board from window sill caused by the buffeting of windows from the Hurricane pressures.

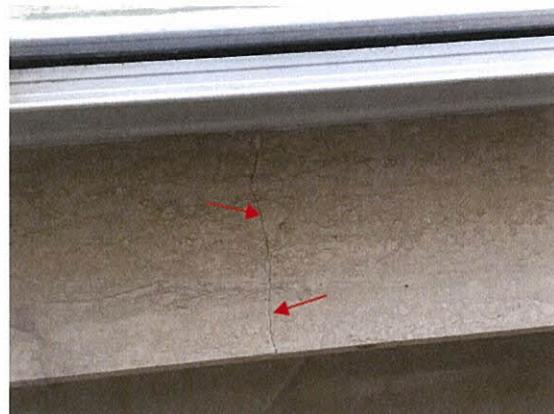
Photo 5.4.1.8 Cracked window board caused by the buffeting of windows due to Irma's Hurricane pressures.

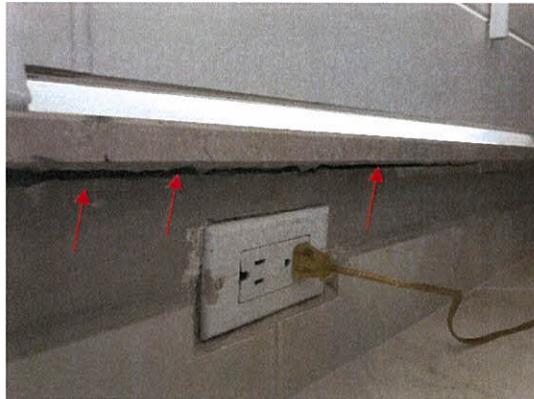
Photo 5.4.1.9 Separation of window board from window sill caused by buffeting of windows caused by the Hurricane pressures.

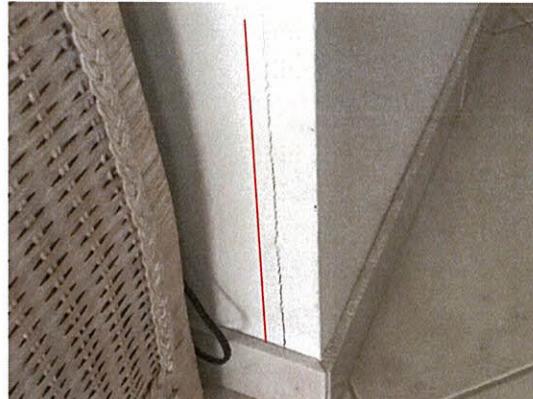
Photo 5.4.1.10 Crack at wall corner adjacent to bead from building movement caused by the Irma's wind pressures.

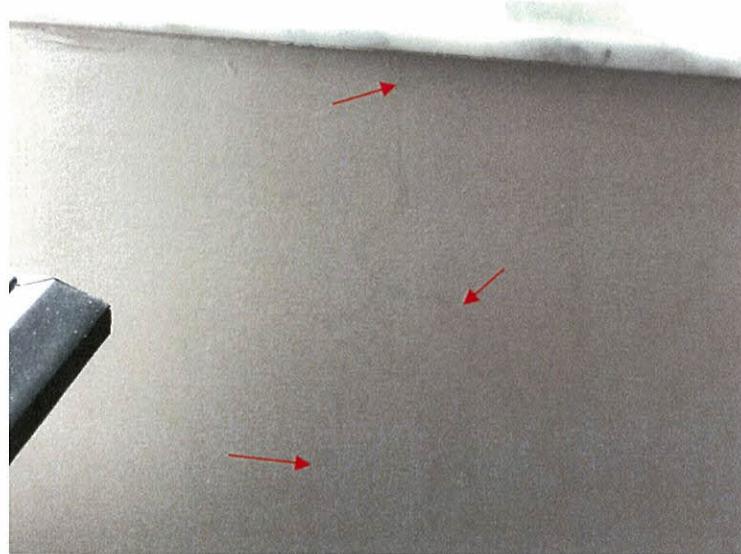
Photo 5.4.1.11 Evidence of water intrusion from opening at window sill created by the buffeting of windows from Irma's wind pressures.

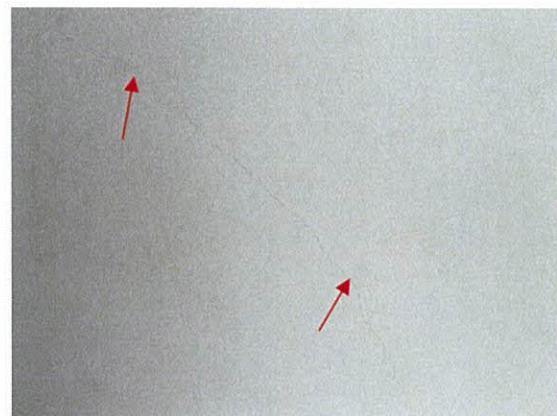
Photo 5.4.1.13 Crack at ceiling from building movement caused by the wind forces exerted on the building during the Hurricane.

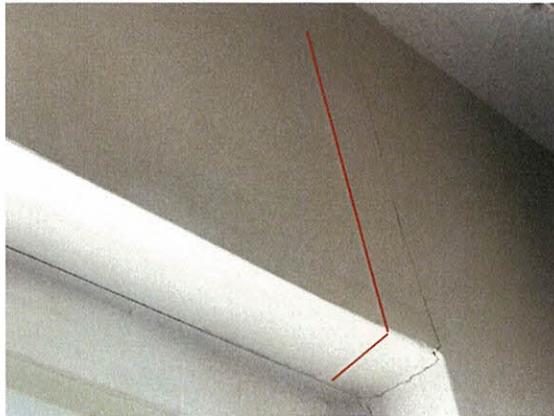
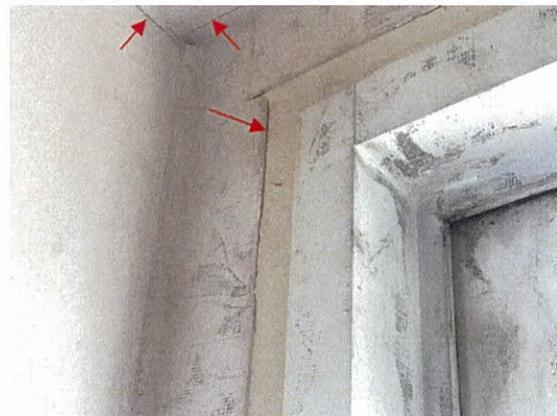
Photo 5.4.1.13 Crack at balcony door header caused by buffeting of doors caused by the winds during the Hurricane.

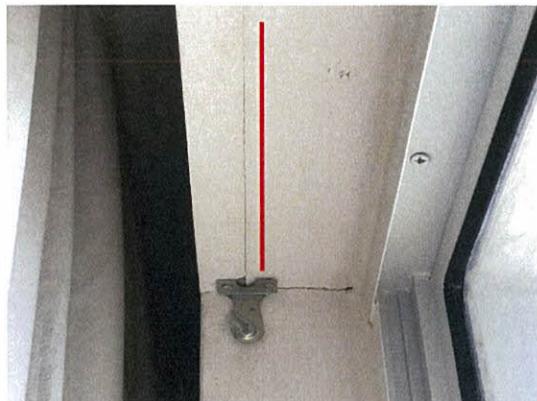
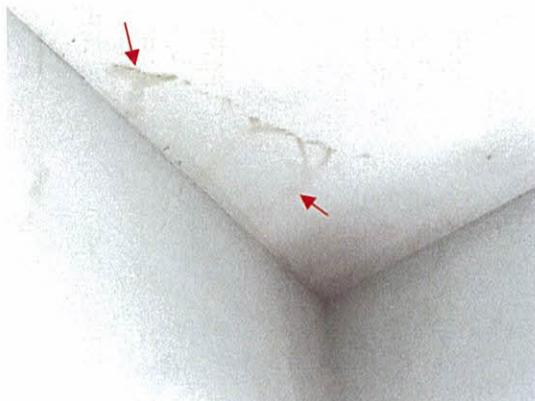
Photo 5.4.1.14 Cracked window header caused by buffeting of windows which occurred due to the Hurricane's wind pressures.

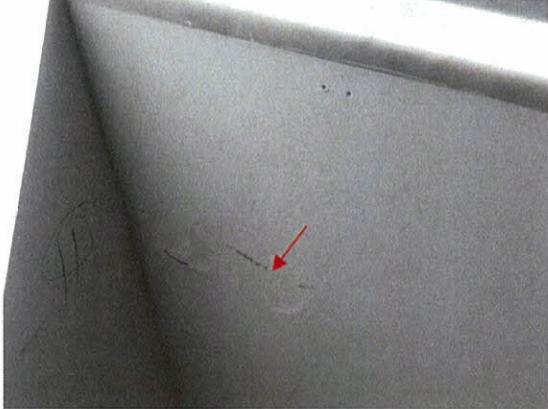
Photo 5.4.1.15 Evidence of water intrusion at wall below window sill which entered through opening at window caused by the wind buffeting due to Irma's wind pressures.

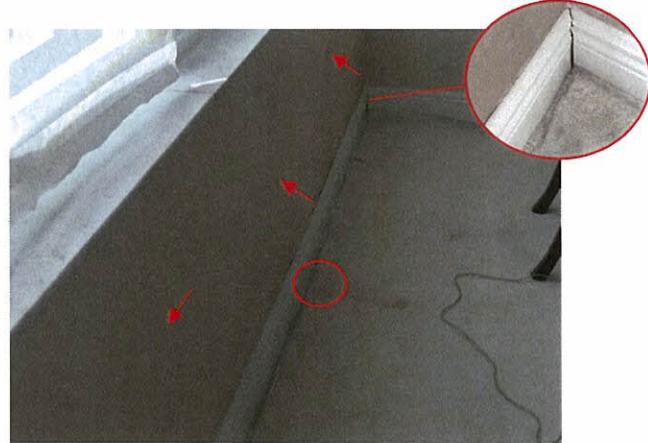
Photo 5.4.1.16 Evidence of water intrusion at wall below window sill from openings created by the wind buffeting due to Hurricane Irma's wind pressures exerted on the building envelope.

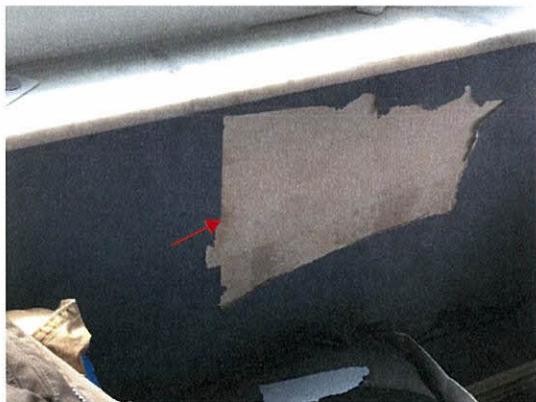
Photo 5.4.1.17 Paint failure from water intrusion through opening at window sill created by the buffeting of windows.

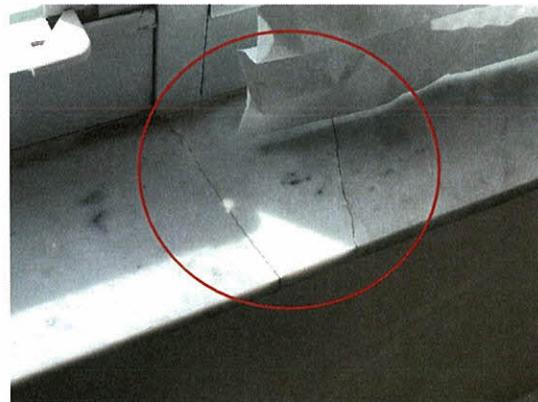
Photo 5.4.1.18 Cracked master bedroom window board caused by buffeting of windows during the Hurricane caused by the wind pressures.

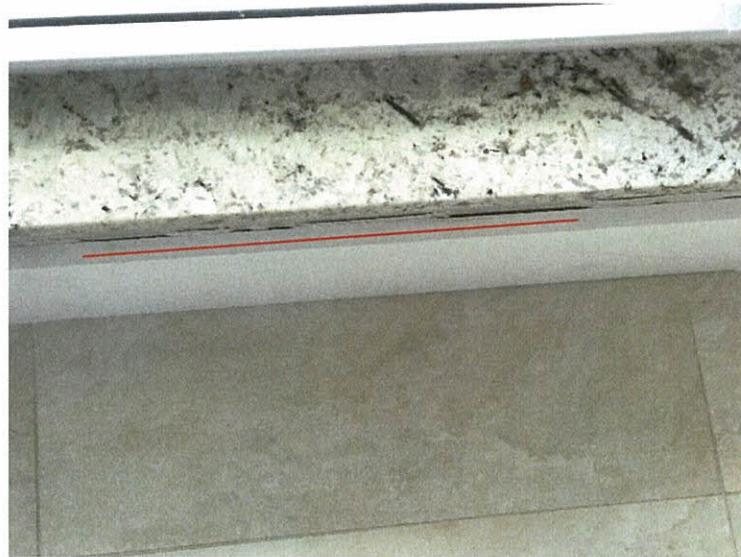
Photo 5.4.1.19 Separation baseboard to knee wall below window sill caused by buffeting of windows produced by Irma's wind pressures.

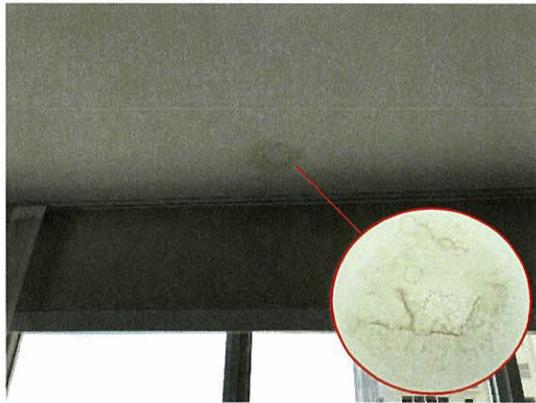
Photo 5.4.1.20 Evidence of water intrusion and damage at ceiling from exterior opening created by the wind buffeting due to Irma's wind pressures. See photo 5.2.2.6.

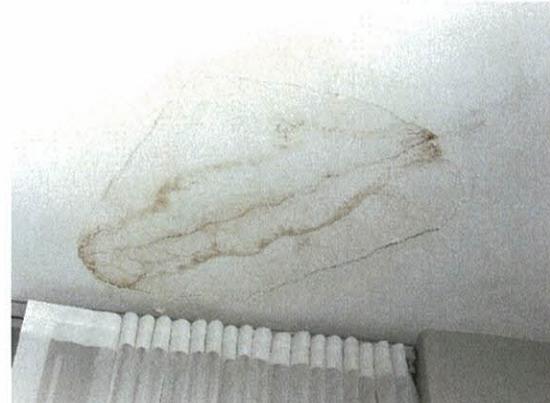
Photo 5.4.1.21 Evidence of water intrusion and damage at ceiling from exterior opening created by the buffeting of windows from Irma's wind pressures.

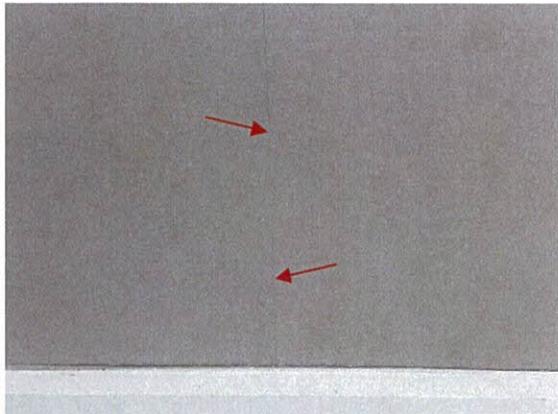
Photo 5.4.1.22 Wall crack below east window in the living room area caused by the movement of the building which occurred during the Hurricane.

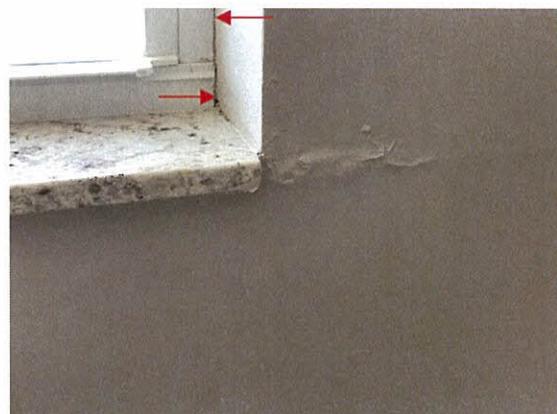
Photo 5.4.1.23 Evidence of water intrusion at window sill level. Also, separation of window frame at jamb location caused by buffeting of windows produced by Irma's wind pressures.

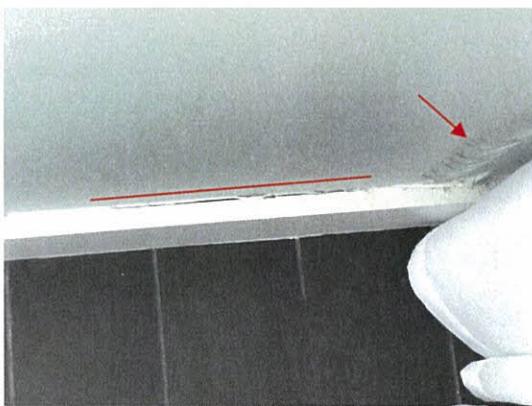
Photo 5.4.1.24 Signs of water intrusion and damage at wall below window and, baseboard which entered through the window sill due to the buffeting of windows which occurred during the Hurricane.

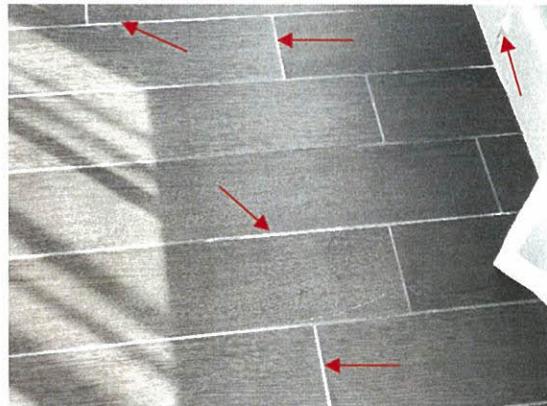
Photo 5.4.1.25 Stained floor finish from water intrusion which entered through opening below window sill caused by the wind buffeting of doors due to the Hurricane's wind pressures.

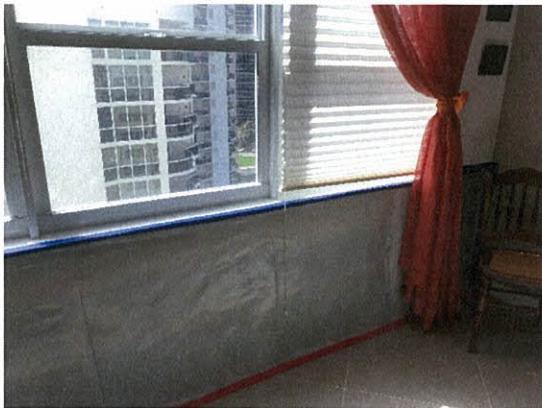
Photo 5.4.1.26 Removed wall section below window sill due to water damage from moisture infiltration.

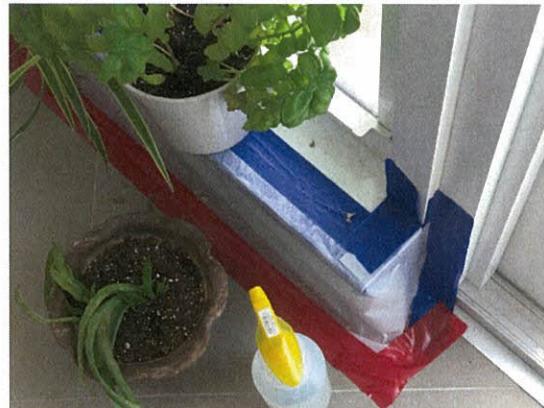
Photo 5.4.1.27 Removed wall section below balcony window sill adjacent to balcony door due to water damage from moisture infiltration.

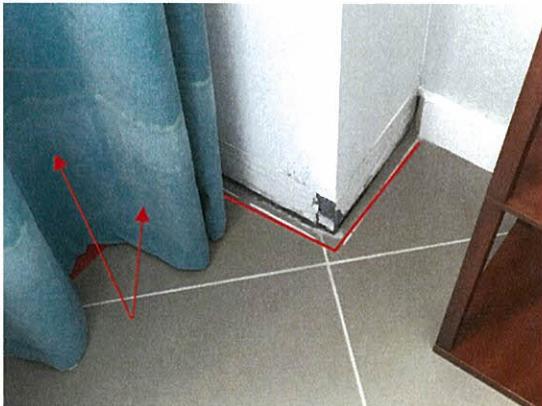
Photo 5.4.1.28 Removed wall baseboard proximate to bedroom window. Also, water stains visible at curtains from the infiltration of water which occurred during the Hurricane.
