Post Hurricane Irma Engineering Evaluation of Southpoint Condominiums Fort Lauderdale, Florida

Prepared for:

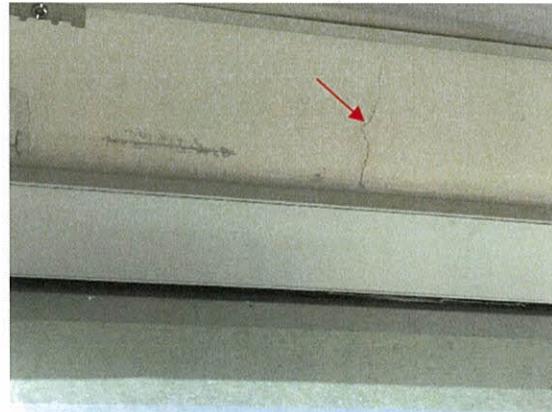
Photo 5.4.1.29 Crack window header caused by buffeting of windows caused by Irma's strong winds.

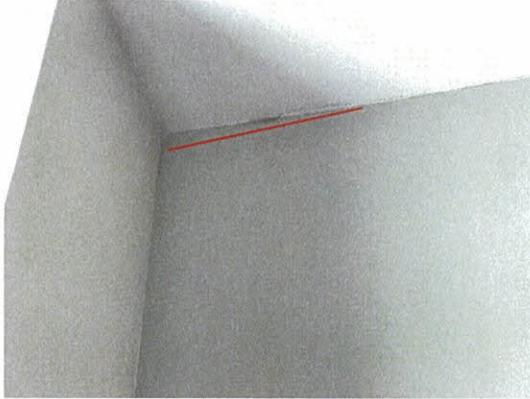
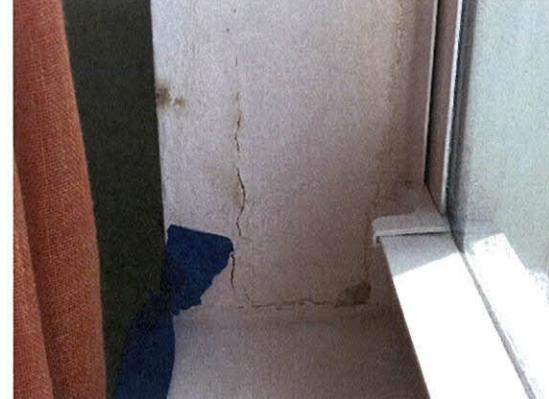
Photo 5.4.1.30 Crack at wall to ceiling interface from building movement caused by the forces exerted on the building envelope by the Hurricane.

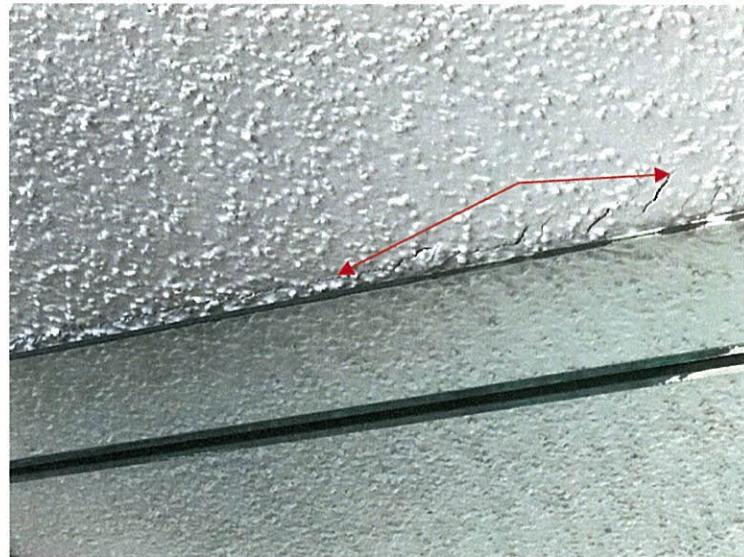
Photo 5.4.1.32 Crack at wall to ceiling interface caused by the building movement which occurred during the Hurricane due to Irma's wind forces. Crack extends along the length of the partition wall.

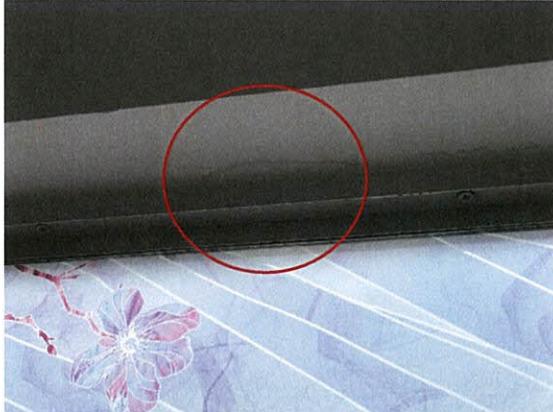
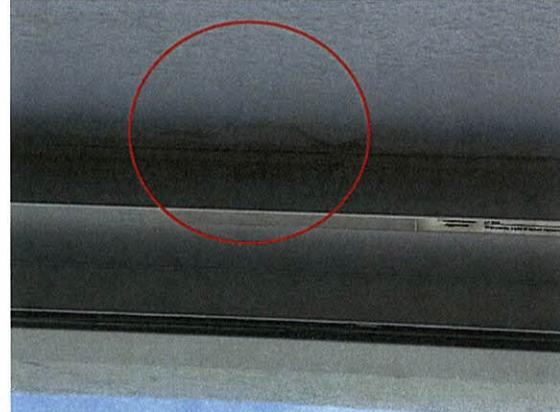
Photo 5.4.1.33 and 5.4.1.34 Evidence of water intrusion at window header which entered through opening created by the buffeting of windows produced by the Hurricane wind pressures.

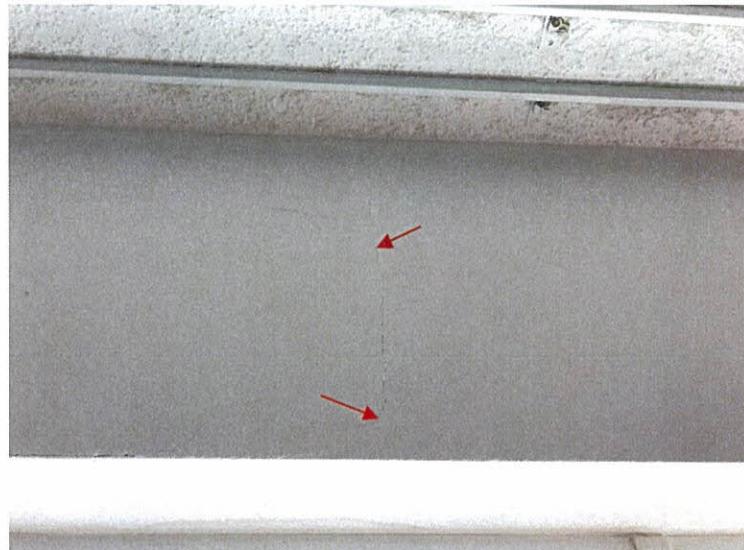
Photo 5.4.1.35 Cracked window header caused by the buffeting of windows due to Irma's wind pressures.

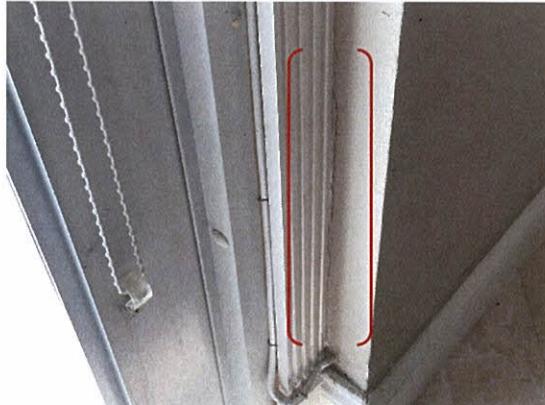
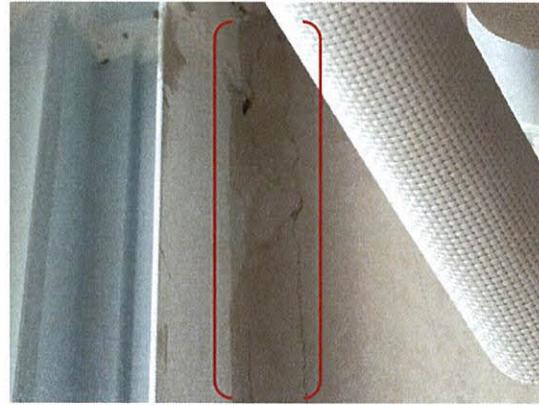
Photo 5.4.1.36 Separation between door frame and jamb caused by buffeting of windows produced by the Hurricane winds.

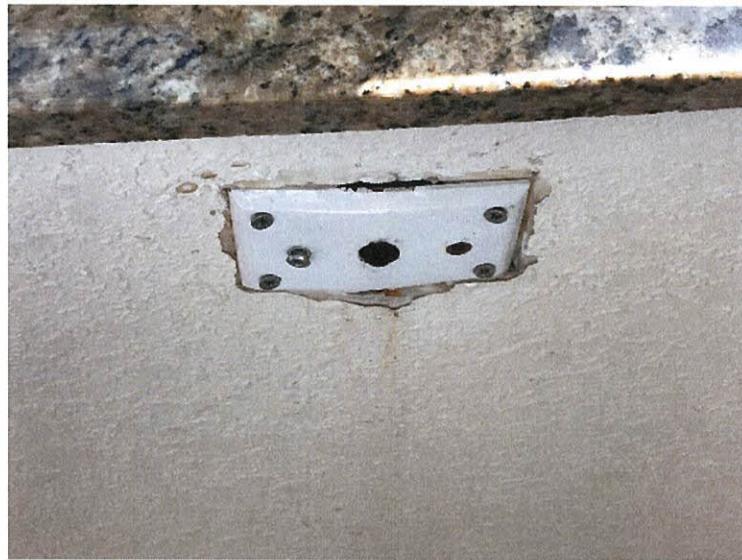
Photo 5.4.1.38 Evidence of water infiltration at wall below kitchen window which entered through opening created by the wind buffeting of windows produced by Irma's wind pressures.

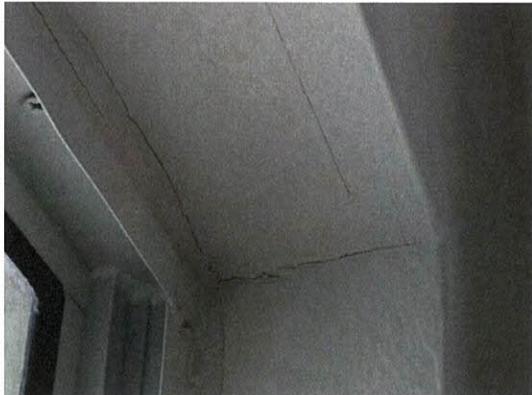
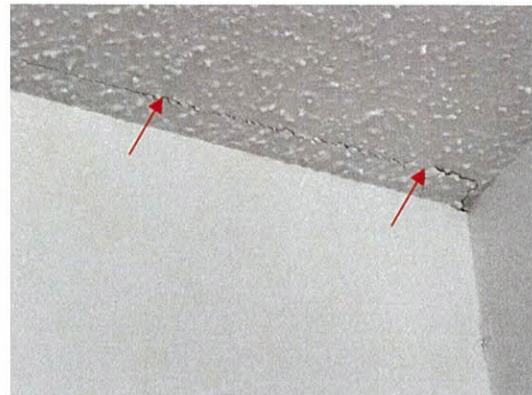
Photo 5.4.1.39 Crack at window header caused by the buffeting of windows from Irma's wind pressures.

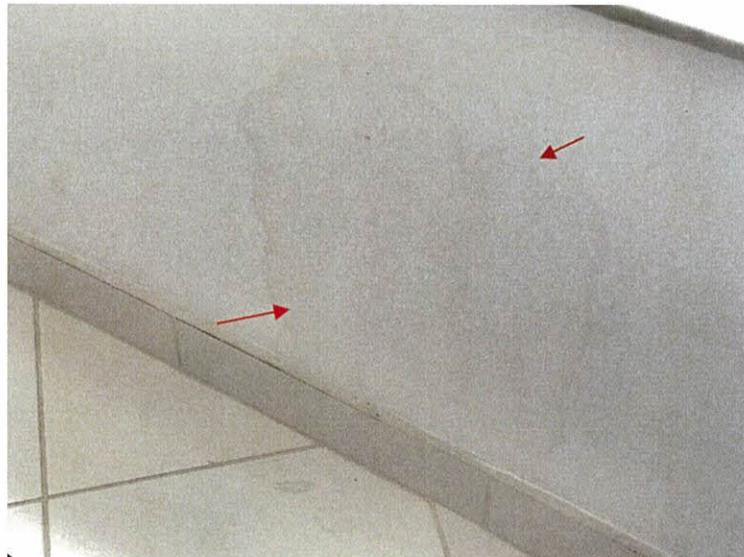
Photo 5.4.1.41 Evidence of water intrusion below windowsill which entered unit through the separation of window baseboard and sill that was caused by the wind buffeting of doors and windows produced by Irma's wind pressures.

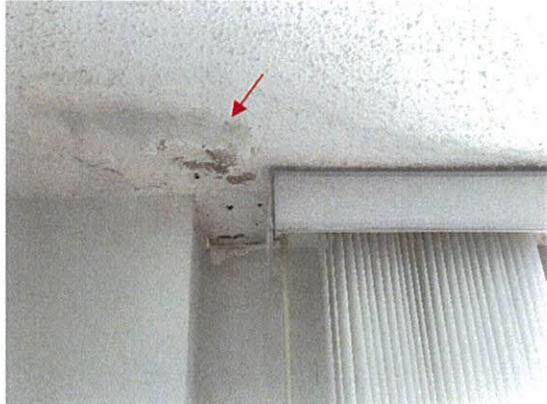
Photo 5.4.1.42 Water intrusion at wall to ceiling interface through window header caused by buffeting of windows created by Irma's wind pressures.

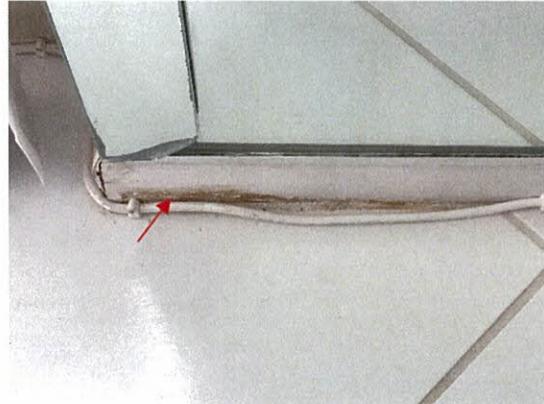
Photo 5.4.1.43 Water damage at baseboard from water intrusion through opening at window created by the wind buffeting produced by the Hurricane wind forces over the building envelope.

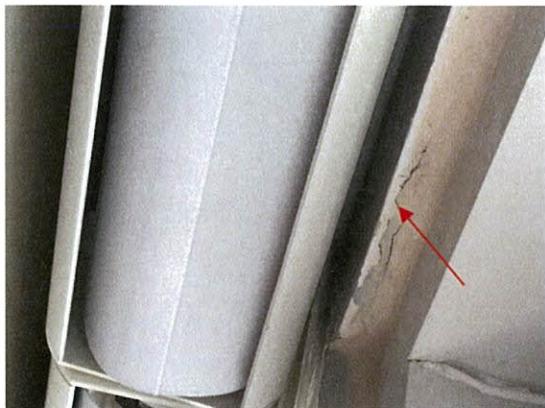
Photo 5.4.1.44 Cracked window header at living room caused by the buffeting of windows produced by Irma's wind pressures. These cracks were also seen at the ceiling and walls.

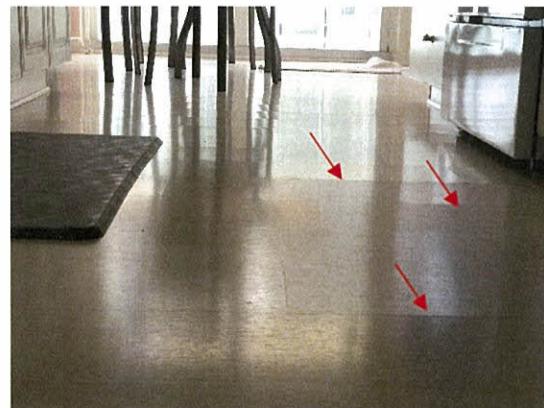
Photo 5.4.1.45 Buckled floor finish at kitchen from water intrusion through balcony door caused by the buffeting of the doors generated by Irma's wind pressures.

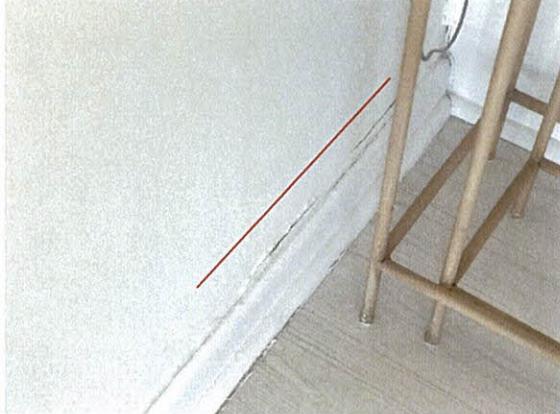
Photo 5.4.1.46 Damaged baseboard at kitchen partition wall from water intrusion through balcony door caused by the wind buffeting of doors produced by the wind pressures of the Hurricane.

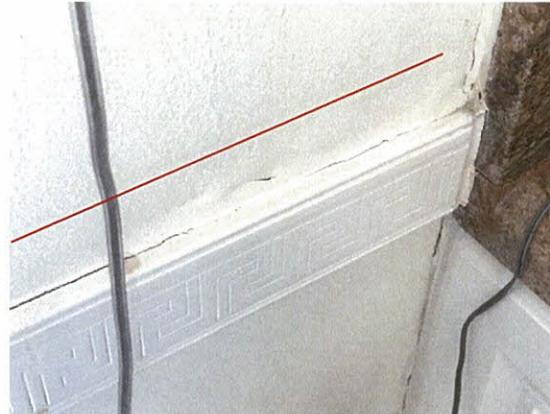
Photo 5.4.1.47 Water intrusion damage at wall trim in the kitchen partition wall from water intrusion from unit above.

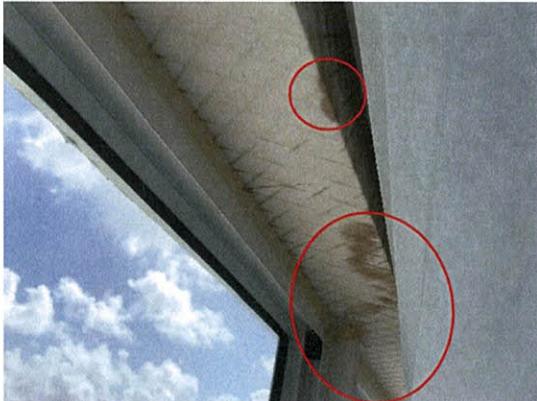
Photo 5.4.1.48 Water intrusion damage at east window header from opening created by the buffeting of windows due to the Hurricane's wind pressures.

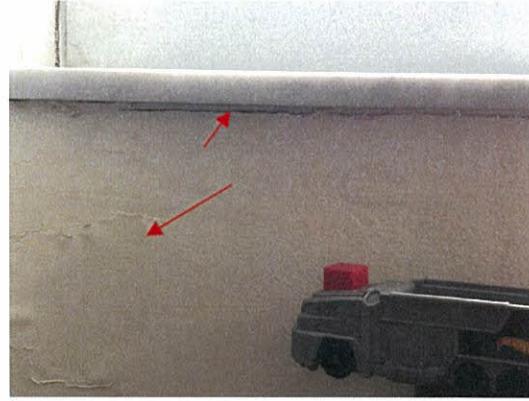
Photo 5.4.1.49 Separation at window sill caused by buffeting of windows created by the Hurricane's wind pressures. Water intrusion damage observed below.

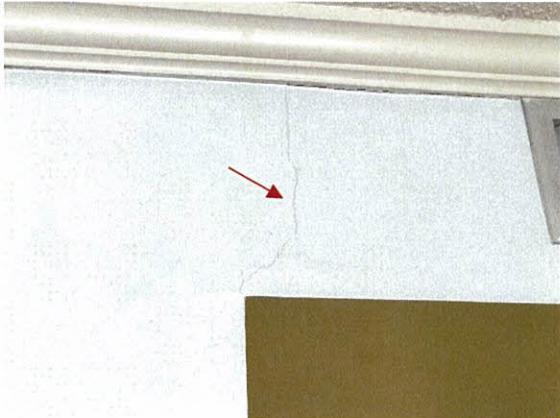
Photo 5.4.1.50 Crack at wall caused by the building movement from the wind pressures exerted on the building envelope during the Hurricane.

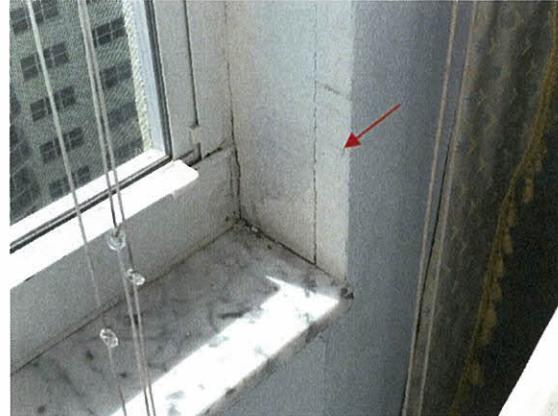
Photo 5.4.1.51 Evidence of water intrusion at window jamb location which entered through openings created by the wind buffeting of windows produced by the Hurricane's wind pressures exerted at the windows.

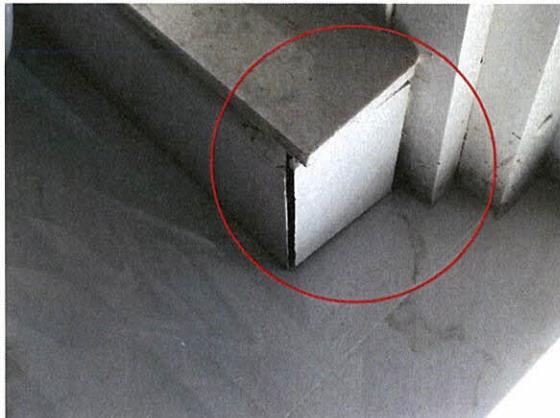
Photo 5.4.1.52 Cracked/damaged baseboard proximate to balcony door from water intrusion through door frame caused by the buffeting of doors due to Irma's wind pressures.

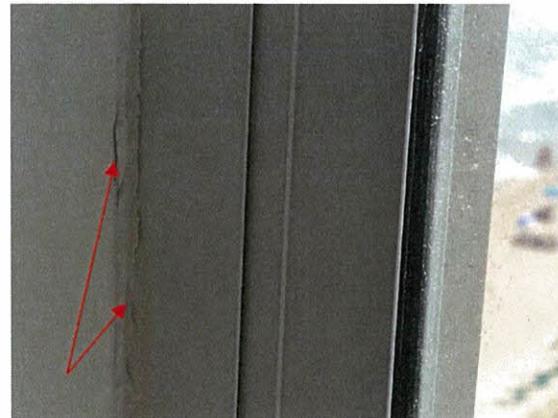
Photo 5.4.1.53 Separation between window frame and window jamb location caused by the buffeting of windows which occurred due to Irma's wind pressures.

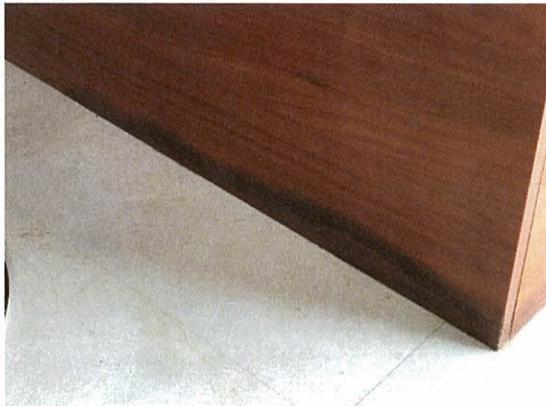
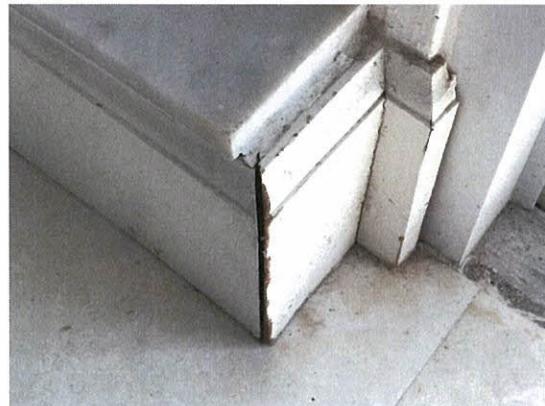
Photo 5.4.1.54 Water stain at base of wood kitchen counter from water infiltration through openings created by the wind buffeting of doors due from Irma's winds pressures.

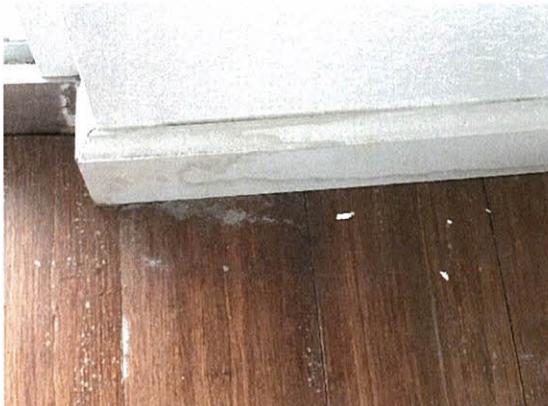
Photo 5.4.1.56 Water damaged baseboard and floor finish from water intrusion though balcony door caused by buffeting produced by the Hurricane's wind pressure.

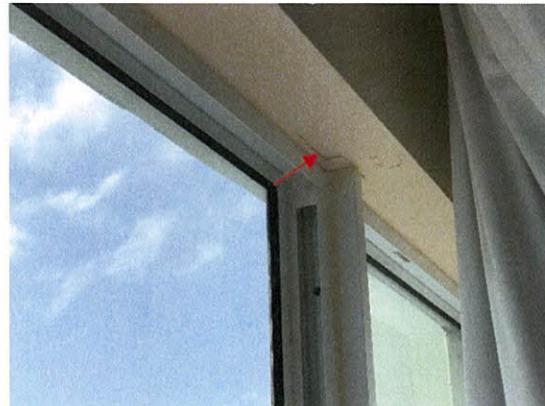
Photo 5.4.1.57 Cracked window header at joint caused by buffeting of windows caused by the Hurricane's wind pressures.

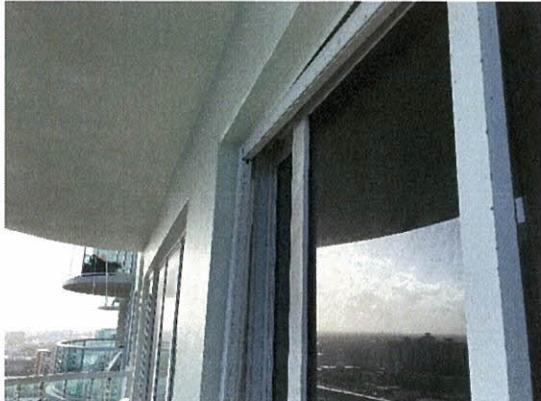
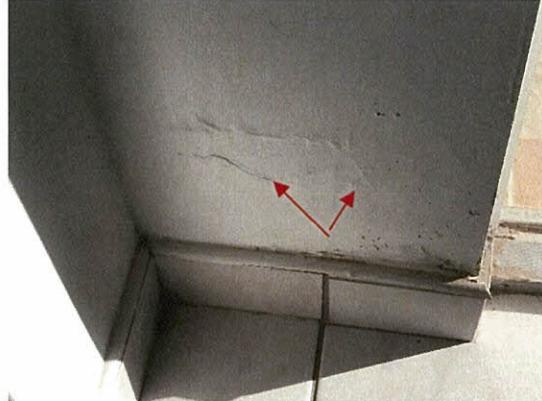
Photo 5.4.1.58 Broken balcony door screener from the wind buffeting of the doors produced by the Hurricane's wind pressures.

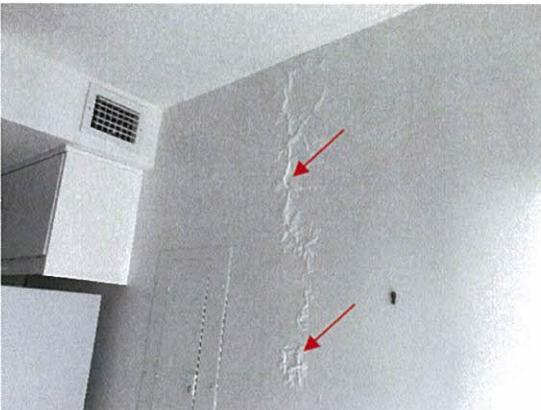
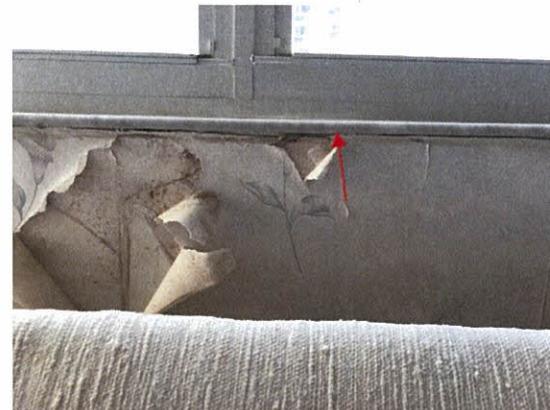
Photo 5.4.1.60 Water damage at walls are visible in multiple location of this unit. Water traveled through the ceiling to various points of the unit from created openings along the balcony door frame product of the wind buffeting that resulted from Irma's wind pressures.

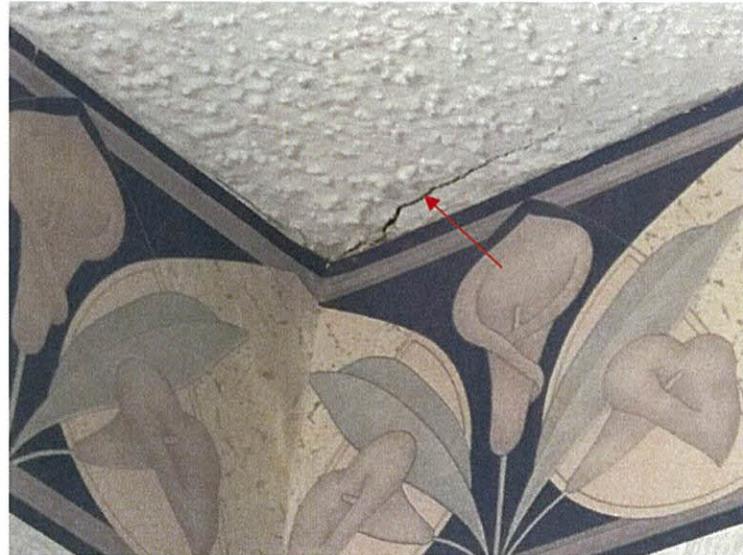
Photo 5.4.1.62 Crack in bedroom wall to ceiling interface caused by the building movement produced by Irma's wind forces exerted on the building envelope.

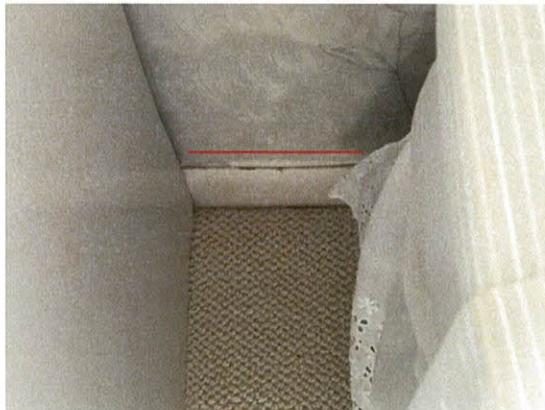
Photo 5.4.1.63 Damaged baseboard from water intrusion through openings at the building caused by wind buffeting of windows due to Irma's wind pressure.

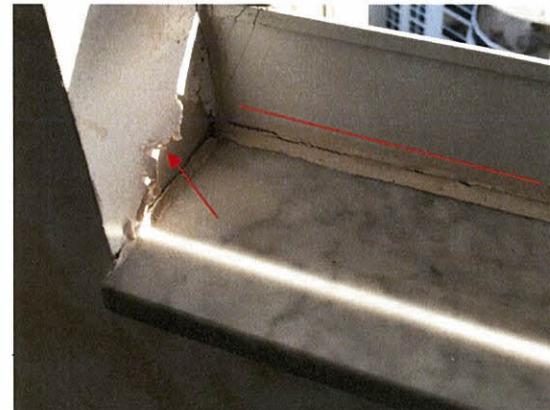
Photo 5.4.1.64 Separation of window frame and window sill board caused by the wind buffeting allowed water infiltration observed around window jamb area as a result of the openings created during the Hurricane by the wind pressures.

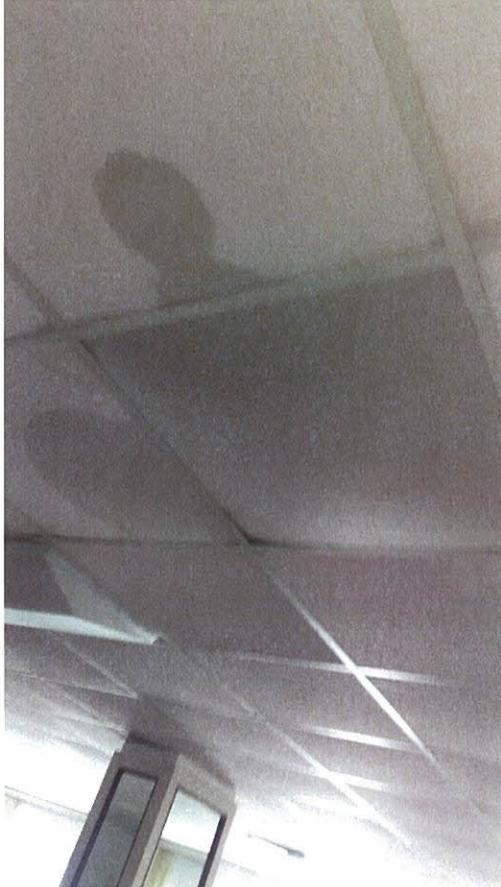
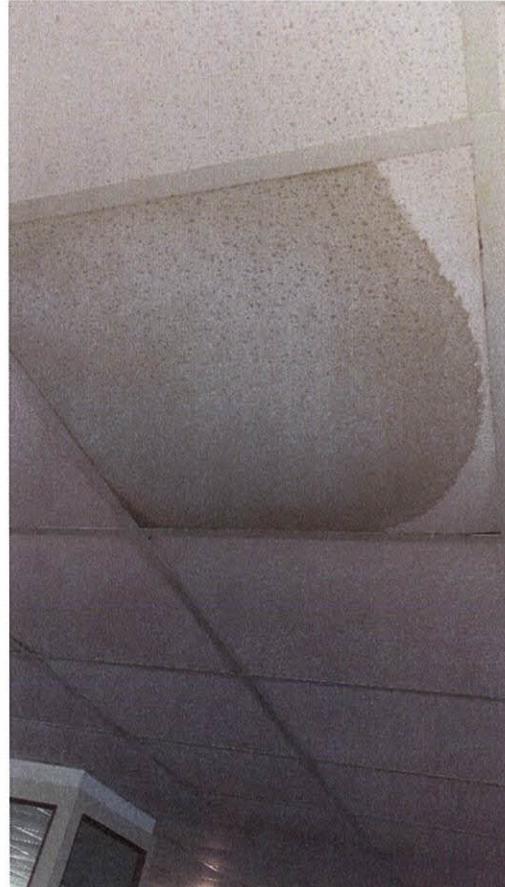
Photo 5.4.2.1 Water damage at lounge area roof that entered through openings created by buffeting of windows due to Irma's wind pressures (south tower).

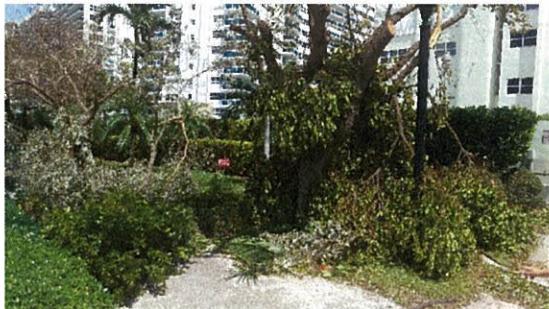
Photo 5.5.1 Damaged landscape at buildings' entrance caused by Irma's wind pressures.

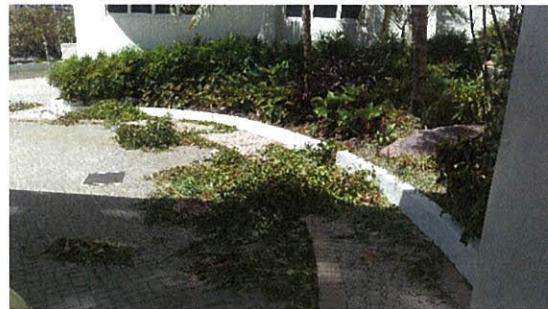
Photo 5.5.2 Displaced landscape at buildings' entrance caused by Irma's wind pressures.

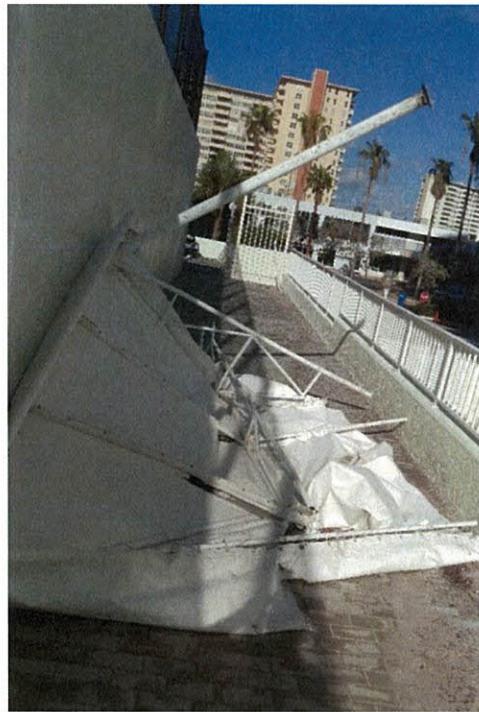
Photo 5.5.3 Blown out metal frame from failed base connections caused by Irma's wind pressures (adjacent to tennis court at north tower).

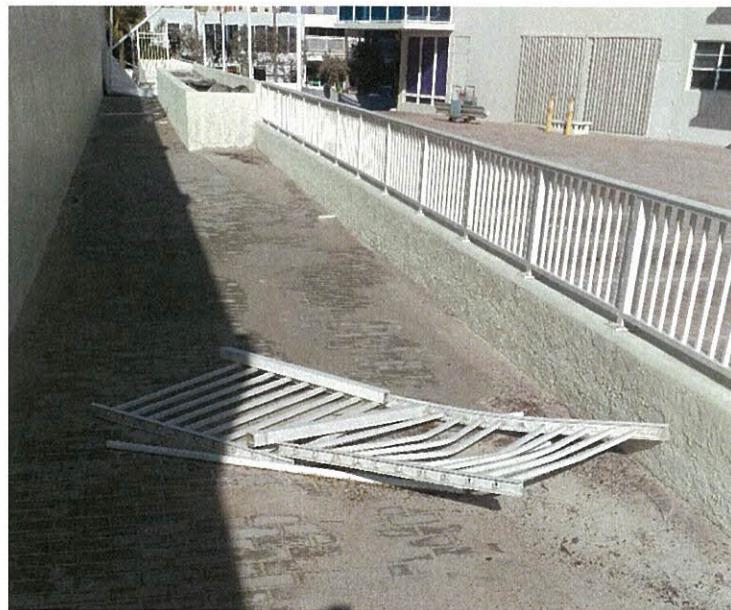
Photo 5.5.4 Blown out aluminum railing from failed post connection caused by Irma's wind pressures (north of tennis court area at north tower).

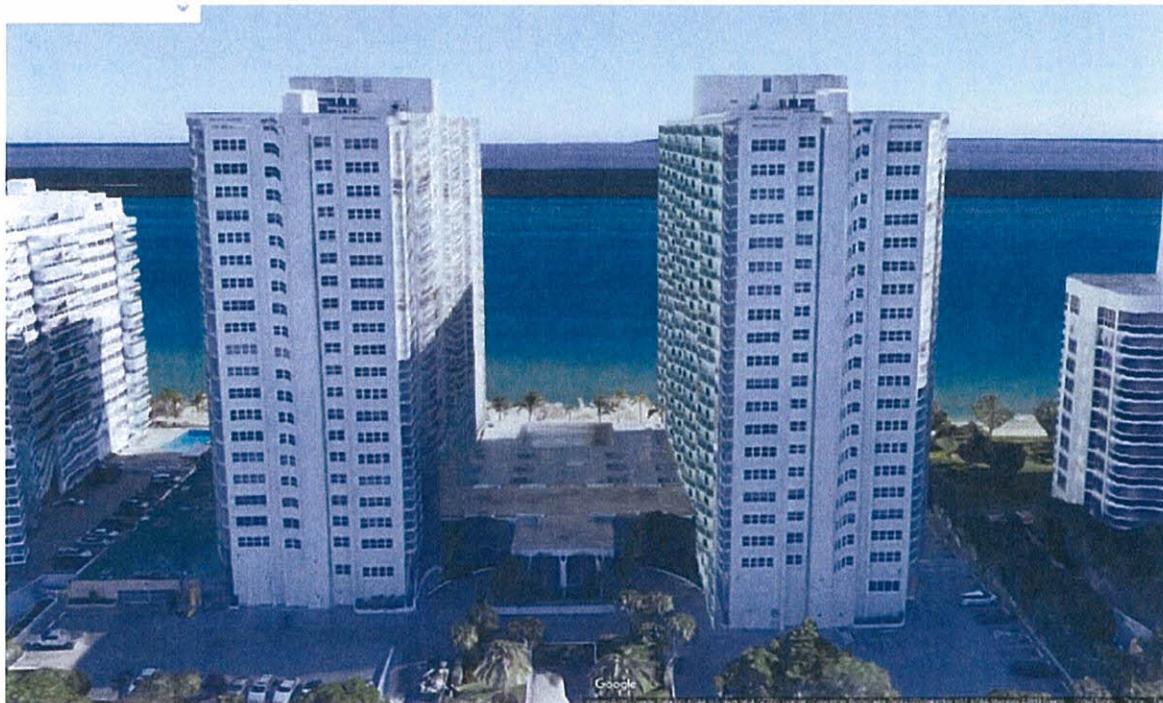
Photo 2.1: West Facade Elevation

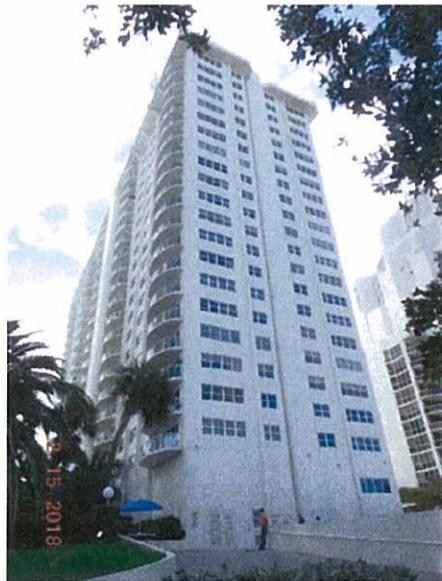
Photo 2.2 South Tower Elevation

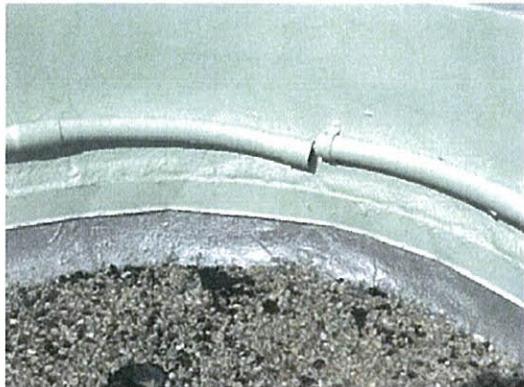
Blisters at parapet wall observed above the counterflashing (typical)/disconnected pipe

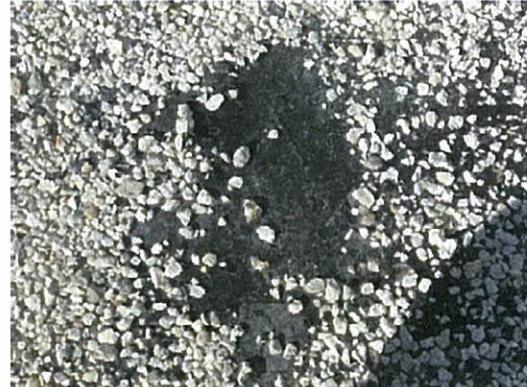
Deteriorated roof membrane panel

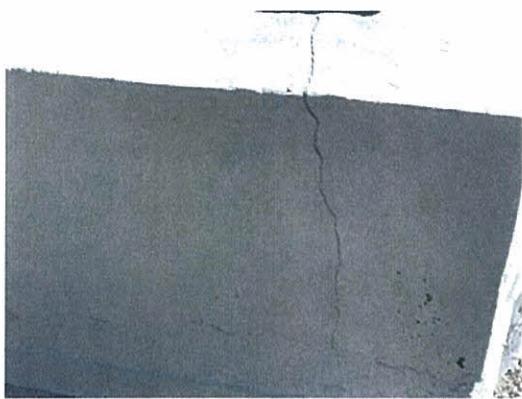
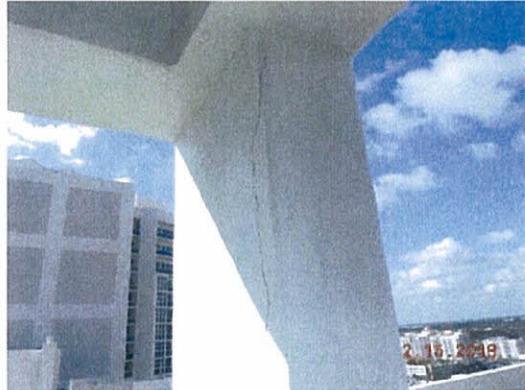
Parapet concrete wall crack on east side of the south tower

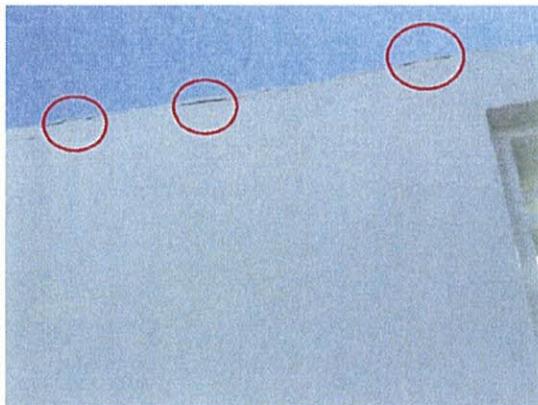
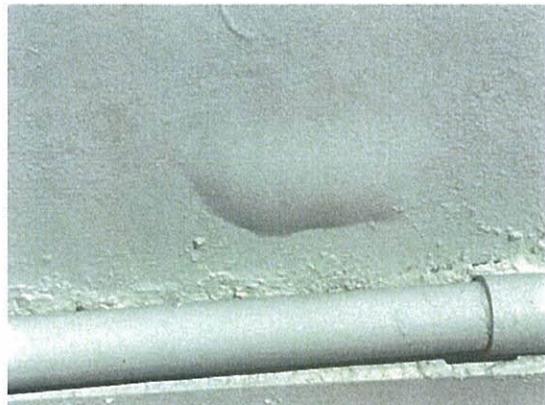
Cracks at superstructure wall cap

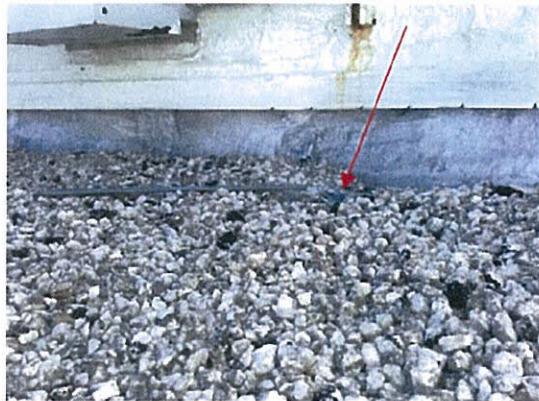
Slab penetration below roof gravel level

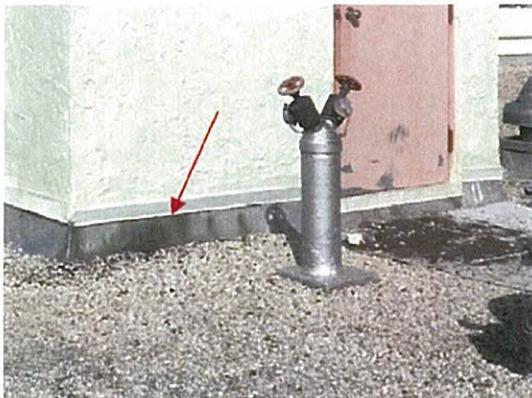
Deteriorated waterproofing system

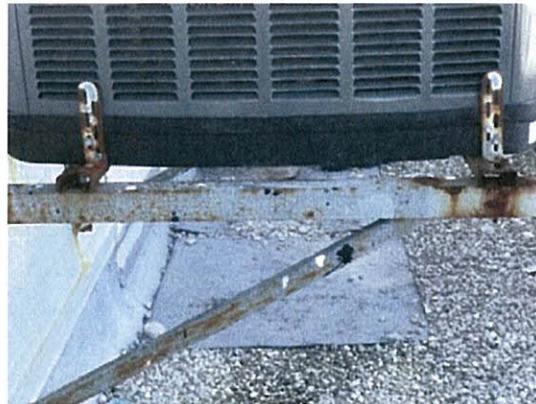
Corroded compressor unit support and connections

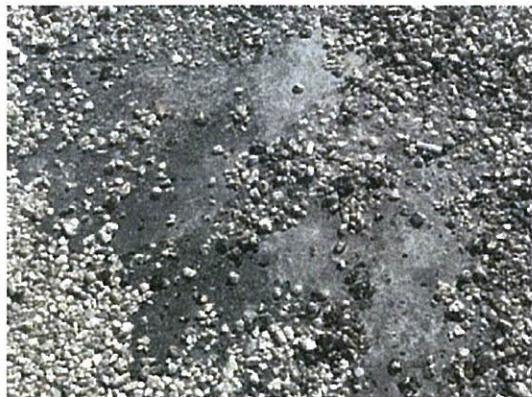
Deteriorated roof deck membrane

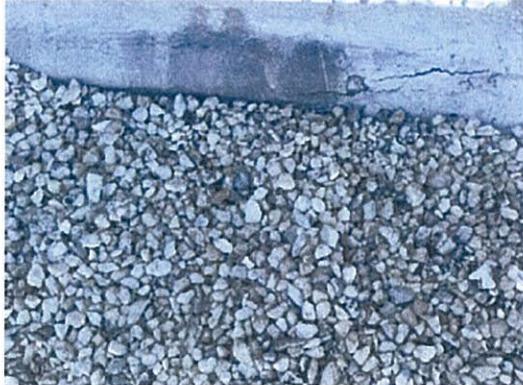
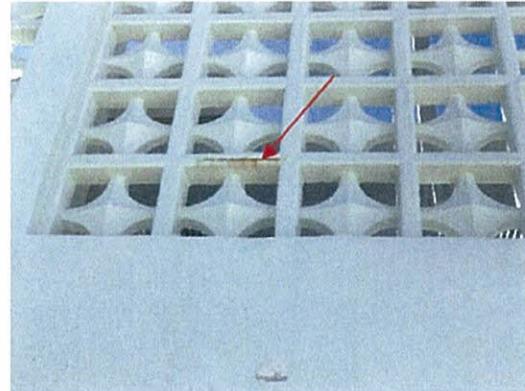
Deteriorated roof membrane

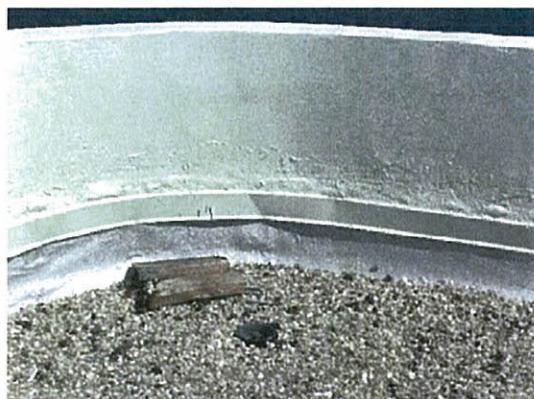
Exposed corroded wall rebar

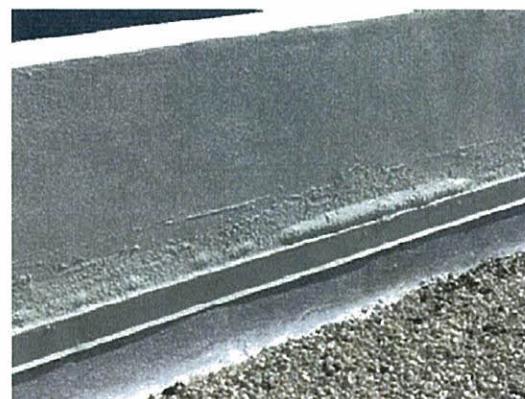
Deteriorated roof deck membrane at angled termination/blister above wall counterflashing

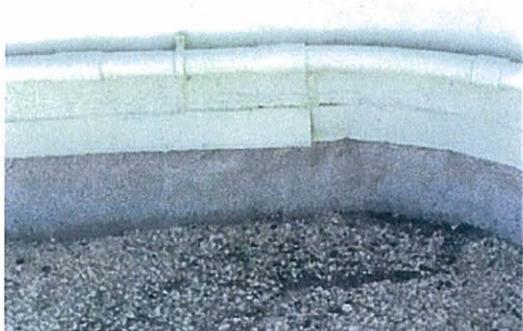
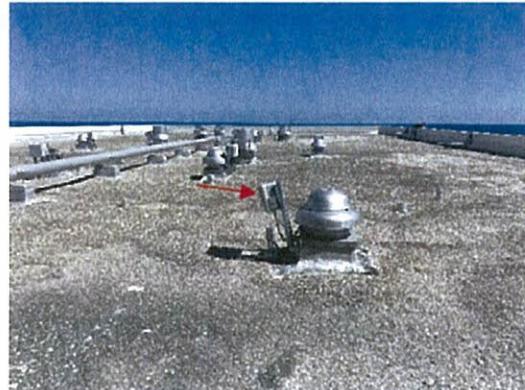
Improper overlap of counterflashing

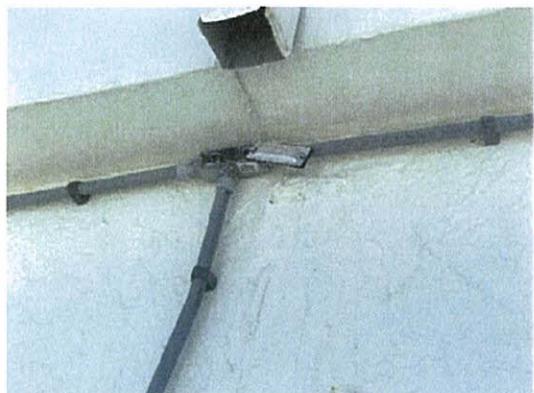
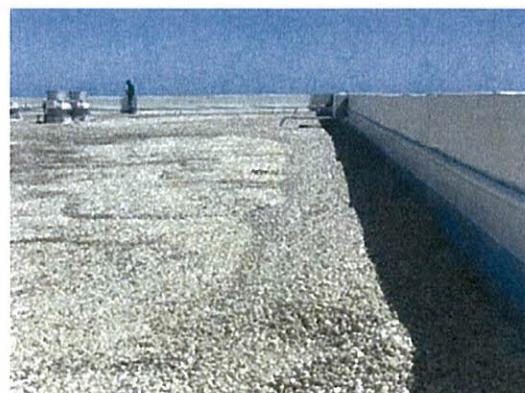
Damaged electric conduit cap

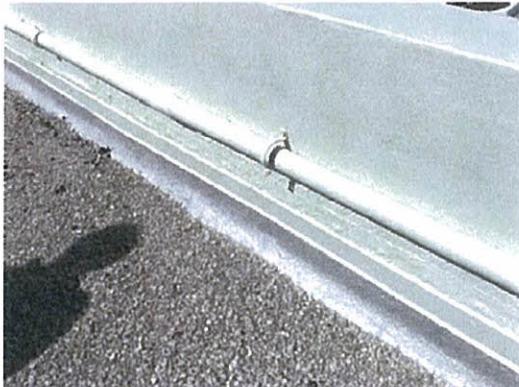
Unhinged pipe clamp. Notice, adjacent clamp is missing

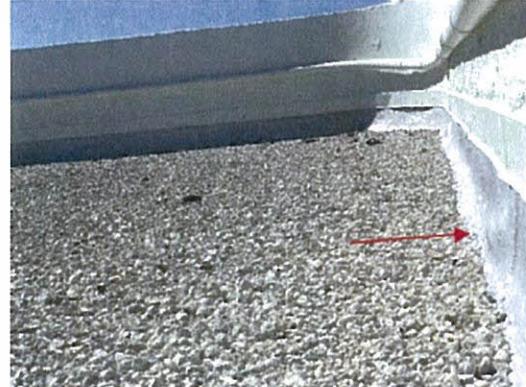
Bulge of membrane at termination of roof deck. This is typical of various location across the perimeter of roof

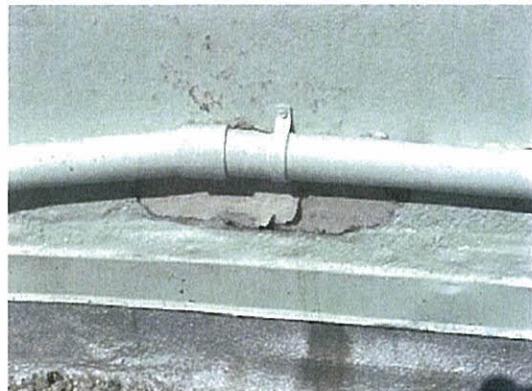
Deteriorated paint and wall flashing with visible signs of water intrusion

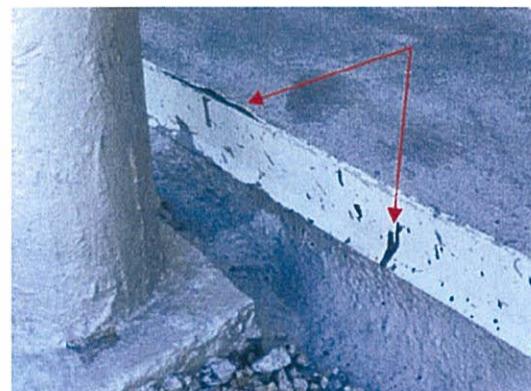
Deteriorated counterflashing and finish

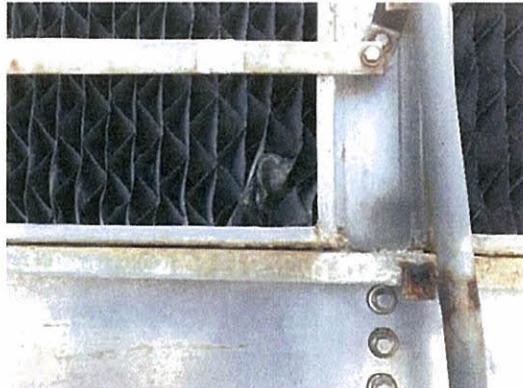
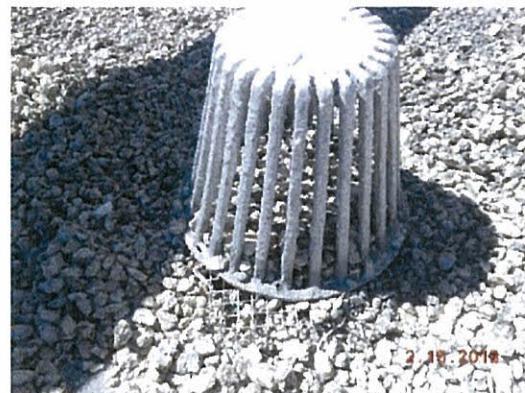
Damaged trickling filter possibly due to wind or debris impact

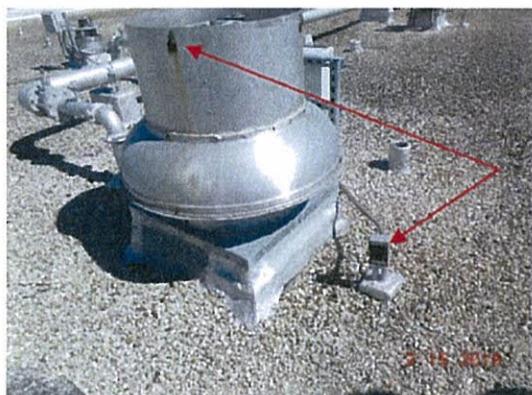
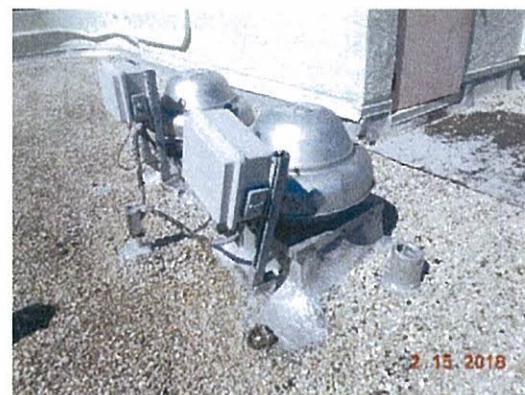
Missing electrical conduit cover/corroded exhaust finish

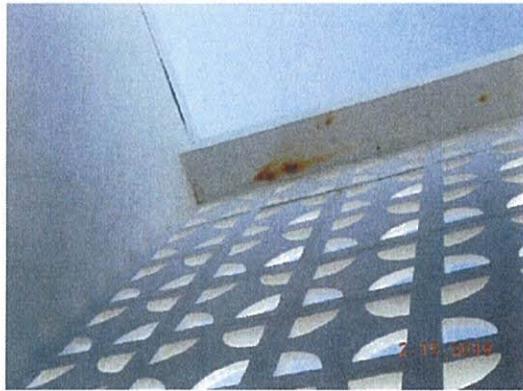
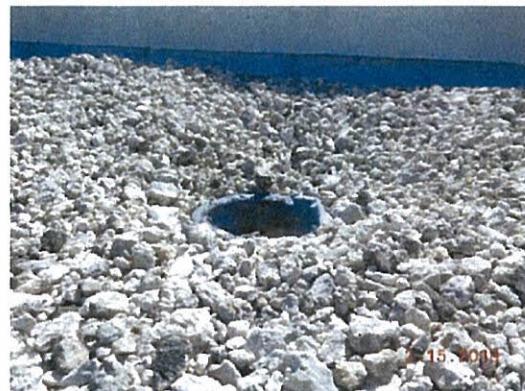
Blisters at parapet wall observed above the counterflashing (typical)/disconnected pipe

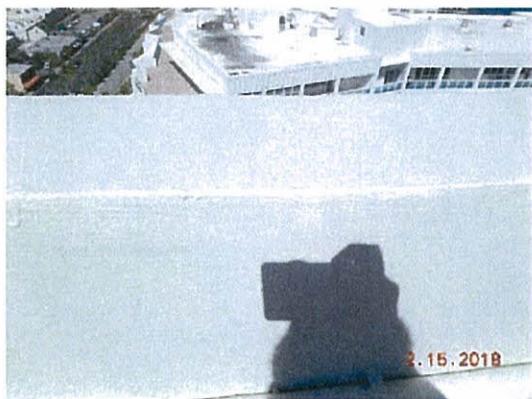
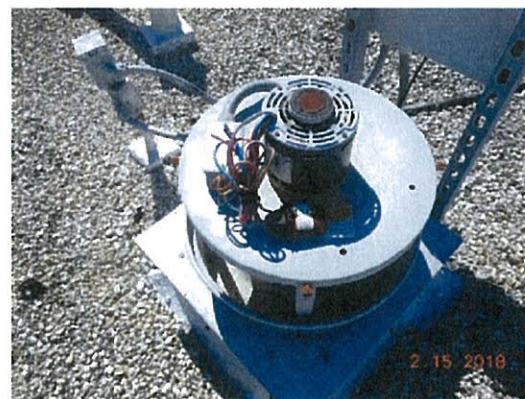
Deteriorated roof deck membrane

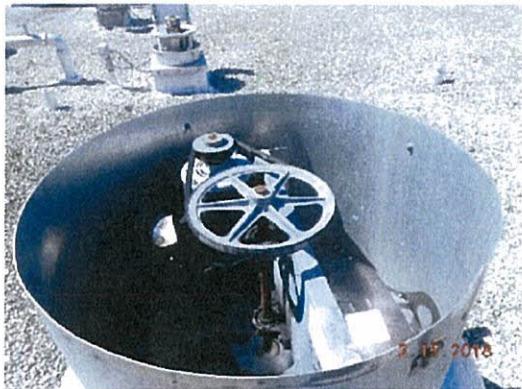
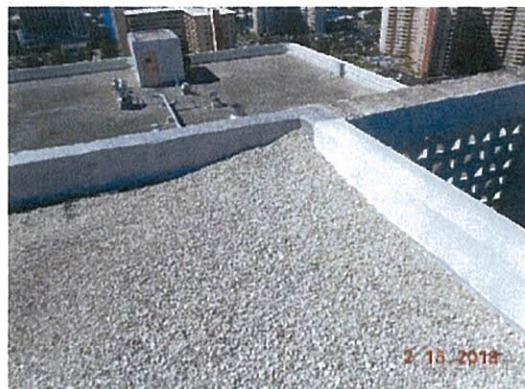
Blown exhaust vent cap

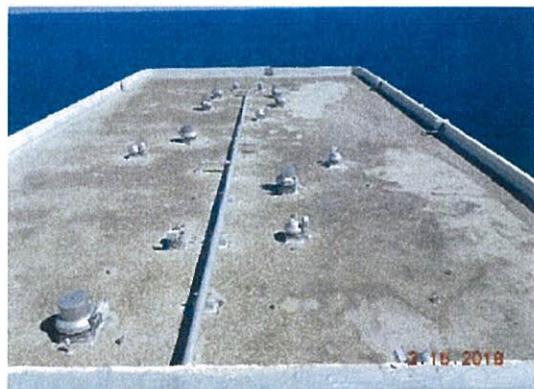
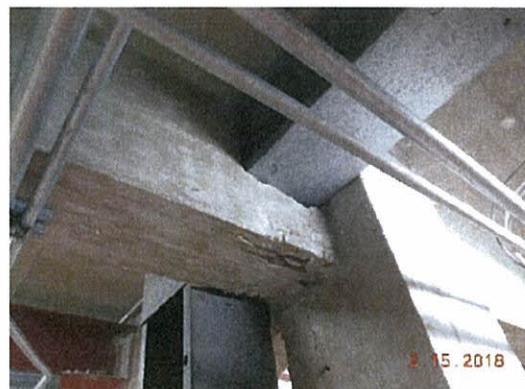
Uneven gravel distribution

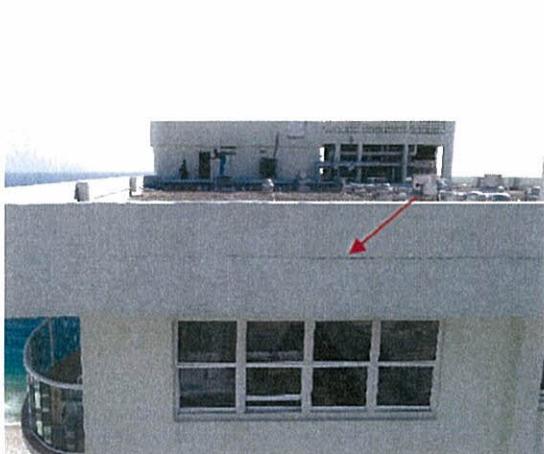
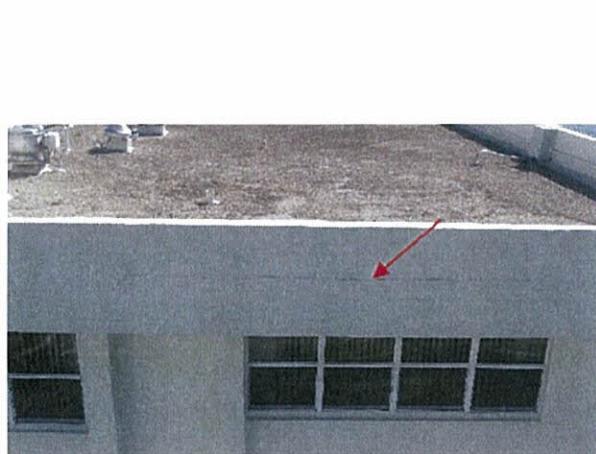
Crack at north most parapet wall of the south tower (north elevation)	Crack at south most parapet wall of the south tower (north elevation)

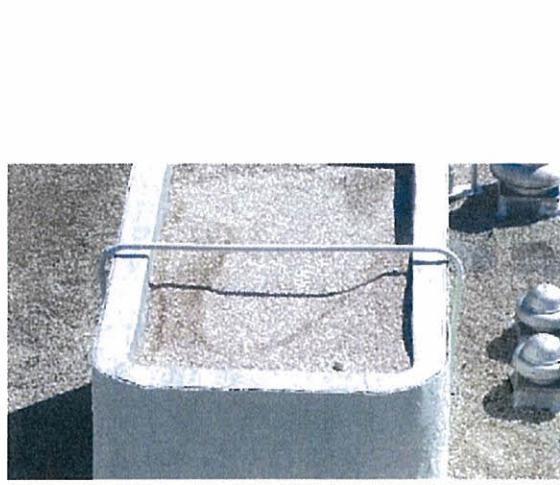
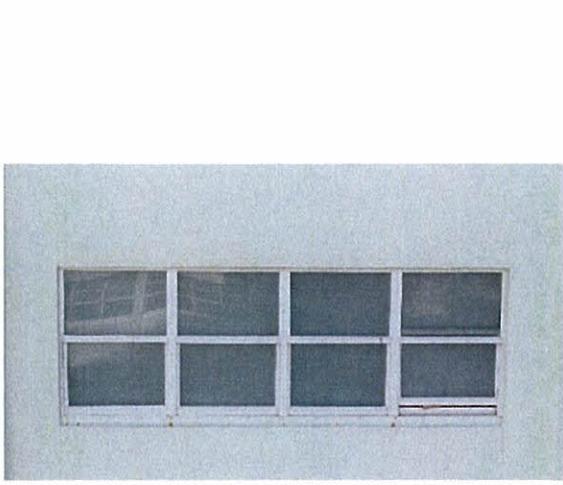
Cracks along perimeter of stair wall caps at south tower	Corroded steel at penetrations left from removal of window shutters

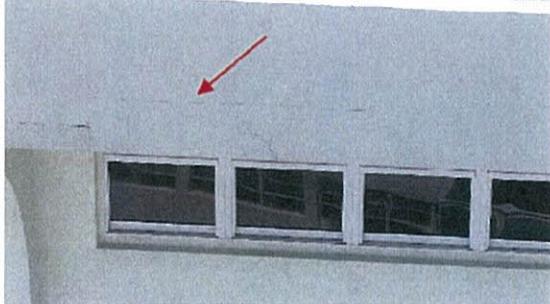
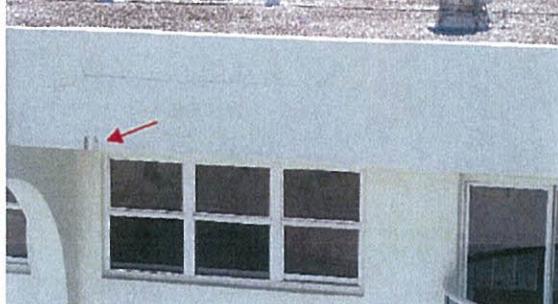
Crack at south parapet wall and visible steel corrosion

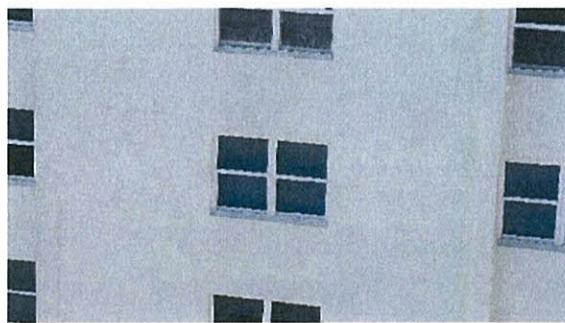
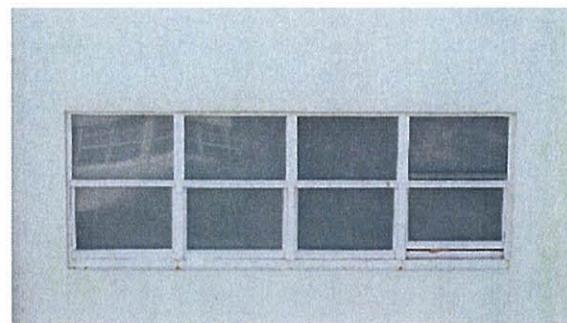
Moisture paths scattered throughout south elevation of the north tower
