Post Hurricane Irma Engineering Evaluation of Southpoint Condominiums Fort Lauderdale, Florida

Prepared for:

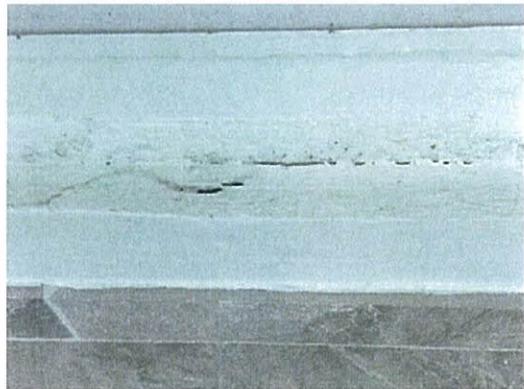
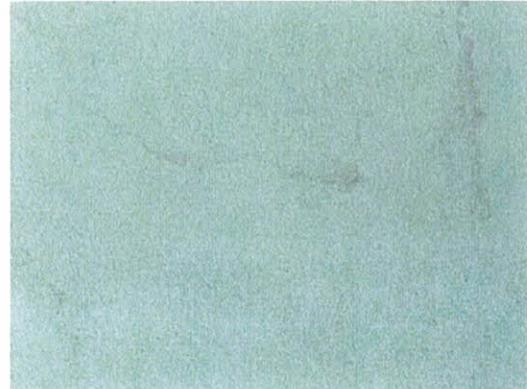
Caulking cracks at base of balcony windows (exterior)

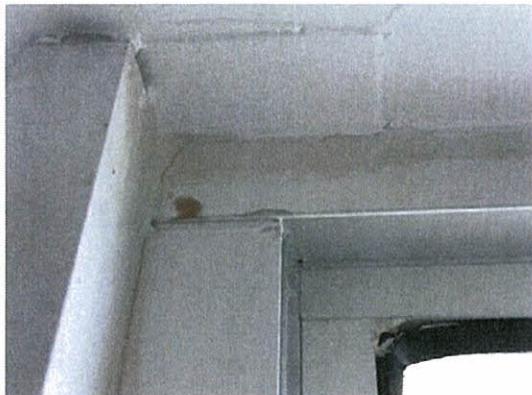
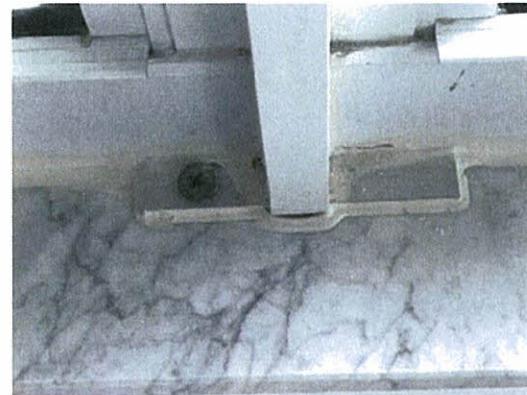
Caulking failure at window frame at the top

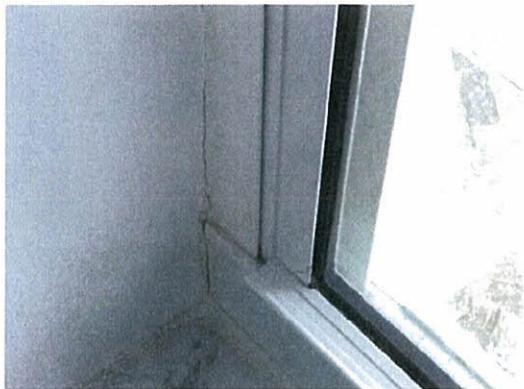
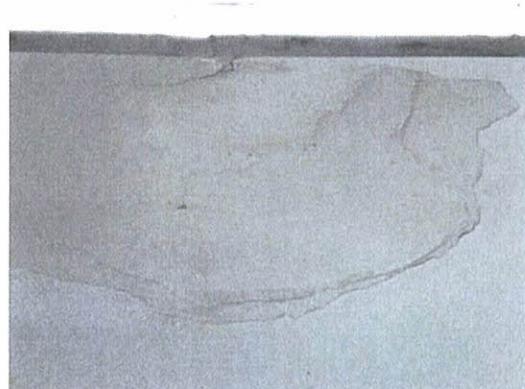
Cracked/Missing window caulking

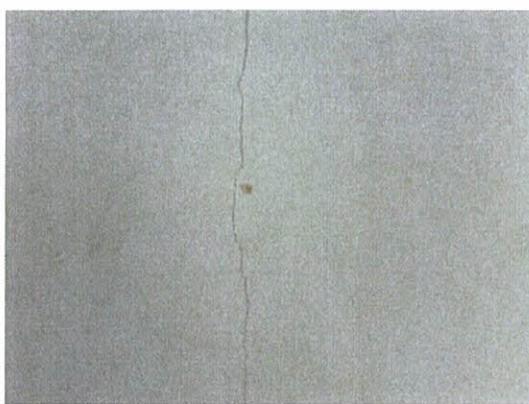
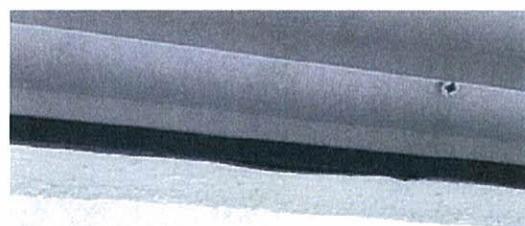
Cracked south wall finish

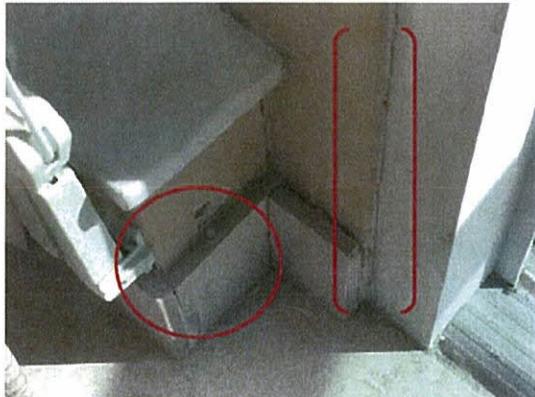
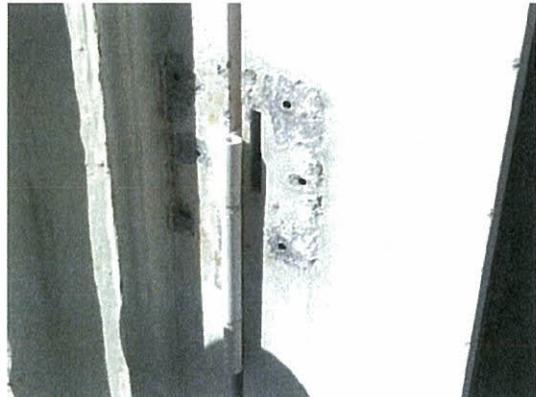
Cracked/detached wall caulking and baseboard

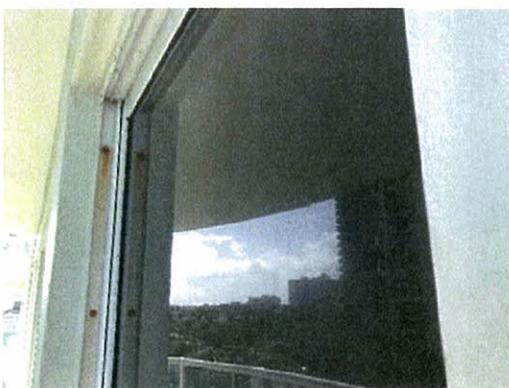
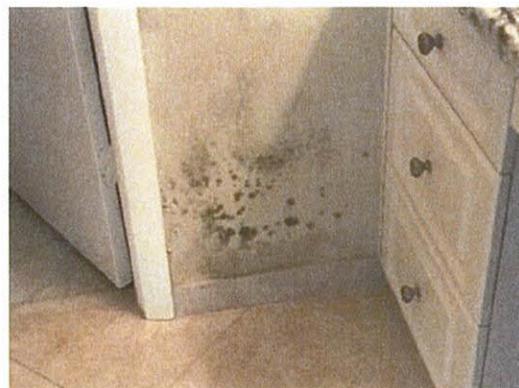
Corroded sliding door screw connectors

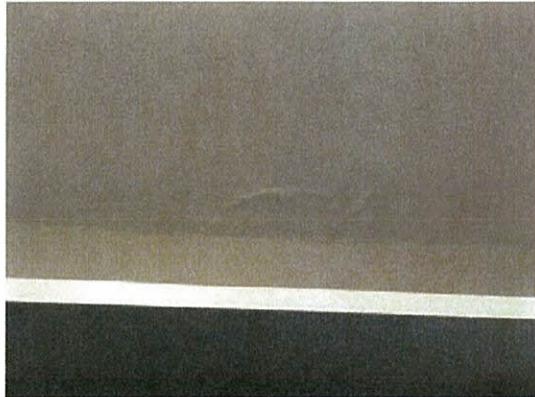
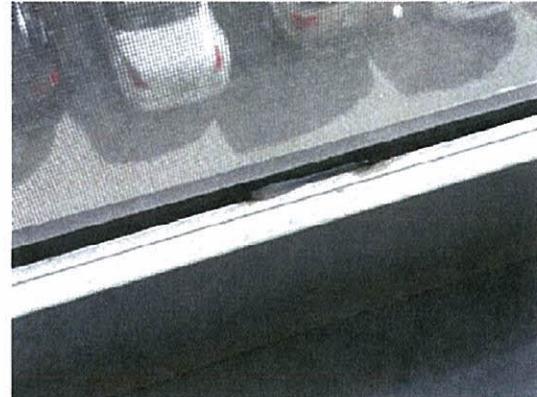
Signs of water intrusion at master closet ceiling

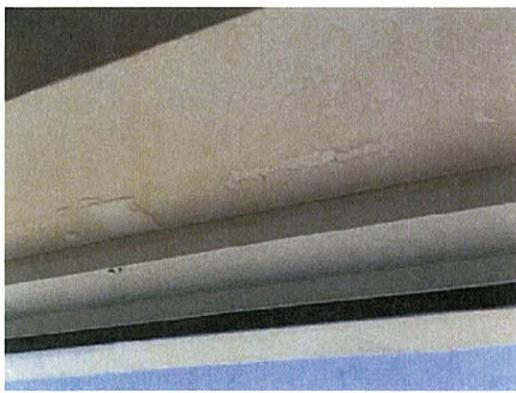
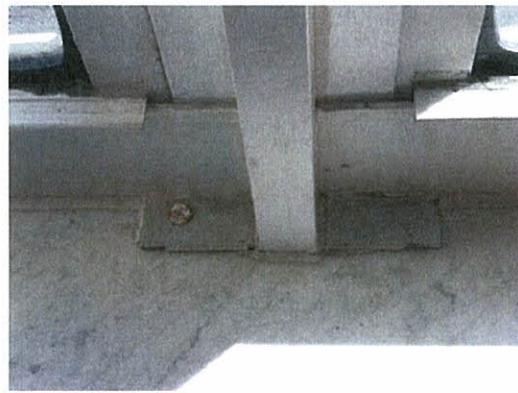
Cracked window header at bedroom

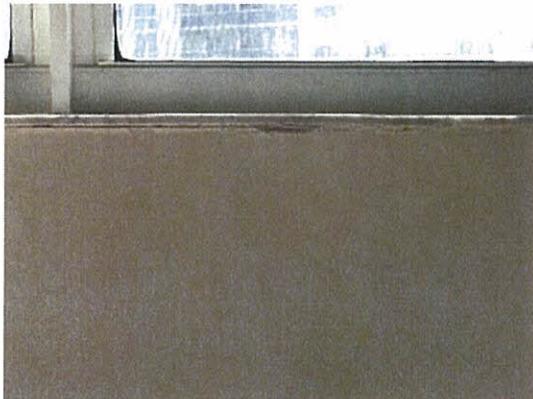
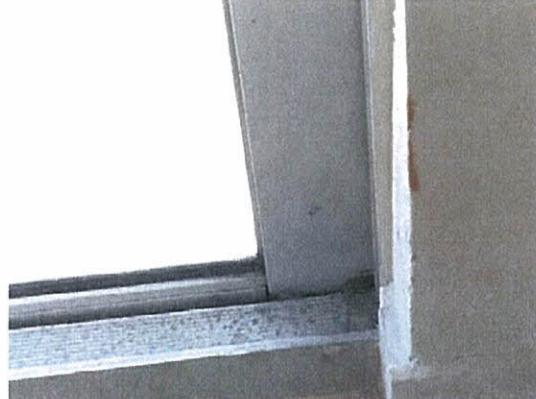
Cracked window sill and missing caulking

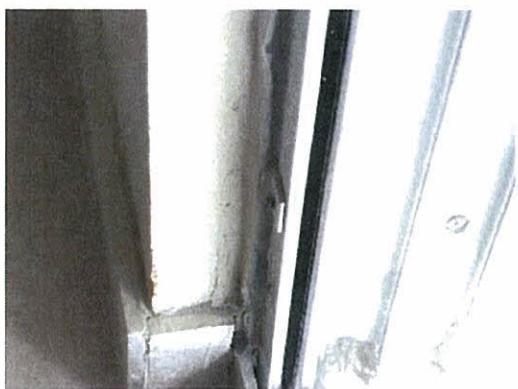
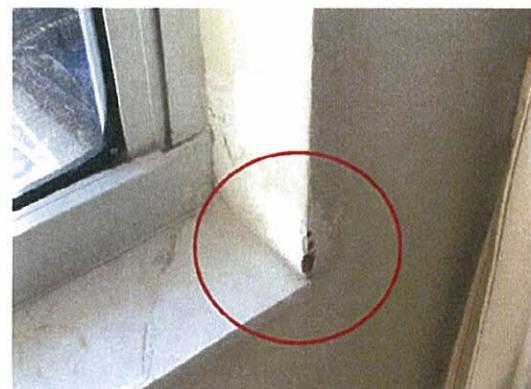
Damaged balcony sliding door frame and baseboard

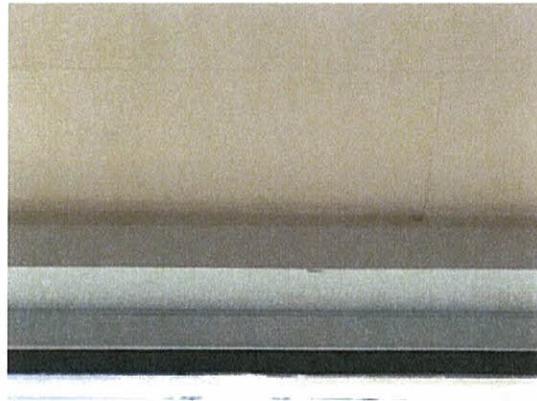
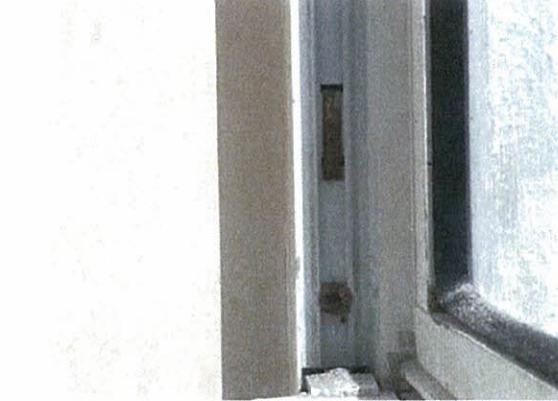
Cracked bedroom window header

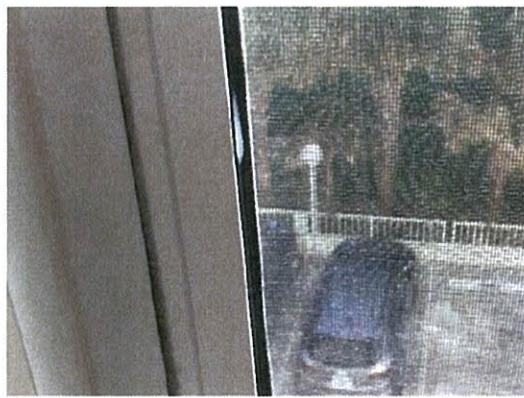
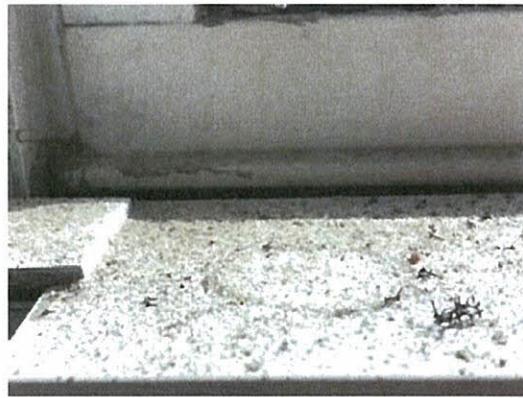
Damaged bedroom window gasket

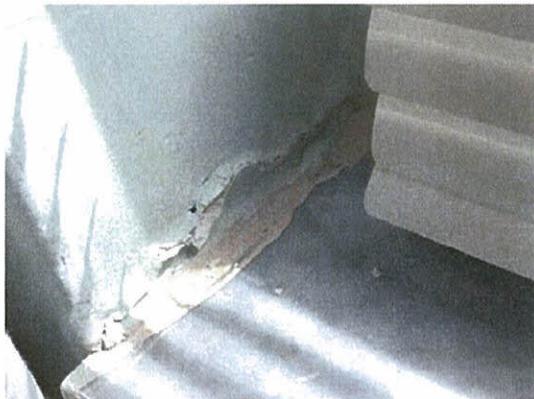
Damaged wall due to water intrusion

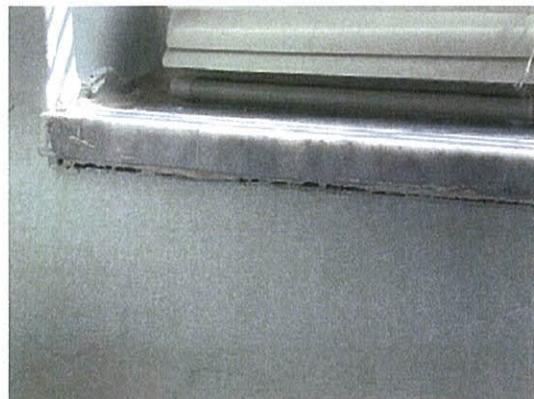
Wall cracked along perimeter of window sill

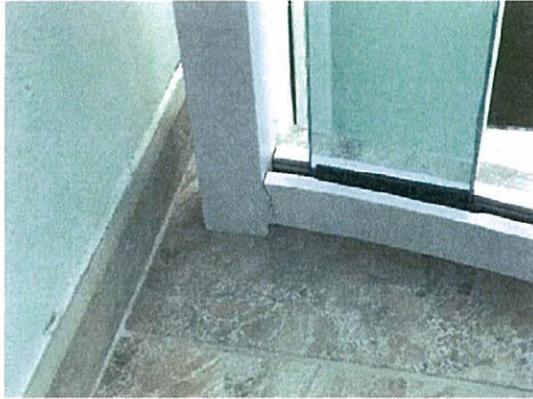
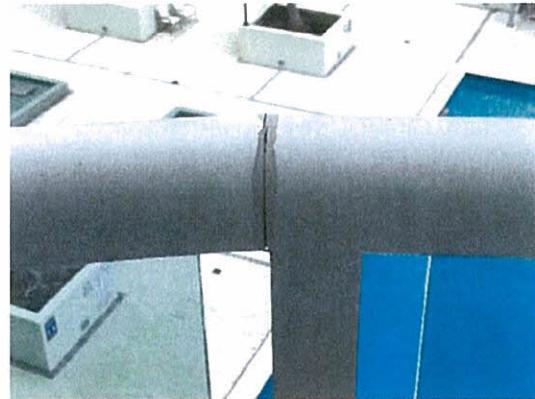
Bottom handrail support cracked

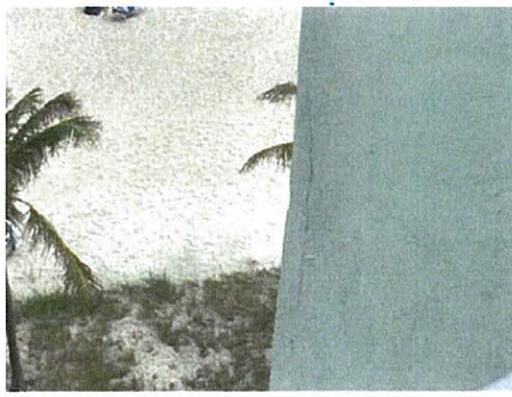
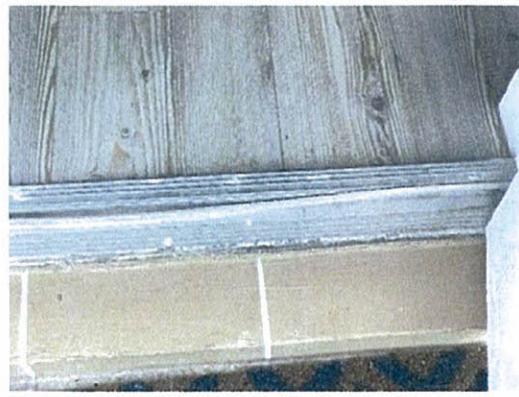
Failed handrail cap joint sealant

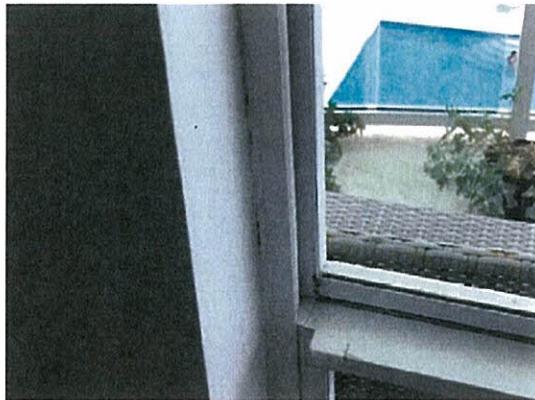
Balcony door bottom gasket damaged

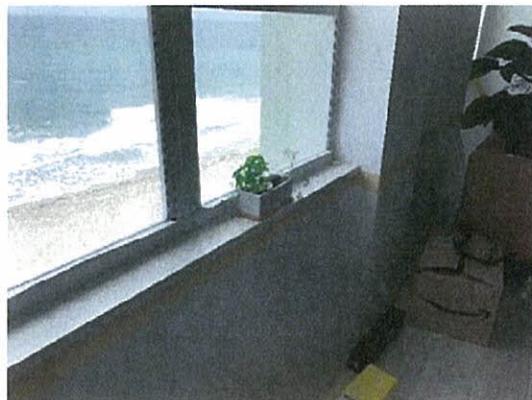
Balcony window caulking cracked

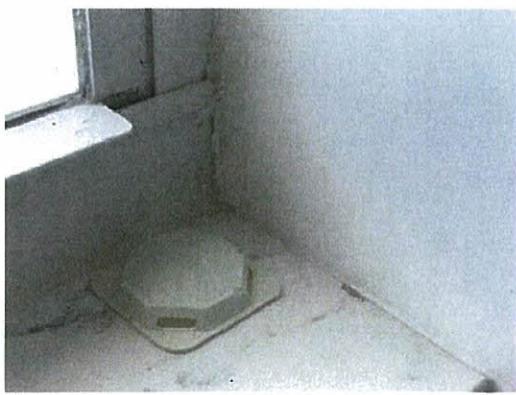
Wall finish removed due to water damage

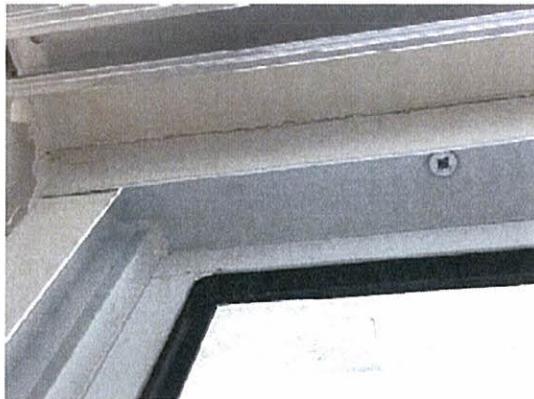
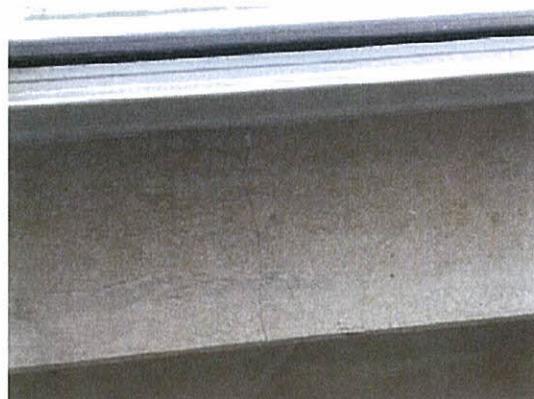
Cracked balcony window header(interior)

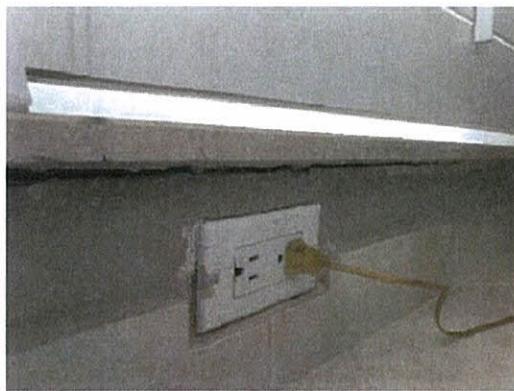
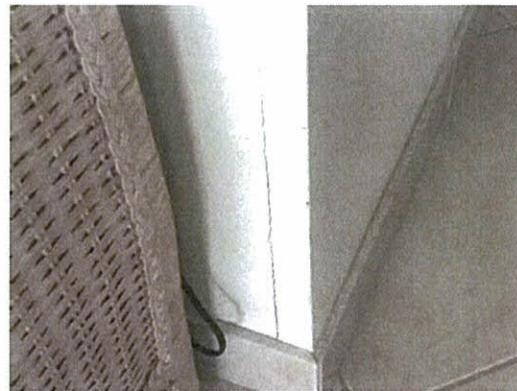
Cracked window base finish

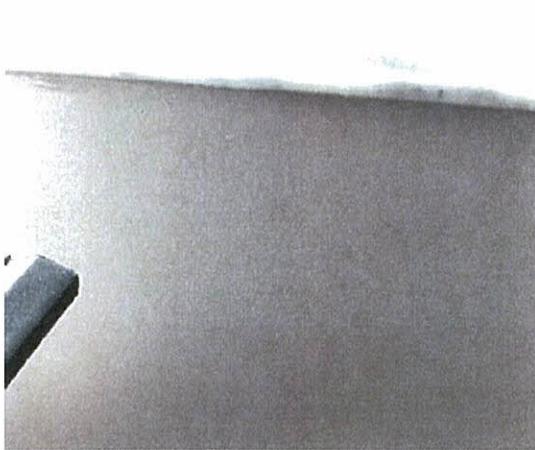
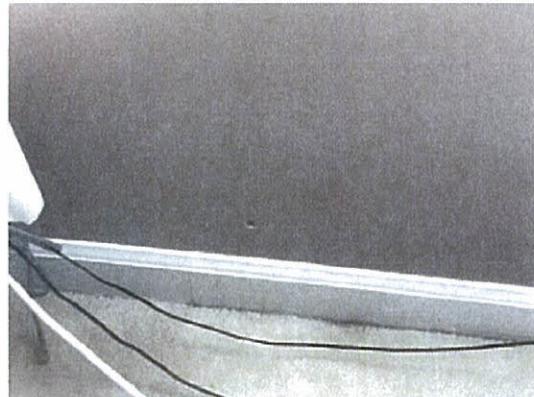
Water stain/path from window sill to floor

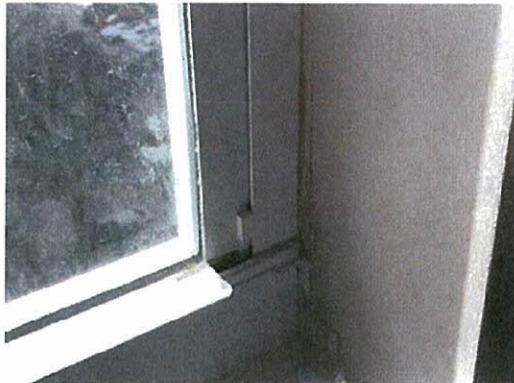
Cracked window frame wall (typical at various locations)

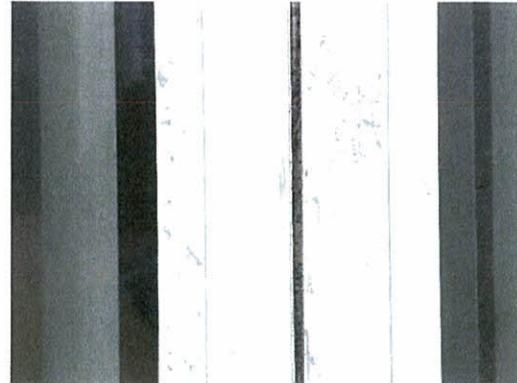
Deteriorated balcony window frame caulking

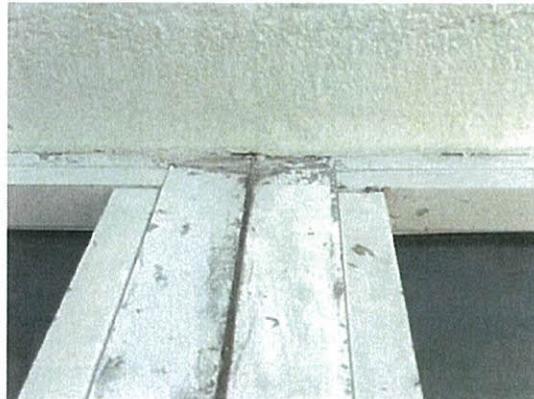
Cracked balcony window header (midspan)

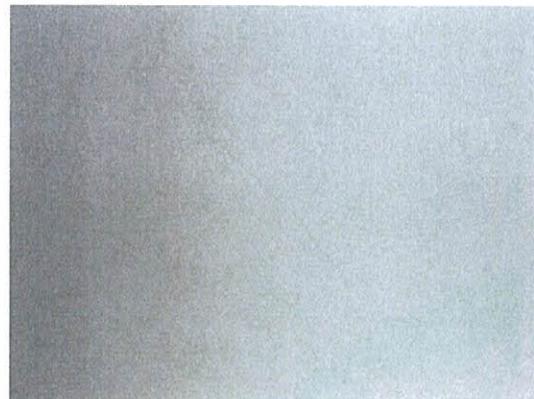
Crack at living room ceiling

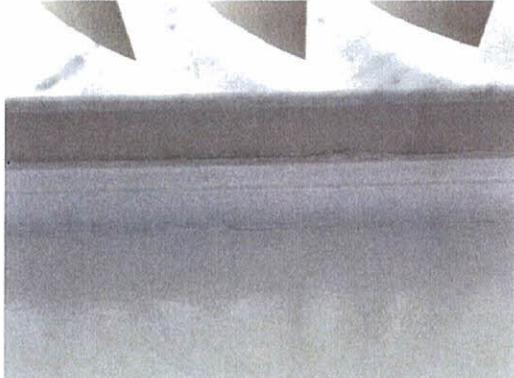
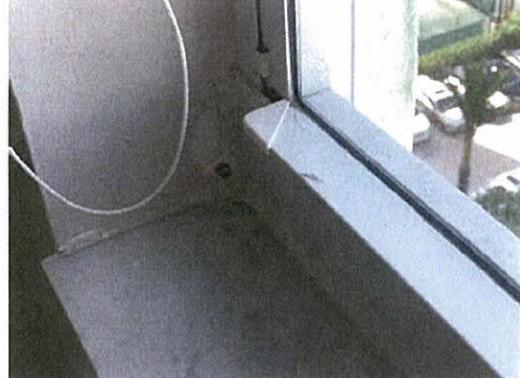
Damaged baseboard below living room window

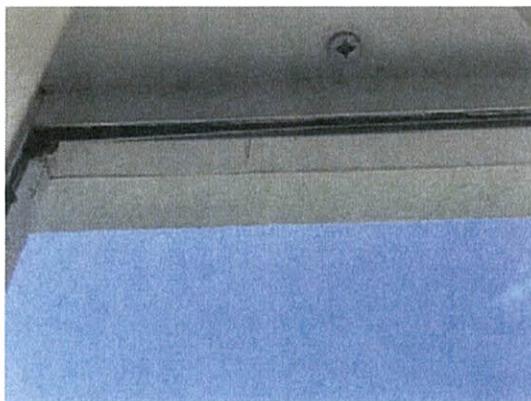
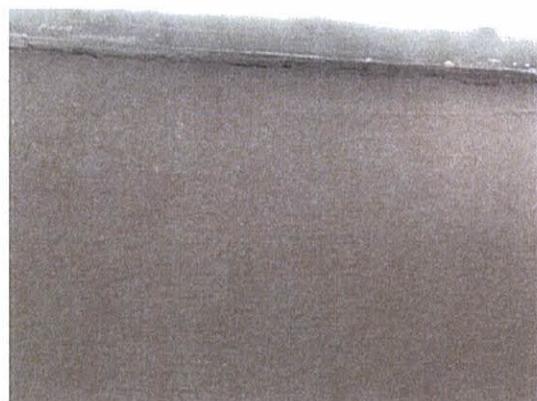
Damaged widow gasket

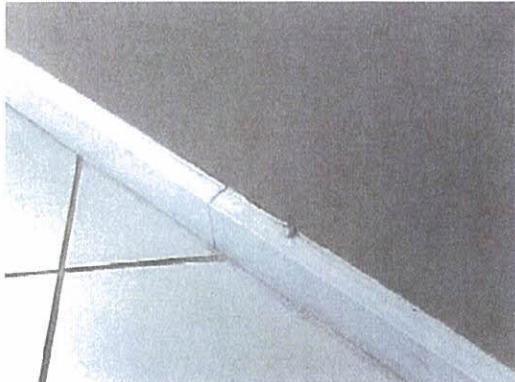
EVALUATION OF DAMAGES FOLLOWING HURRICANE IRMA

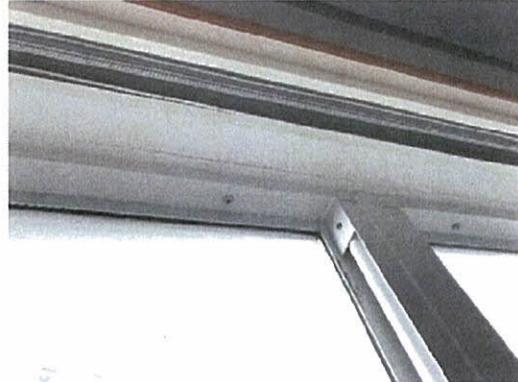
Cracked window header at bedroom

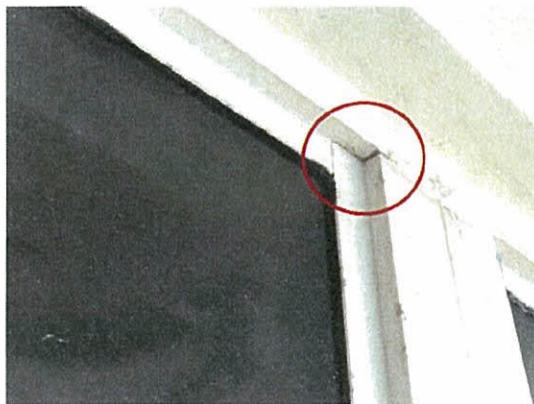
Cracked balcony window frame at top

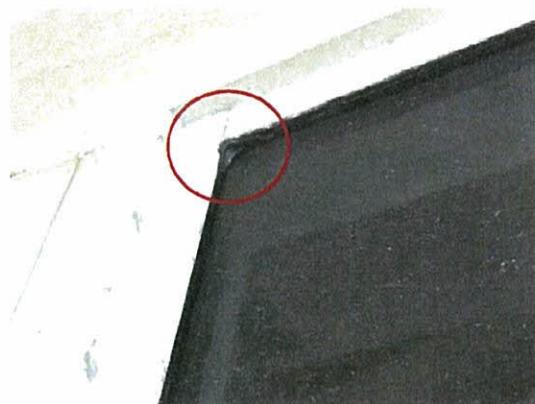
Damaged window gasket at balcony

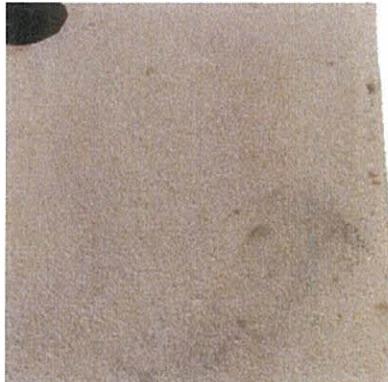
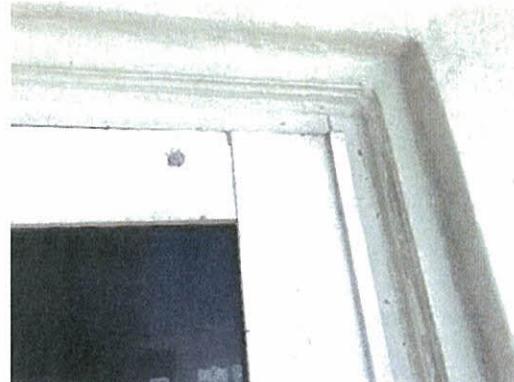
Rust spots at balcony slab (various locations)

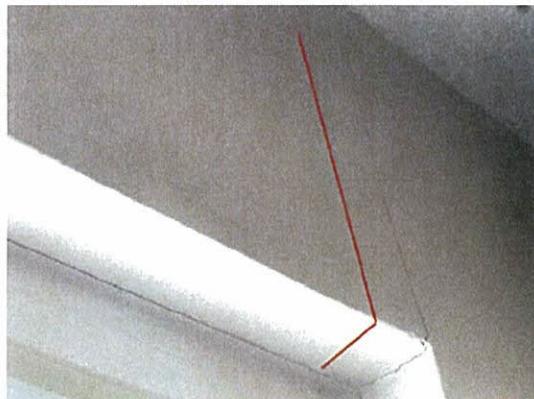
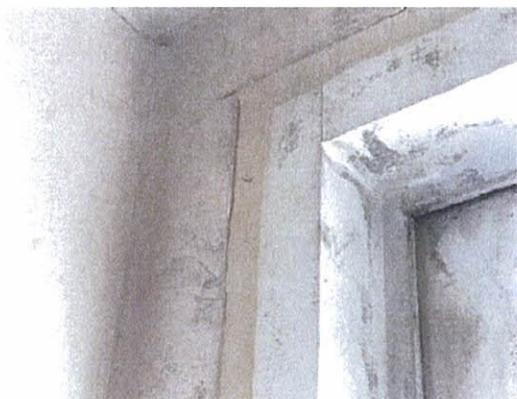
Cracked balcony door header

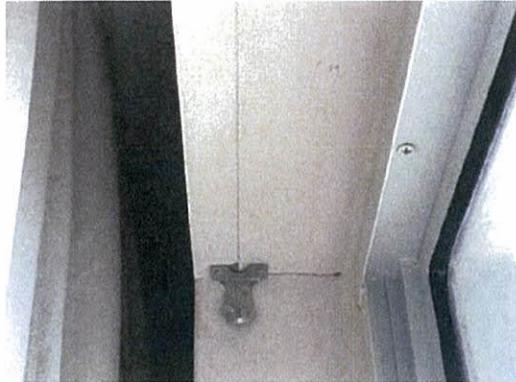
**Cracked window header at living room
(east side)**

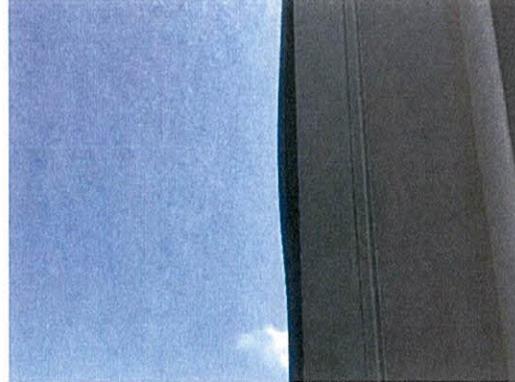
**Damaged window gasket at living room
(east)**

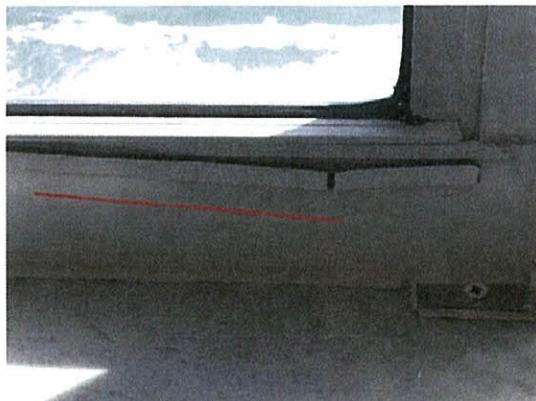
Damaged window bottom frame

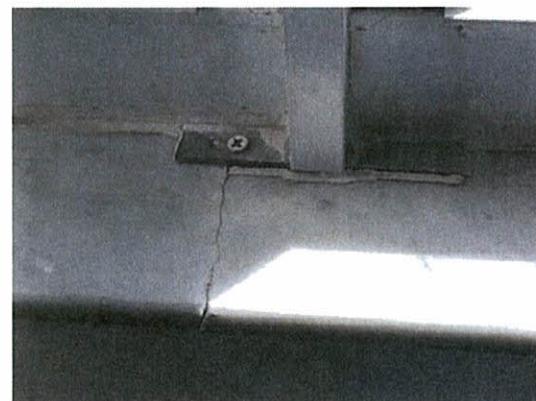
**Cracked window sill and displaced window
bottom connection**

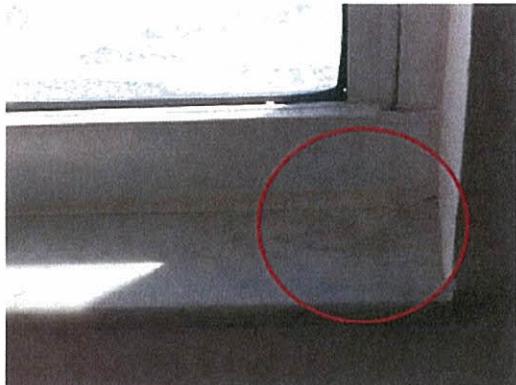
Sand accumulation at bottom corner of kitchen window sill (east). Typical all units

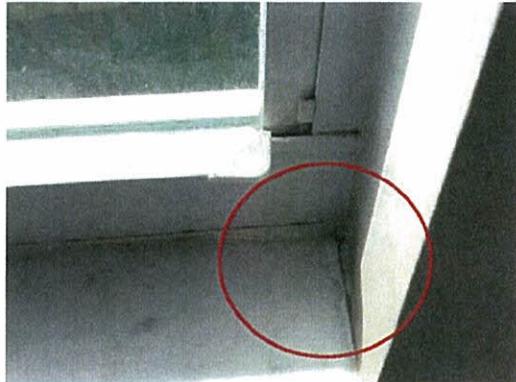
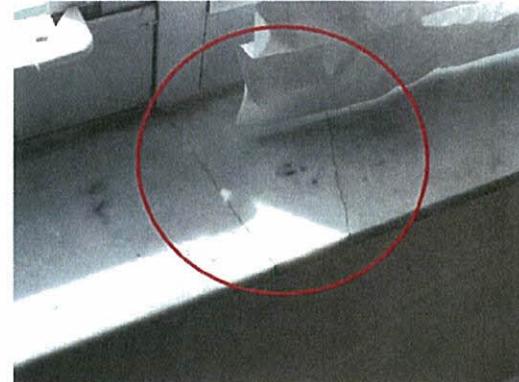
Cracked master bedroom window sill at right hand corner

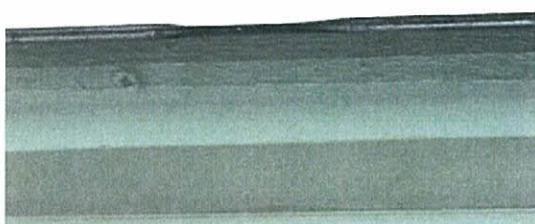
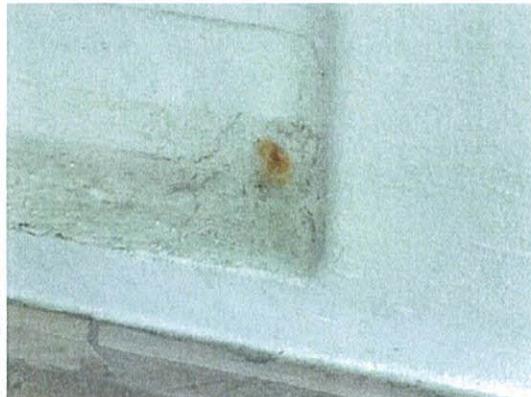
Damaged balcony window gasket

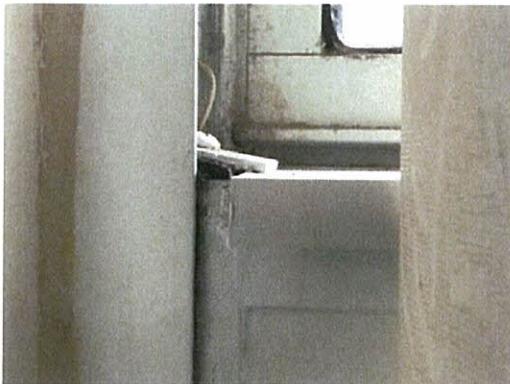
Damaged window frame at living room

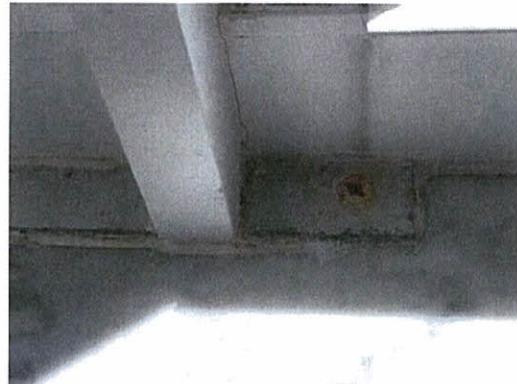
Cracked window frame

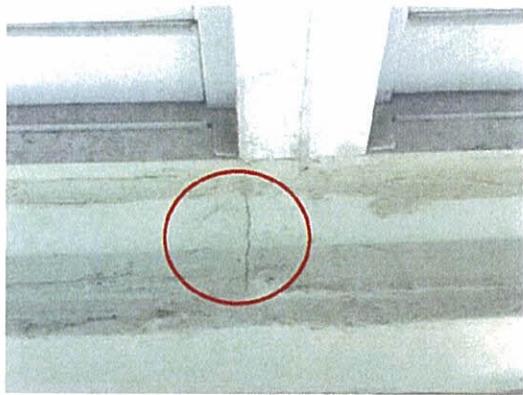
Crack visible at balcony window sill level (exterior)

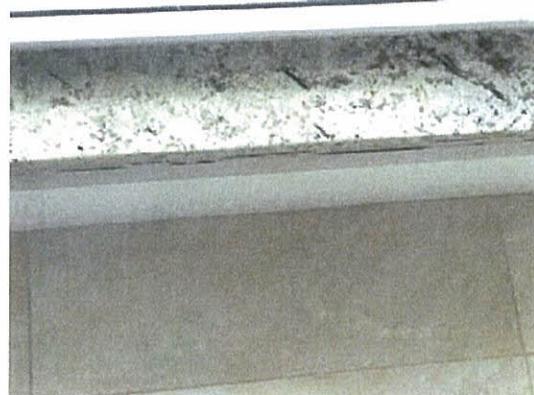
Damaged baseboard below balcony window at living room space

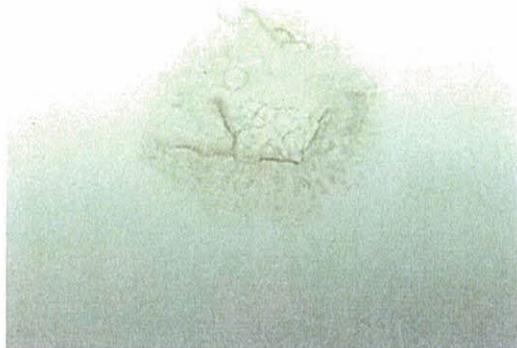
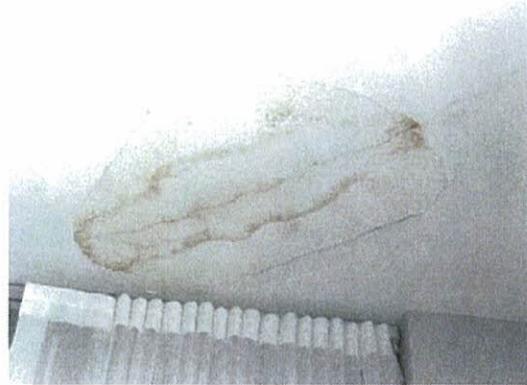
Water intrusion damage at ceiling spot near balcony window

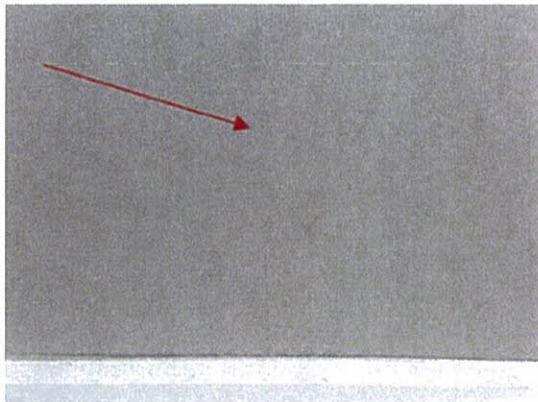
Wall crack noticed below east window in the living room area

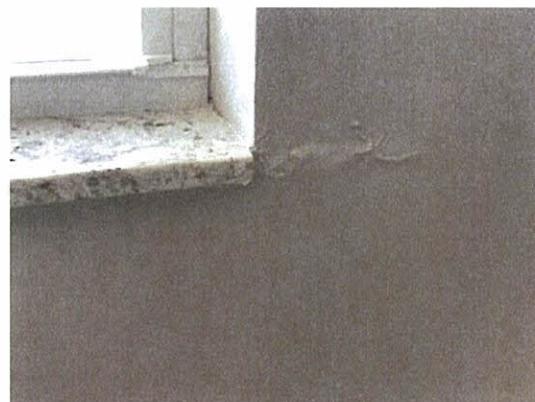
Paint blisters possibly due to water intrusion visible at the east window at window sill level

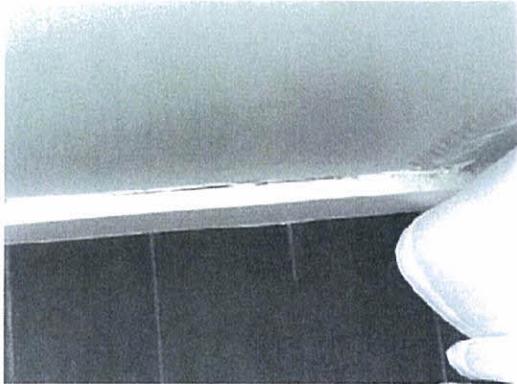
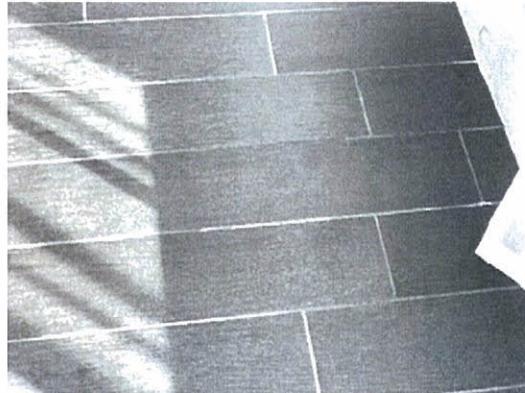
Water damage at baseboard and wall at master bedroom

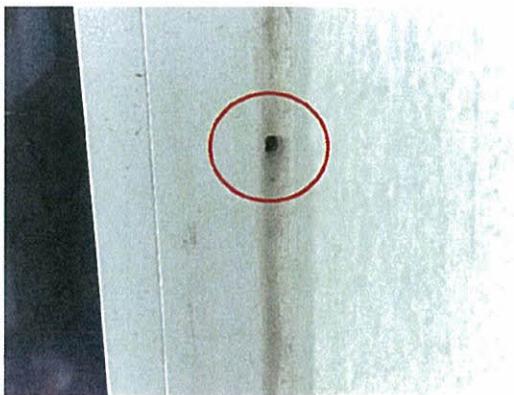
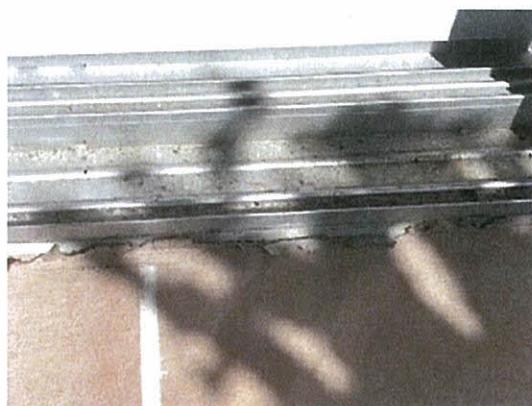
Perforated balcony window caulking

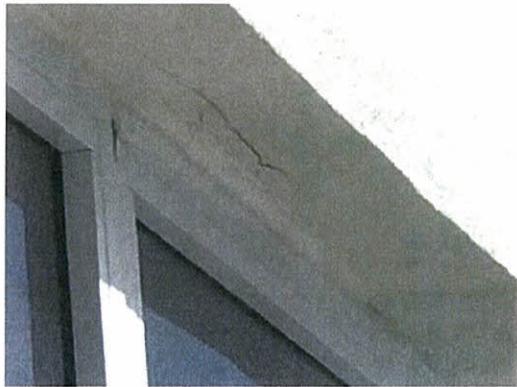
Cracked bedroom window header as seen from balcony (exterior)

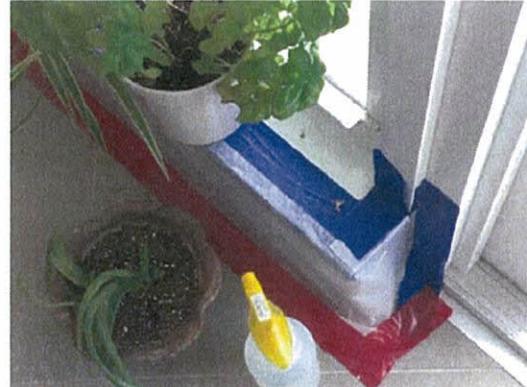
Removed wall panel below balcony window sill due to water intrusion

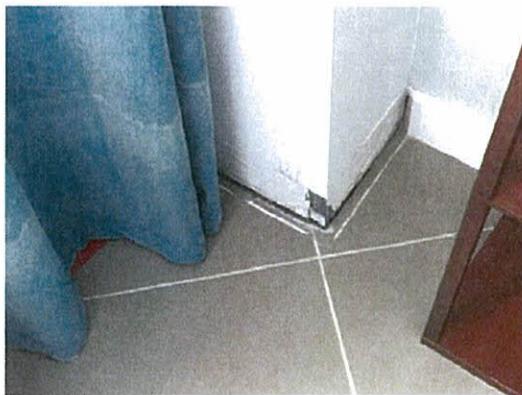
Removed wall baseboard proximate to bedroom window. Water stains visible at curtains

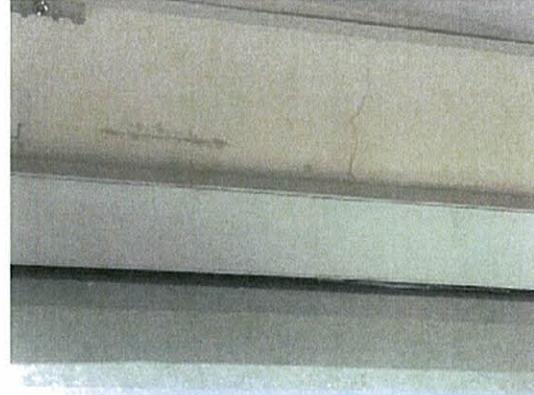
Cracked window header

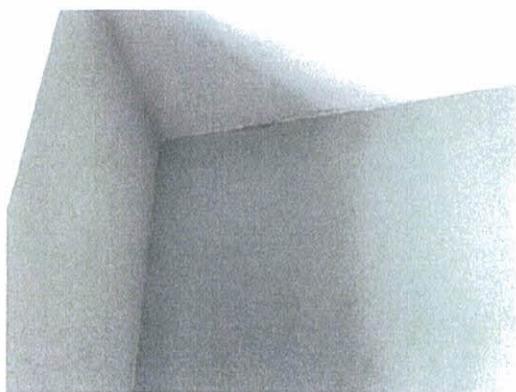
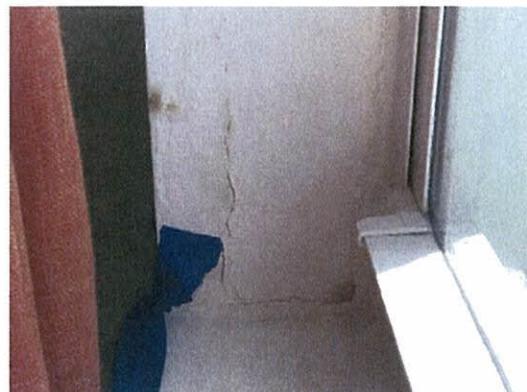
Crack visible between ceiling and wall

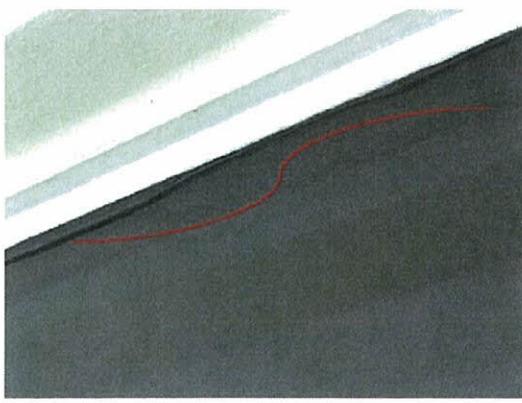
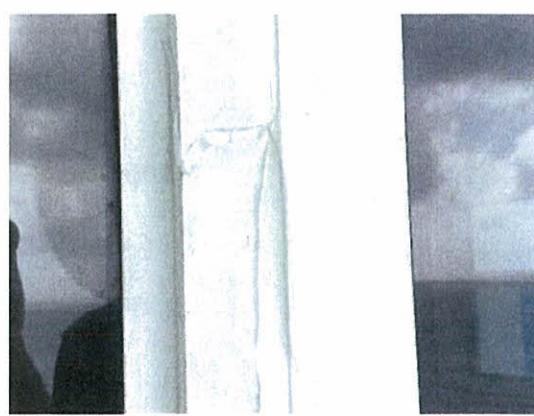
Damaged balcony window gasket

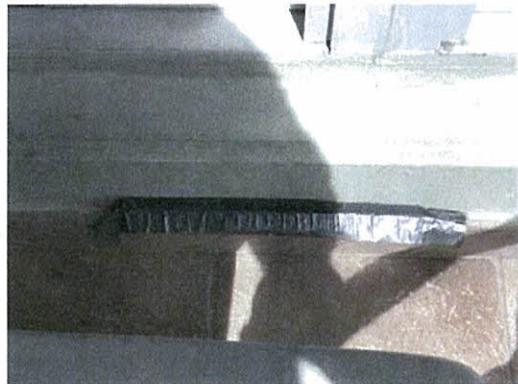
Cracked window sill at balcony window between base and wall (exterior)

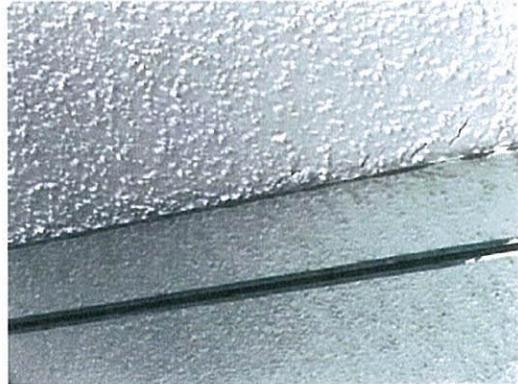
Cracked popcorn ceiling near balcony door entrance. This extends along all the partition wall.

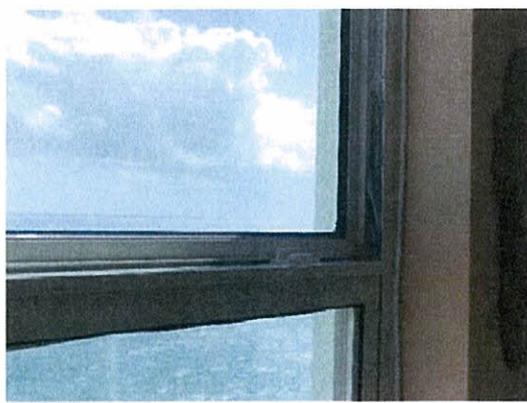
Cracked window frame at living room (east window)

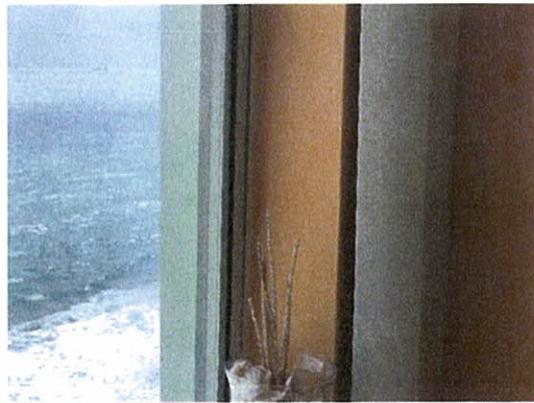
Failed kitchen window caulking

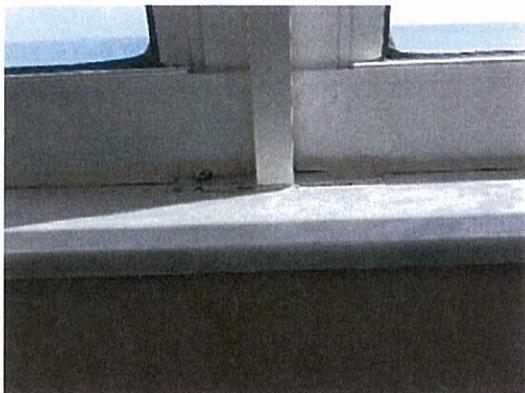
Deteriorated window caulking

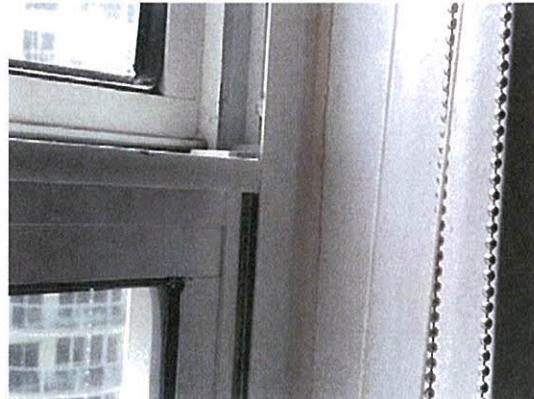
Deteriorated/cracked window caulking

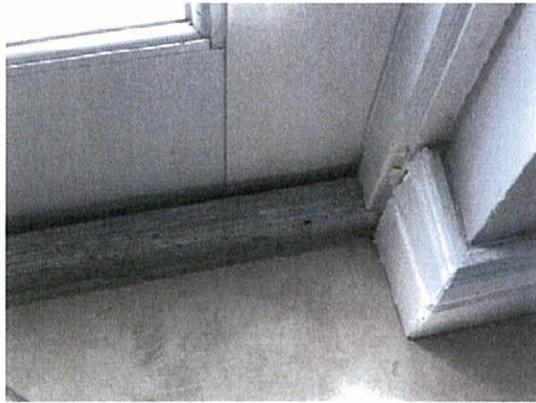
Damaged baseboard at balcony door (interior)

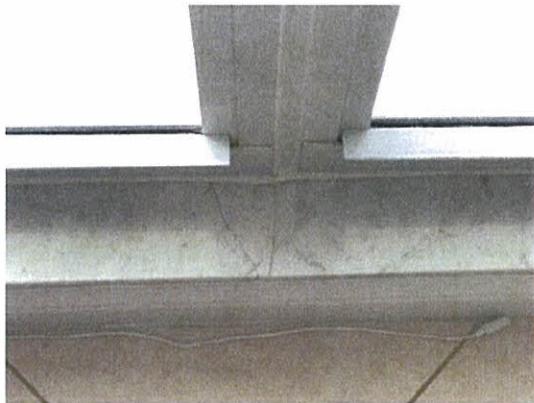
Cracked balcony window sill (interior)

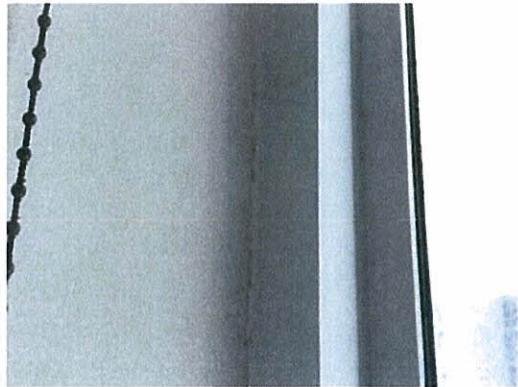
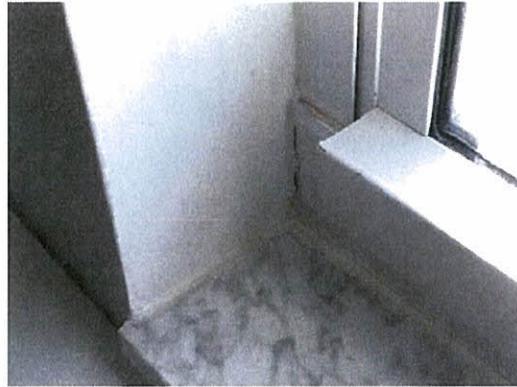
Cracked window caulking at bedroom window

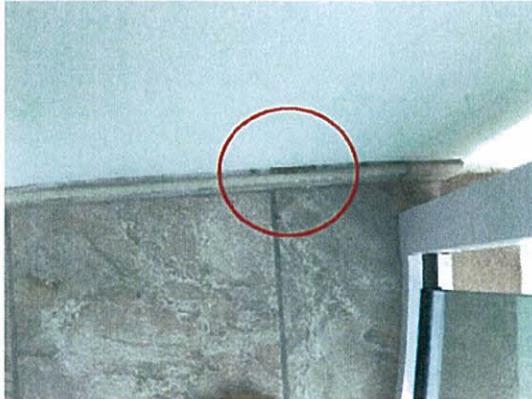
Signs of water intrusion through balcony baseboard

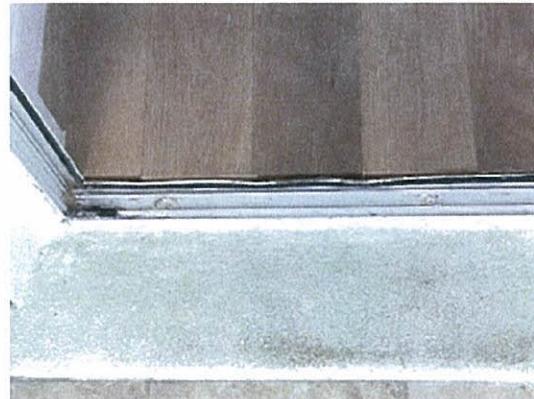
Corrosion happening at balcony window sill

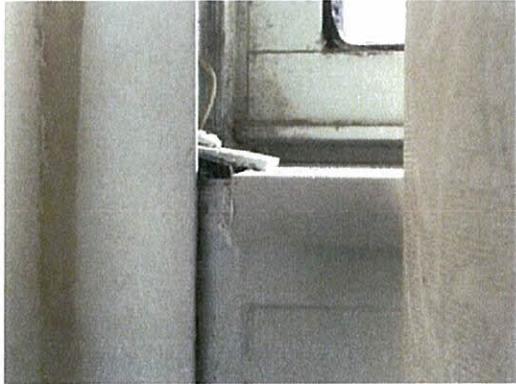
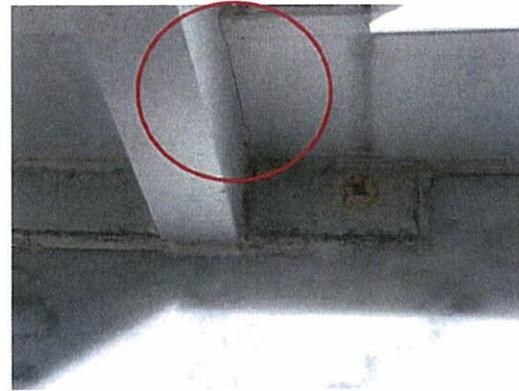
Damaged window frame at living room

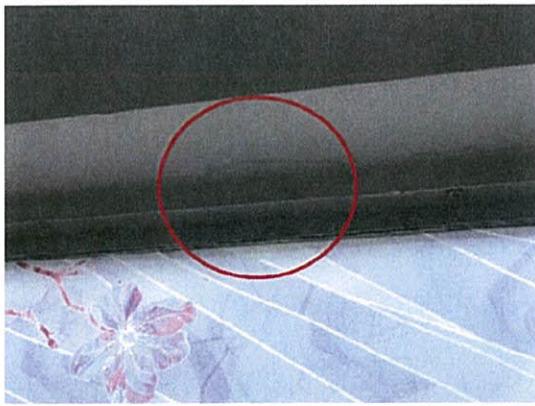
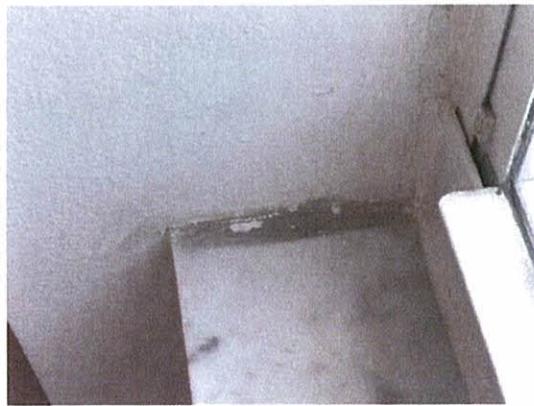
Signs of water intrusion deposited at living room window header

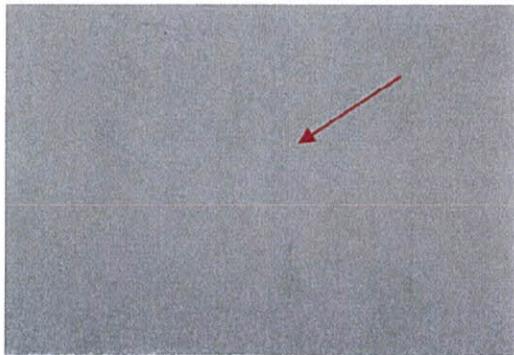
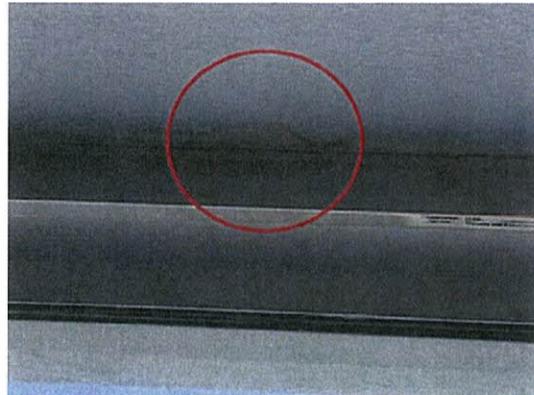
Cracked window header

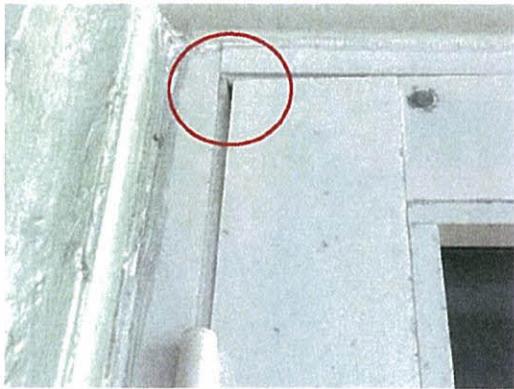
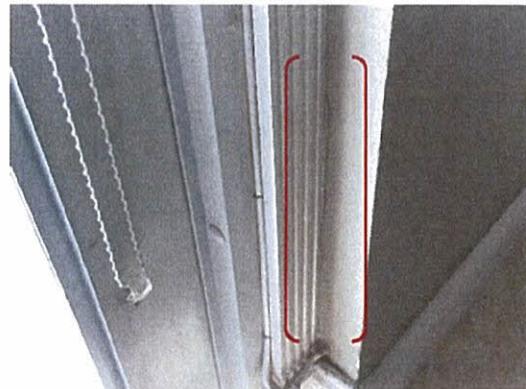
Opening in balcony door weather-strip

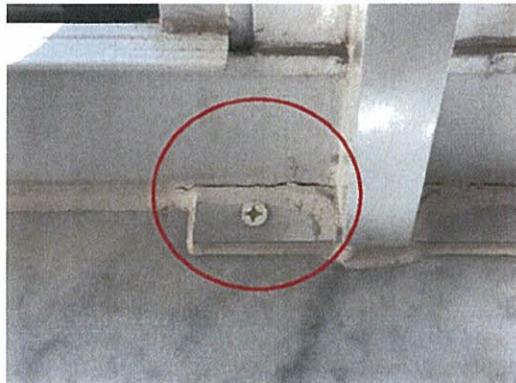
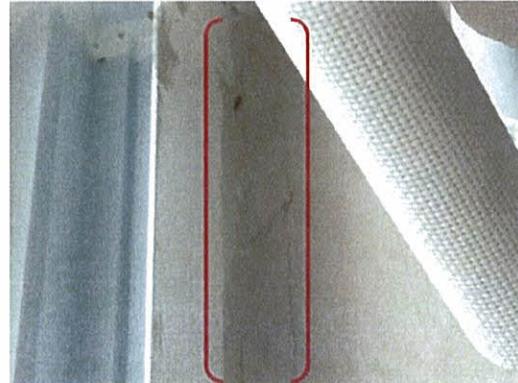
Cracked window caulking. Bent screw

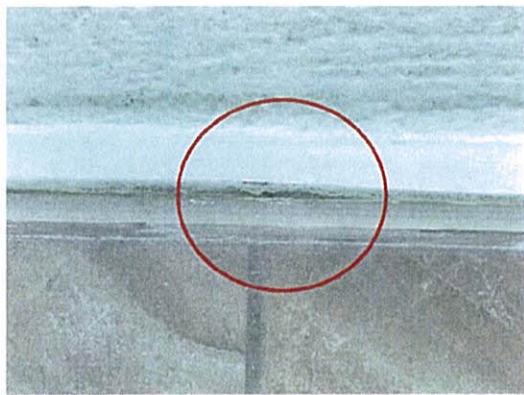
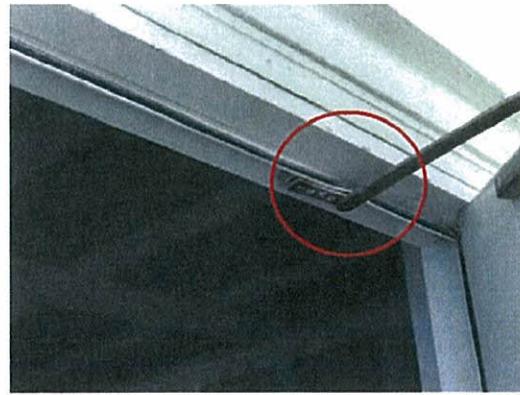
Caulking crack at balcony wall base trim
