Post Hurricane Irma Engineering Evaluation of Southpoint Condominiums Fort Lauderdale, Florida

Prepared for:

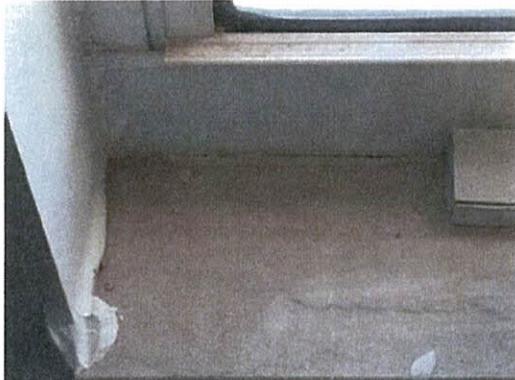
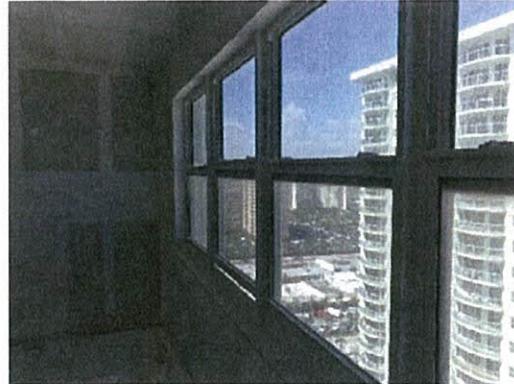
Cracked window caulking at window sill

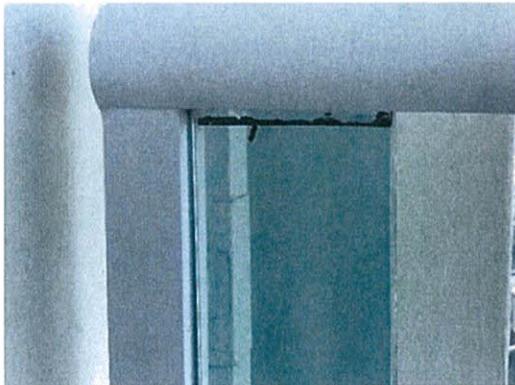
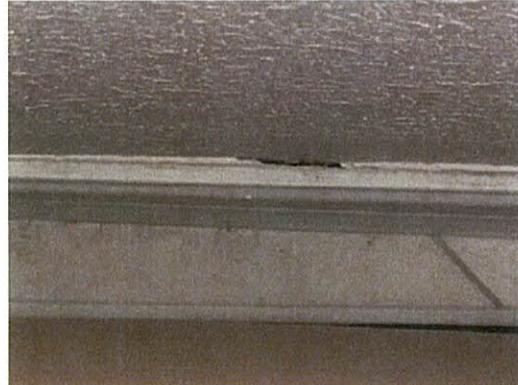
Handrail glass panel gasket failure observed

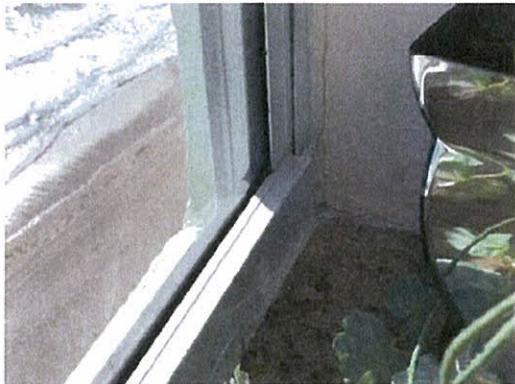
Cracked stucco along window frame at southeast corner near kitchen

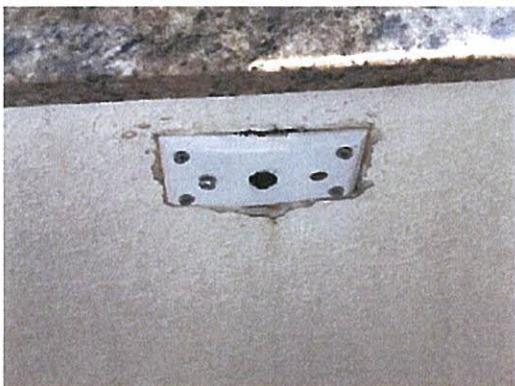
Water intrusion damage at wall below kitchen

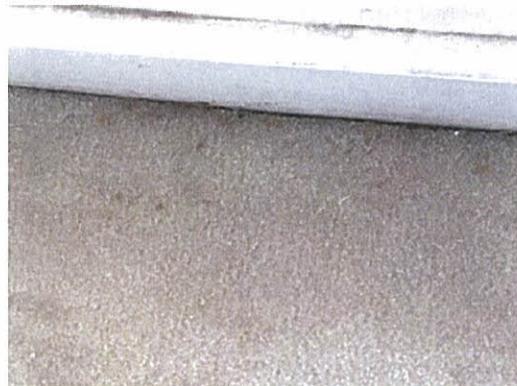
Damage baseboard and spotted corrosion at floor. Carpet was not removed

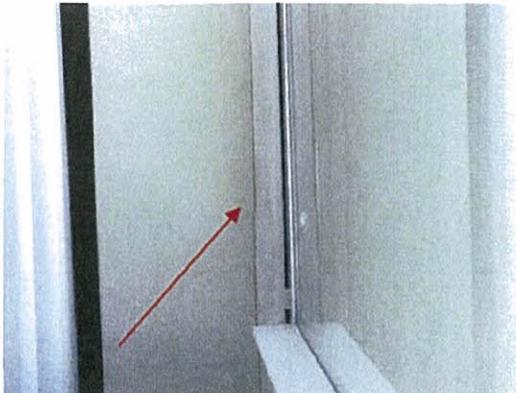
Cracked wall at window frame

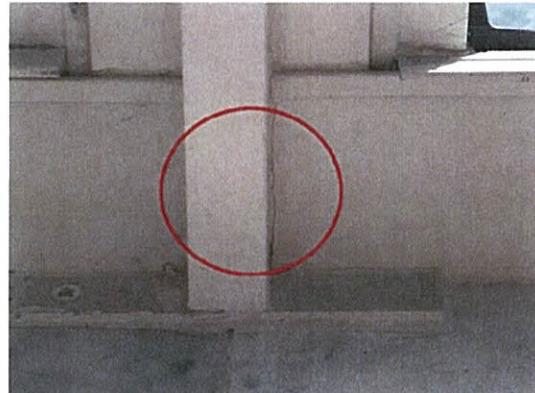
Cracked window frame

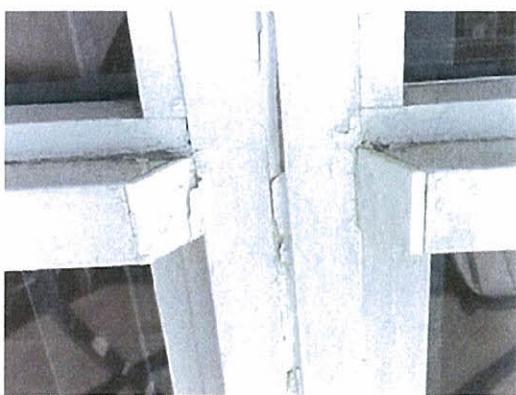
Deteriorated window caulking

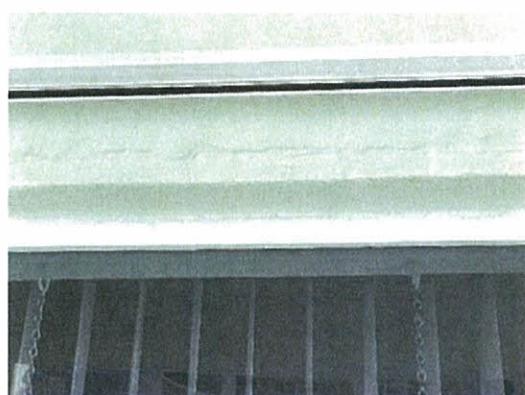
Water bubble atop balcony window header

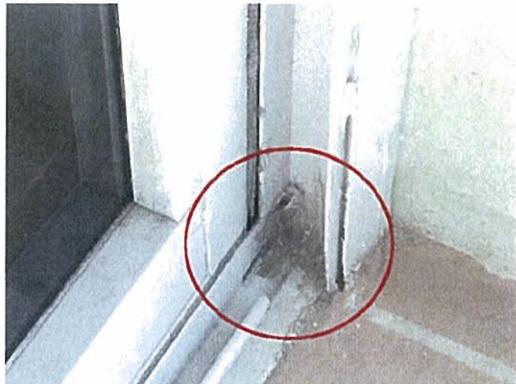
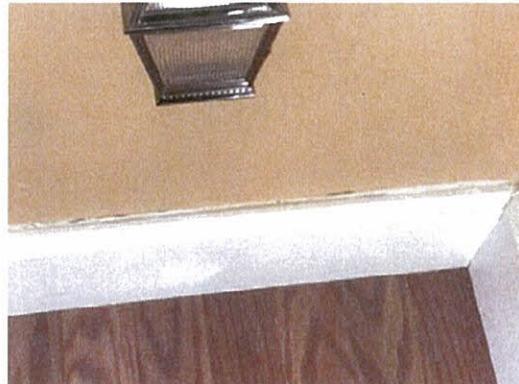
Damaged balcony sliding door and track possibly due to buffeting

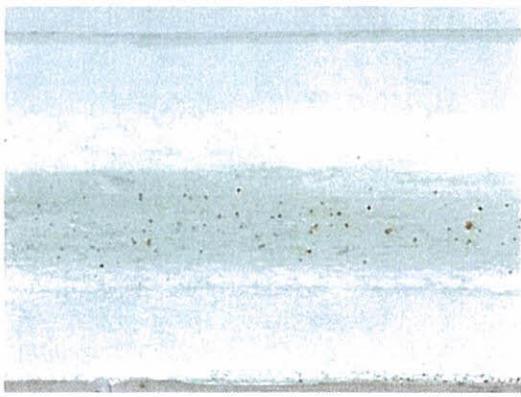
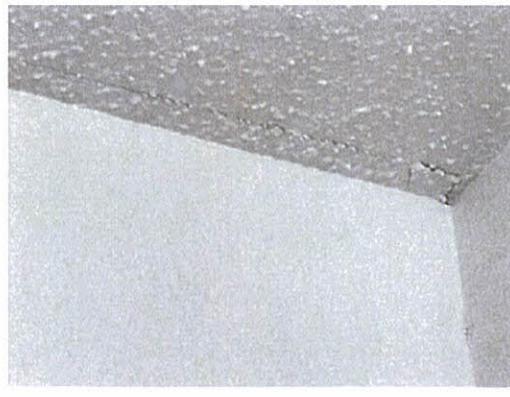
Corrosion at balcony window sill (exterior)

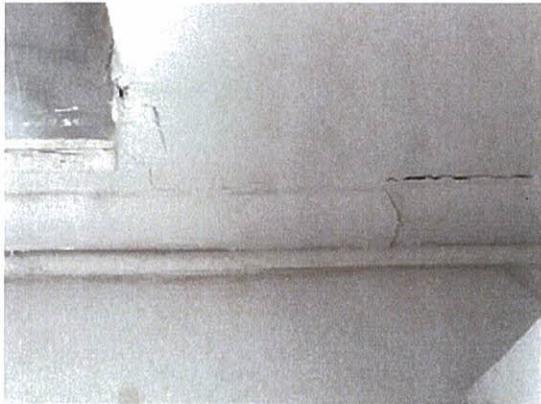
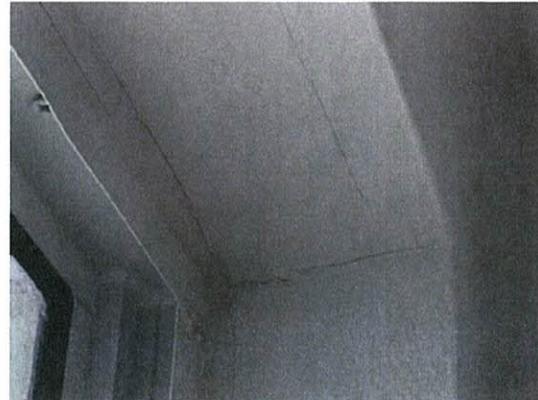
Cracked baseboard proximate to balcony window

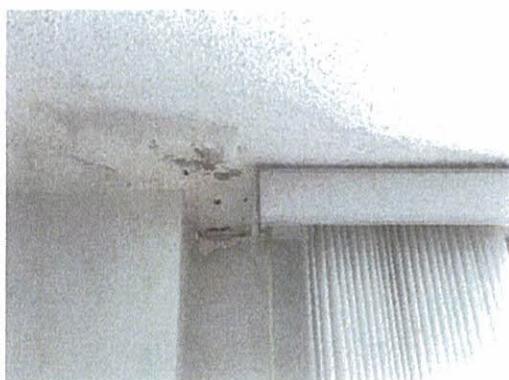
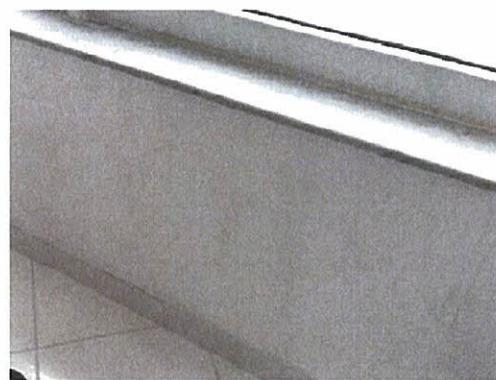
Water intrusion damage at ceiling near balcony window

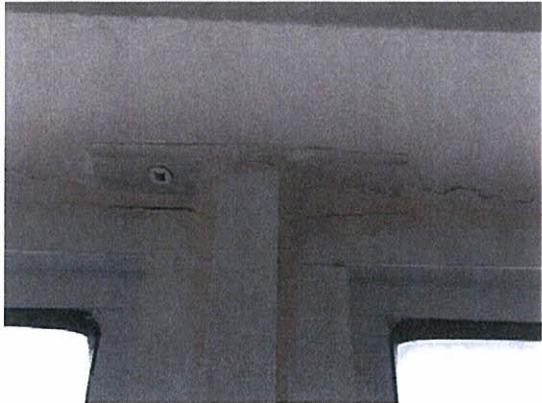
Cracked caulking at mullion connector

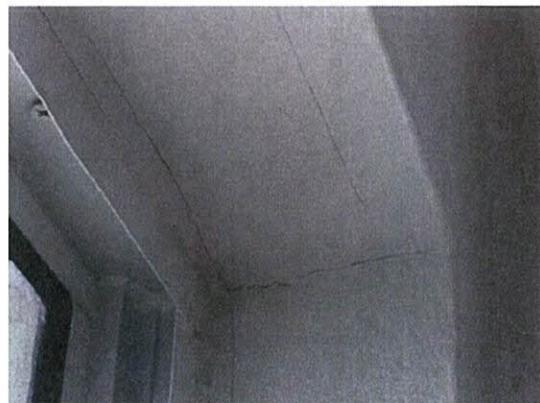
Cracked window header

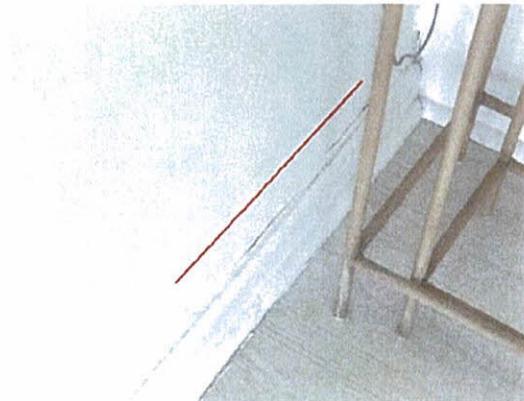
Buckled wood floor at unit kitchen

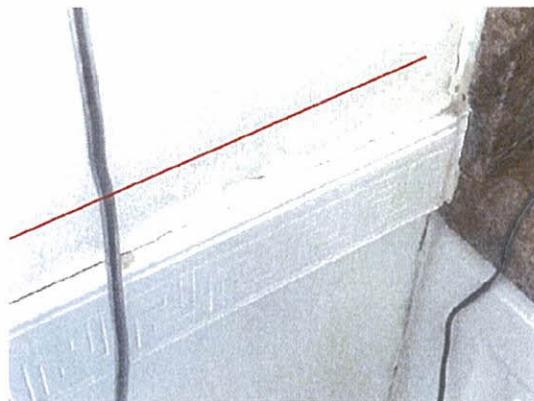
**Damaged baseboard at kitchen partition
wall**

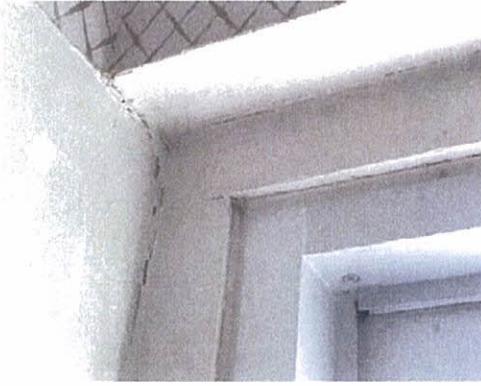
Deteriorated balcony window caulking

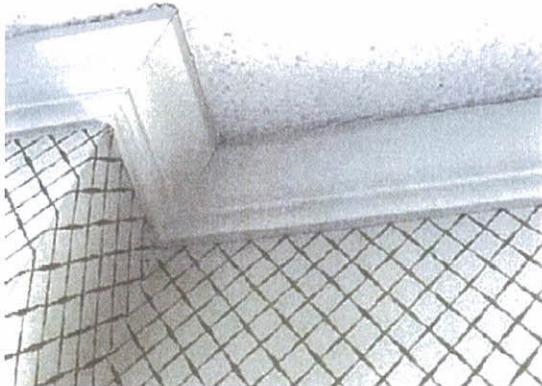
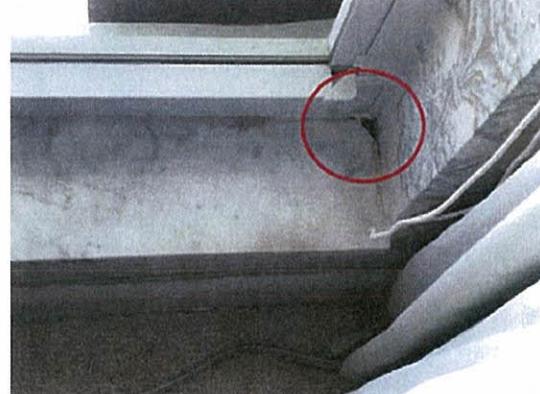
Cracked ceiling board proximate to balcony access. The crack prolongs in length along partition wall and other locations in the living room

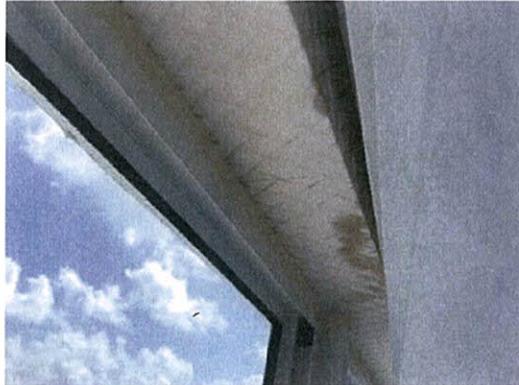
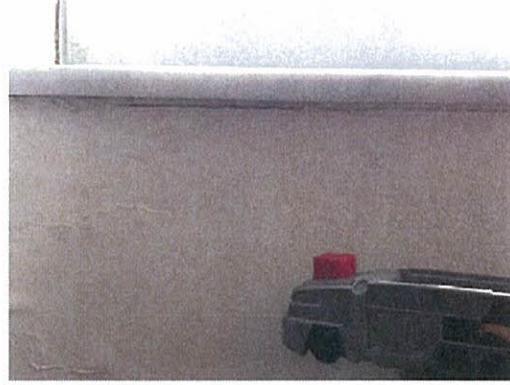
Water intrusion damage and crack at east window header

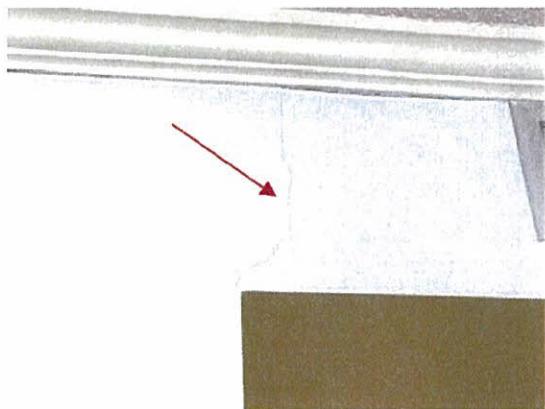
Cracked opening header at master bedroom

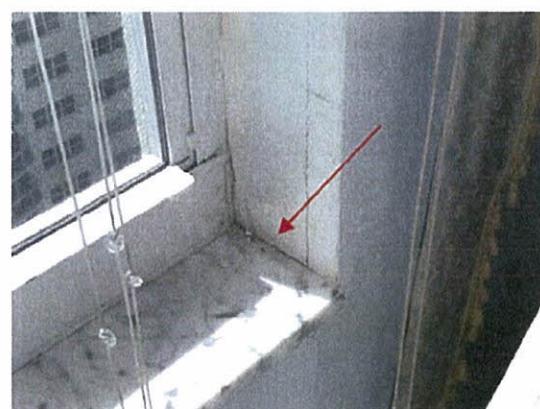
Damaged window frame wall with signs of water intrusion at master bedroom

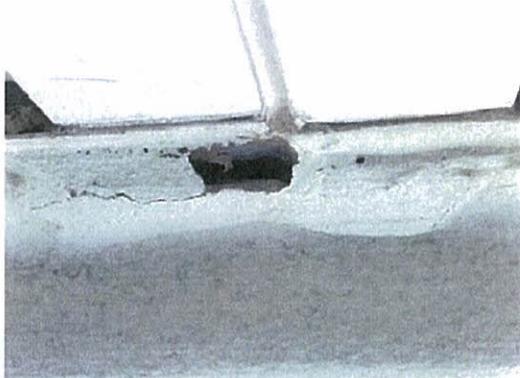
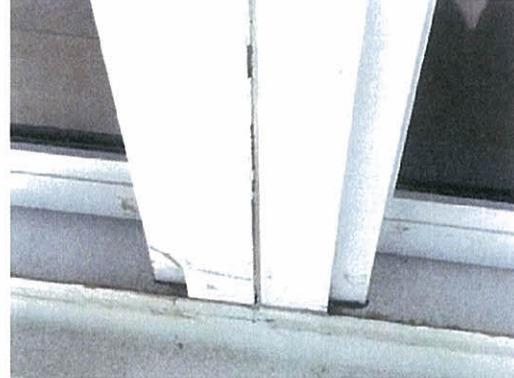
Perforated balcony window caulking

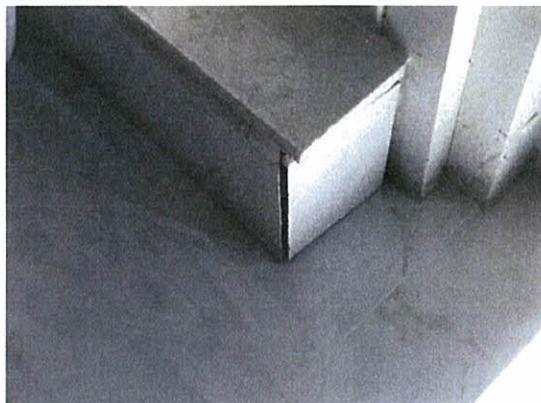
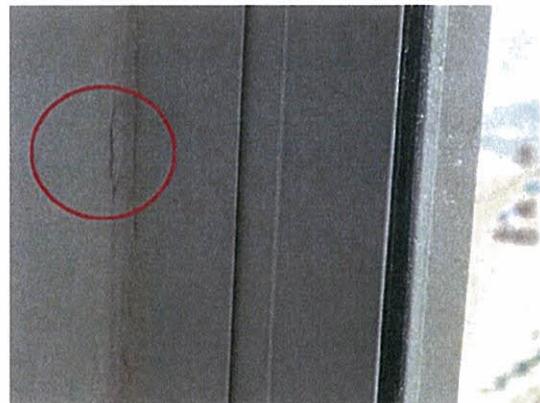
Cracked/damaged baseboard proximate to balcony access. The crack is typical at other locations in the living room area

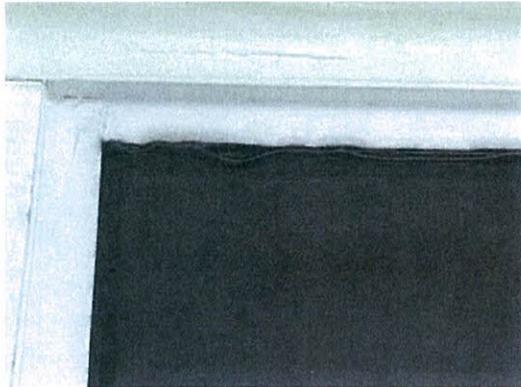
Deteriorated window gasket

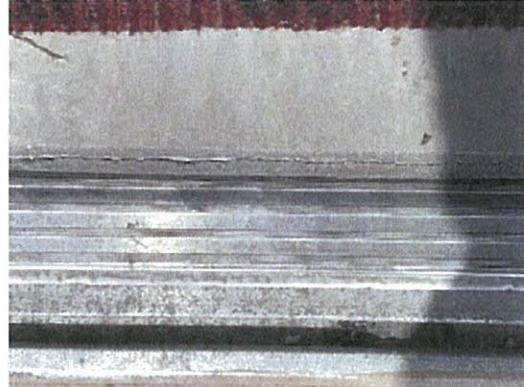
Cracked tile joints at balcony door

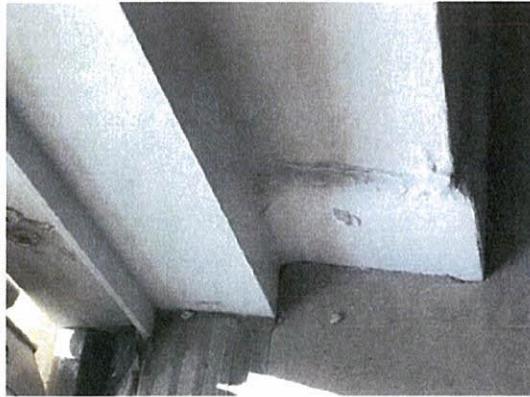
Cracked baseboard and wall finish at balcony door. Signs of water intrusion noticed.

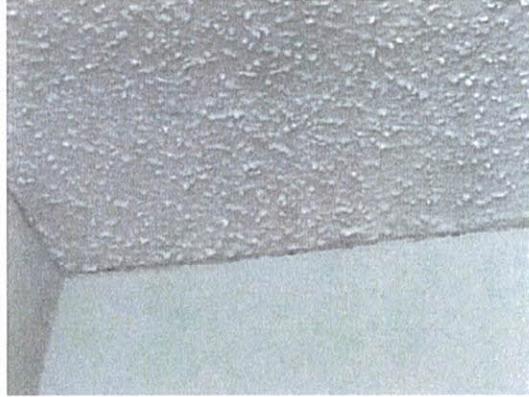
Visible cracks between partition wall and ceiling at living room

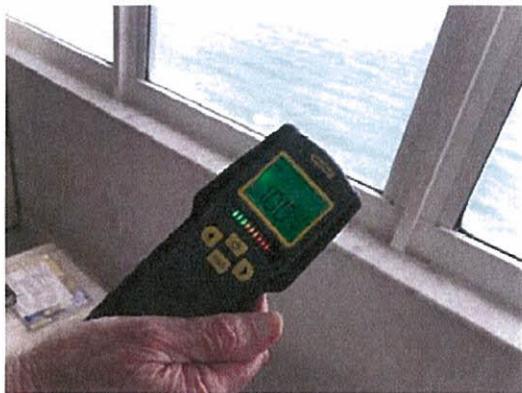
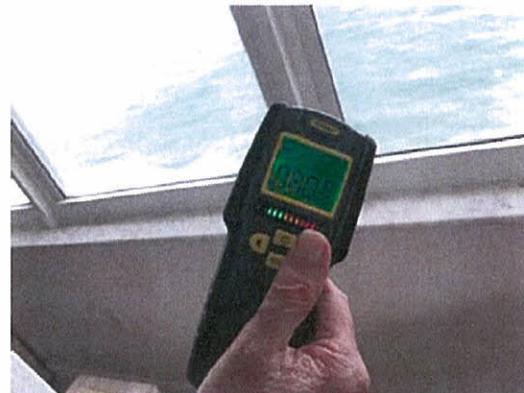
**Allocated wall moisture content at midspan
(windows facing east)**

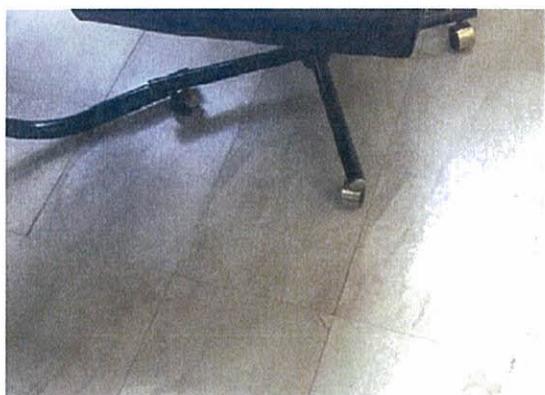
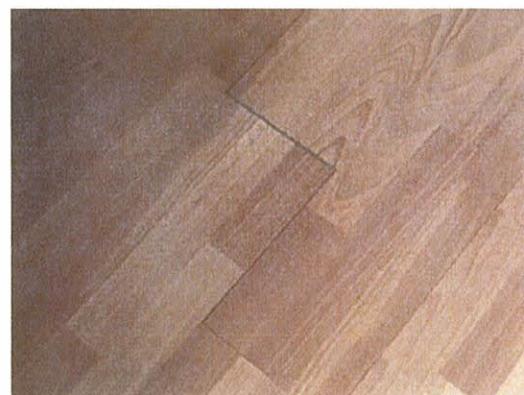
Cracked and disjoint tiles

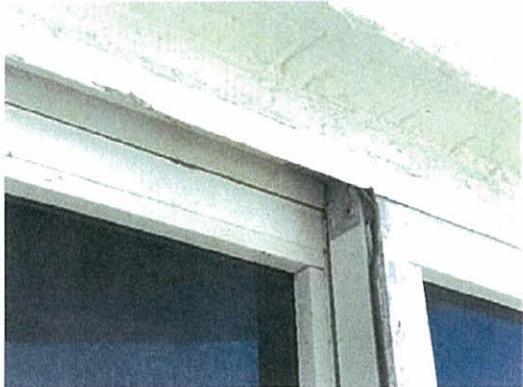
Damaged balcony sliding door weatherstripping

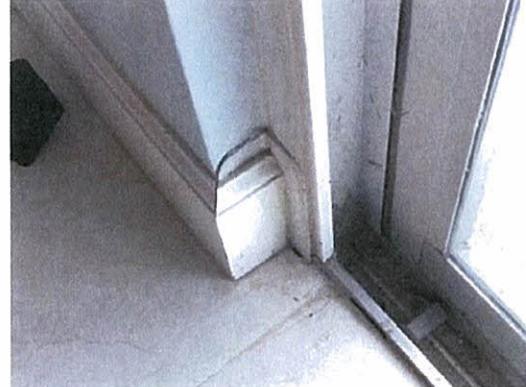
Cracked and detached baseboard at balcony sliding door

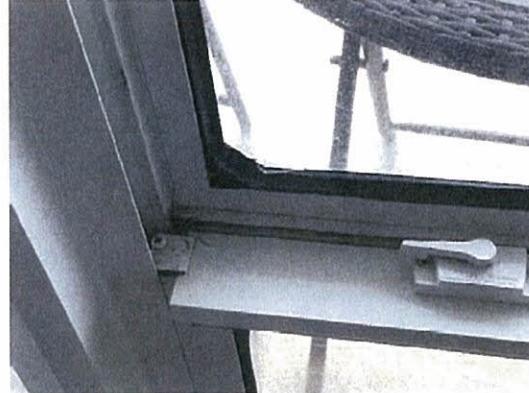
Damaged balcony window gasket

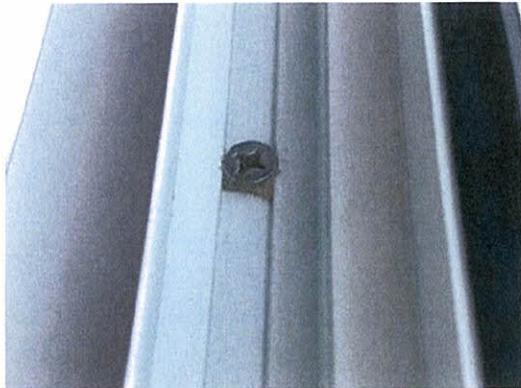
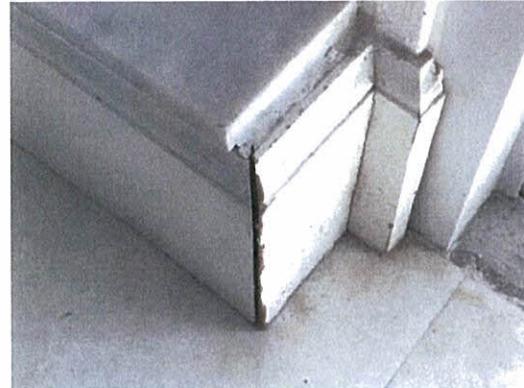
Accumulation of particulates around window semi loose screw (interior)

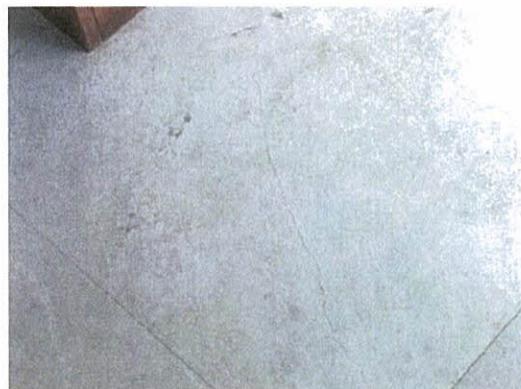
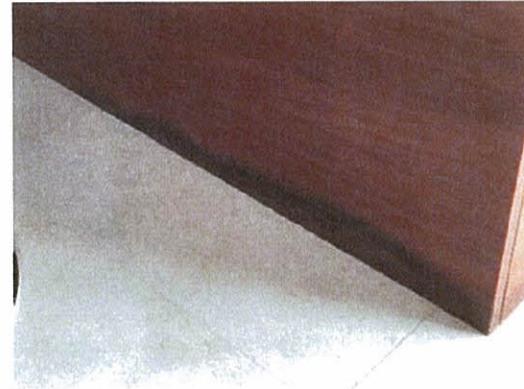
Cracked tile at living room proximate to kitchen counter

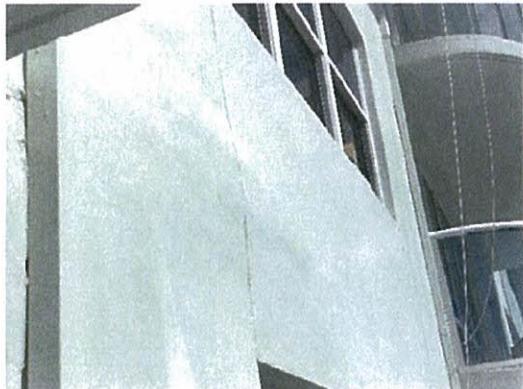
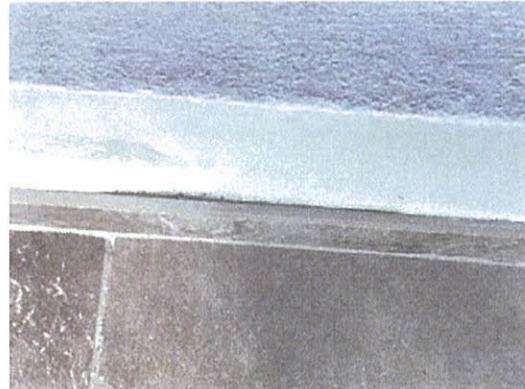
Bulge at building façade as seen from unit's 2008S balcony

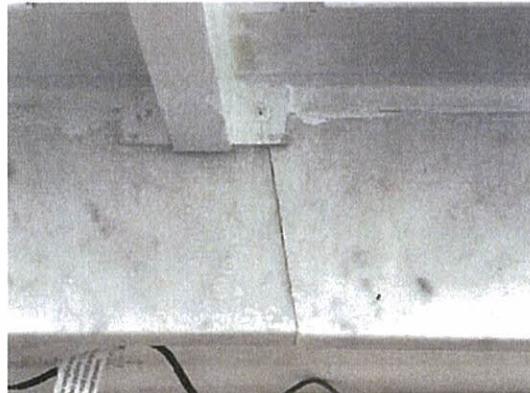
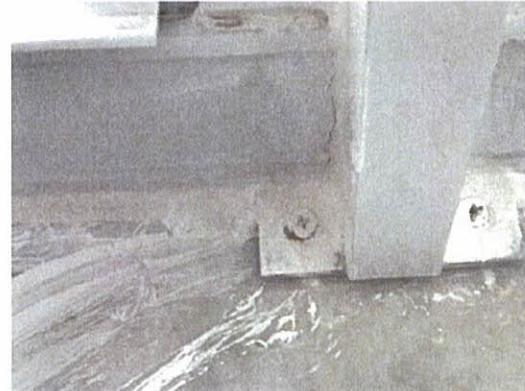
Cracked base finish at window sill

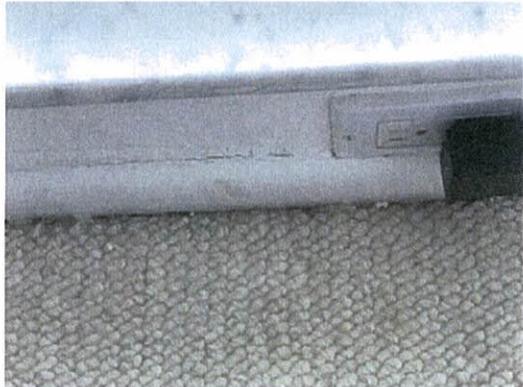
Cracked base board at bottom of window

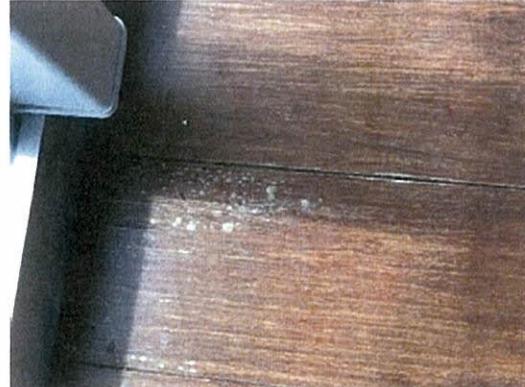
Disjointed and damaged wood floor

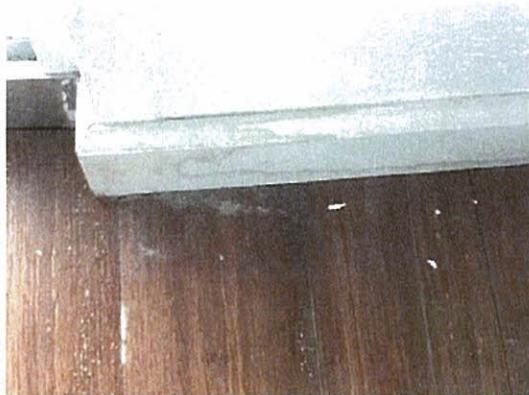
Water stained baseboard and floor

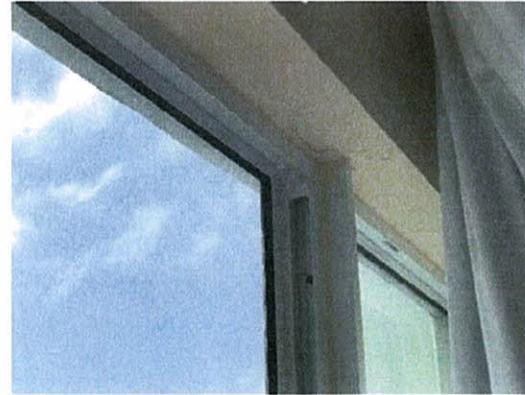
Cracked window header at bedroom window

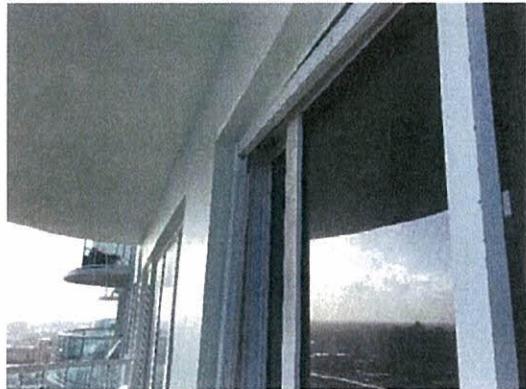
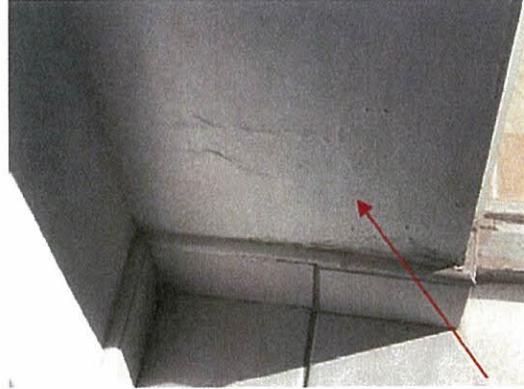
Broken balcony door screener

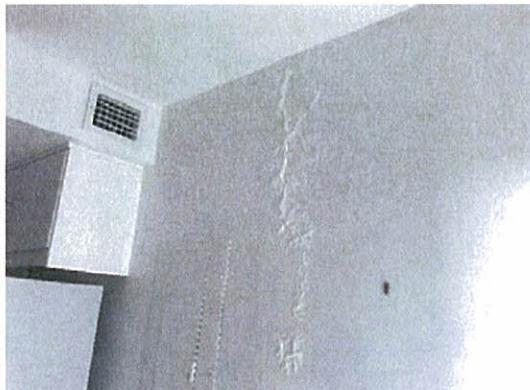
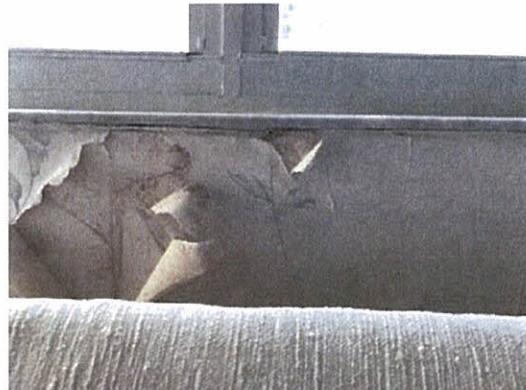
Water damage at kitchen wall adjacent to electrical panel. Water damage at walls and ceiling is visible in multiple location of this unit

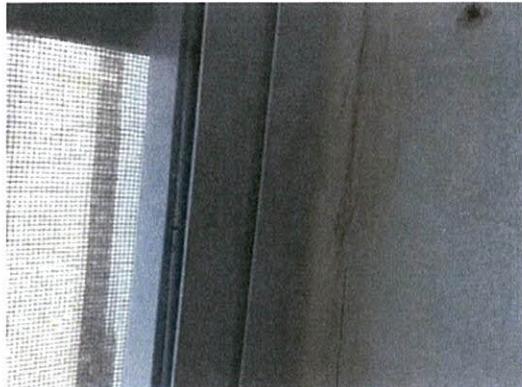
Cracked window frame wall

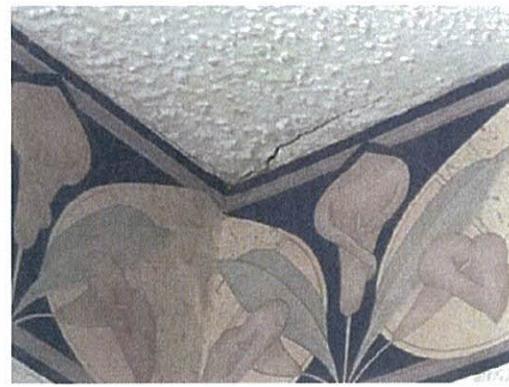
Crack in bedroom ceiling finish typical at spotted locations

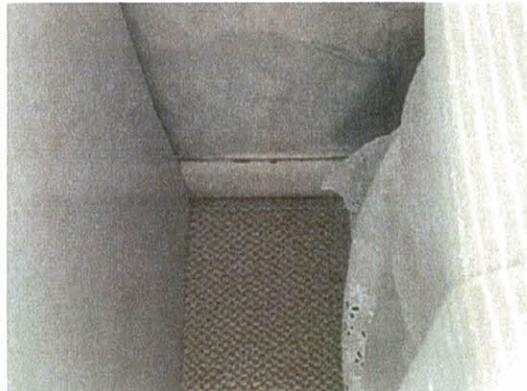
Damaged baseboard typical at various locations

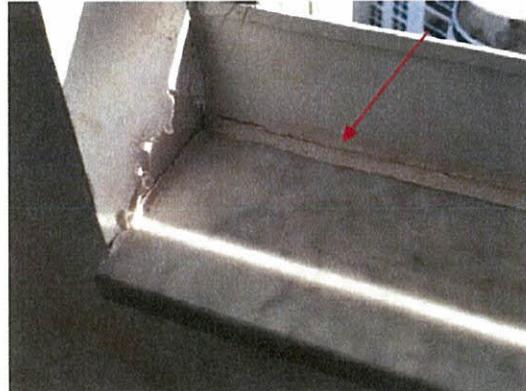
Failed window caulking typical at various locations
